Welcome back inside the friendly confines of Fort  $NO_X$ ! As you may recall, last month's issue featured a Honda which had failed the I/M 240 test for excessive  $NO_X$ . This month's car, a 1988 Volvo 240, was also an I/M 240  $NO_X$  failure. While the owner of last month's car had insisted there were no driveability problems, and had blissfully ignored the car's persistent pinging, the Volvo's owner readily acknowledged a lack of power. He also told us that his car pinged badly under all conditions unless he used high octane fuel. Even on high-test, the Volvo still pinged mildly on acceleration.

## Fort No<sub>x</sub> Part Three

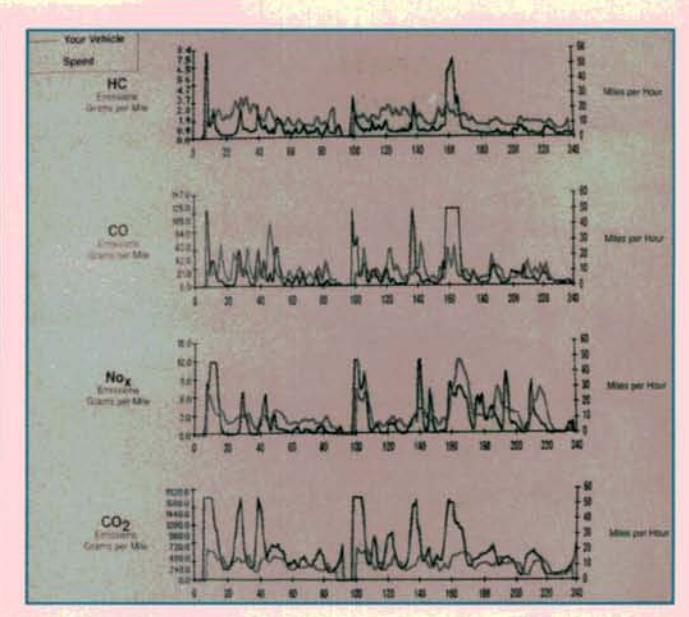
We quicky discovered that the fuel pressure was just 1.5 bar (20 PSI). With the gauge attached, we slowly clamped down on the return line until the pressure reached 2.5 bar (36 PSI).  $O_2$  sensor activity also returned to normal as pressure increased. We ordered a new pressure regulator and kicked ourselves for neglecting to check fuel pressure first.
