Repair Shop

Episode Two: The Case of the Two-Stepping TPS

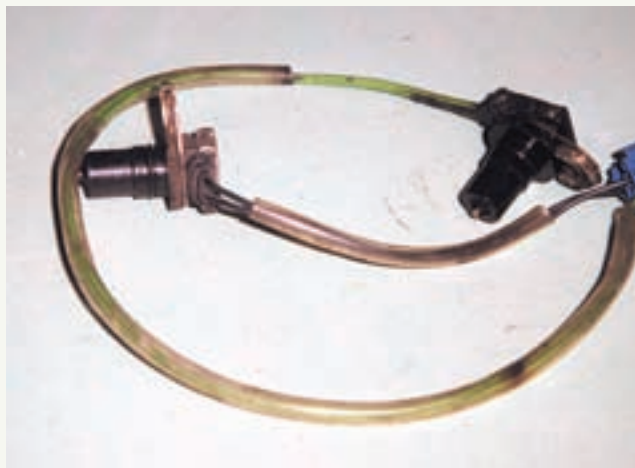
Here is one of the easy-to-see pulse generator connectors. Not the same as the one in the story — this one is actually on a Sonata. It is liable to suffer from the same 'loose-connector syndrome' because the wiring in the lower half (the pulse-generator side) hangs from the bracket. Over time and miles, vibration and transaxle movement may cause the male side of the connection to become loose inside the female side. An intermittent connection may develop.
