FACTORY SERVICE BULLETINS

These suggestions and solutions for technical problems come from service bulletins and other technical information published by Mercedes-Benz, selected and rewritten for independent repair shops.

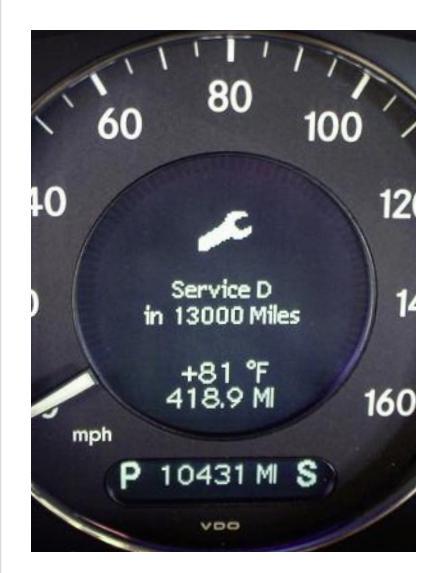
Synthetic Oil Recommended with FSS All models equipped with the Flexible Service System

In case you haven't heard, Mercedes-Benz USA has changed the engine lubricant recommendation for all FSSequipped vehicles (1998 and up): Use only MB-approved synthetic motor oil. Approved synthetic engine oils are listed in the MBUSA oil specification sheet 229.3 or 229.5 which also meet API SL/SM classifications. Oil specification sheets 229.3 and 229.5 for worldwide use can be found on the Workshop Information System (WIS).

MBUSA requests that all service facilities institute this transition from standard mineral oil to approved synthetic oil equipped with FSS technology. Replacement of Model 129 Automatic Climate Control Blower Motor, 1996 and Up Production

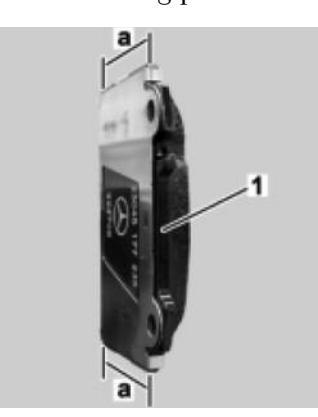
Front Brake Squeal Models ML430, ML500 and ML55 AMG

Although squealing brakes are not the problem they once were, the condition still shows up from time to time. It may be aggravated by cool, damp weather in combination with light braking effort. Besides switching to improved friction material, it's been found that the judicious application of brake paste to the ends of the pad backing plates as shown can reduce the noise. If you receive customer reports in the above model vehicles of brake squeal emanating from the front of the vehicle, please order the improved brake pads available from your local M-B dealer's parts department, and perform the following procedure:

1. Remove the existing brake pads. Reference WIS document AR42.10-P-0161GI.

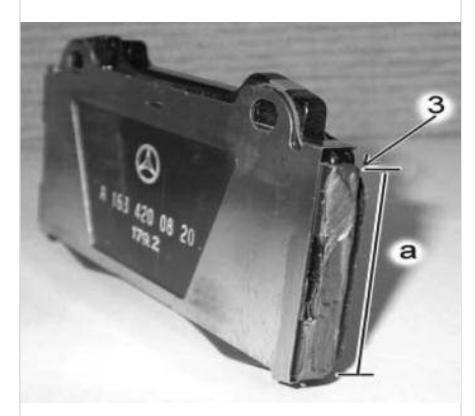
Note: Do not allow any paste to contact brake pad friction surface or apply paste to any other areas besides those specified. Immediately remove any excess paste that contacts pad front or

2. Apply brake pad paste to the ends of the replacement brake pads' backing plates as shown. Reference WIS document AR42.10-P-0161-01GH

back surfaces. 3. Install the improved brake pads. Reference WIS document AR42.10-P-0161GI.
