Another Mystery Solved

Hesitating Corolla with MIL

By John Anello

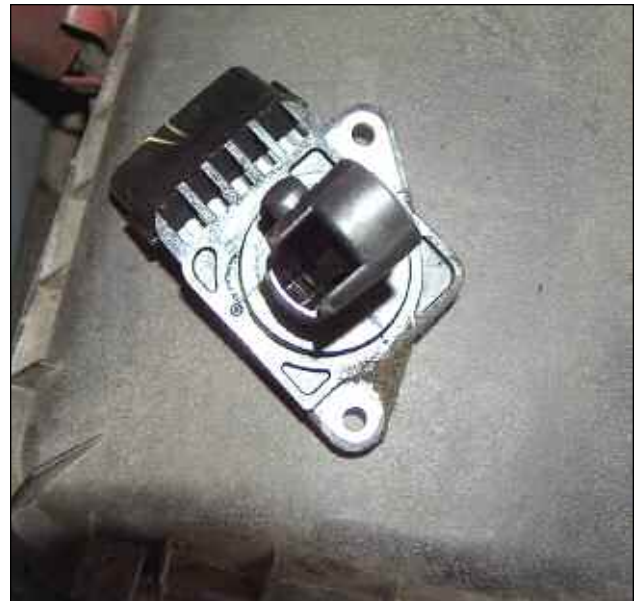
Figure 5

I removed the MAF sensor and inspected the air cleaner housing and duct for any restrictions or leaks and found none. Looking at a MAF sensor (Figure 5), many people get confused by the *intake air temperature-sensing* device on the outside and mistake it for the *MAF sensing element*. They clean the intake air temperature-sensing unit and then reinstall the sensor in the MAF sensor housing. This is just what this shop had done. By looking through the top of the sensor (Figure 6), you can see the MAF sensing element. This one was still very dirty, so I blasted it with electrical cleaner.
