Switching It Up

*No power window switches on
a 2003 Pontiac Bonneville SSEI*

by John Anello,
"The Auto Tech on Wheels"

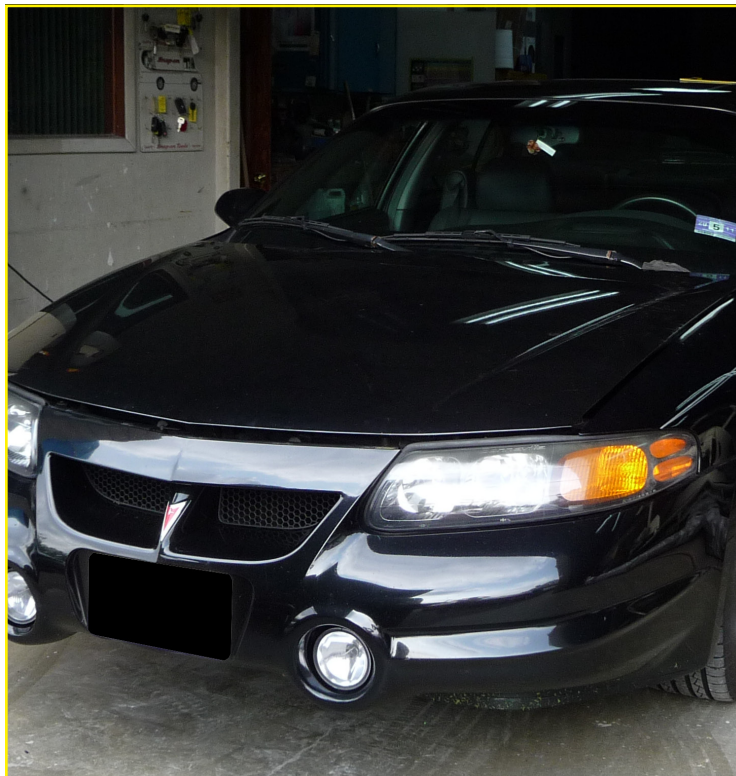
Figure 1: 2003 Pontiac Bonneville SSEI.

I was called in to a shop for a complaint of no power window operation on a 2003 Pontiac Bonneville SSEI (Figure 1). They had already checked the power and ground feeds at the driver door master switch and everything seemed okay. The odd thing was that the other door windows would not operate from their individual switches. It was just hard to believe that this vehicle could have four bad window switches. The window motors all worked okay when power and ground were applied to each motor individually. The garage was uncertain where to turn, so rather than throwing parts at this car they decided to call me in for a second opinion.

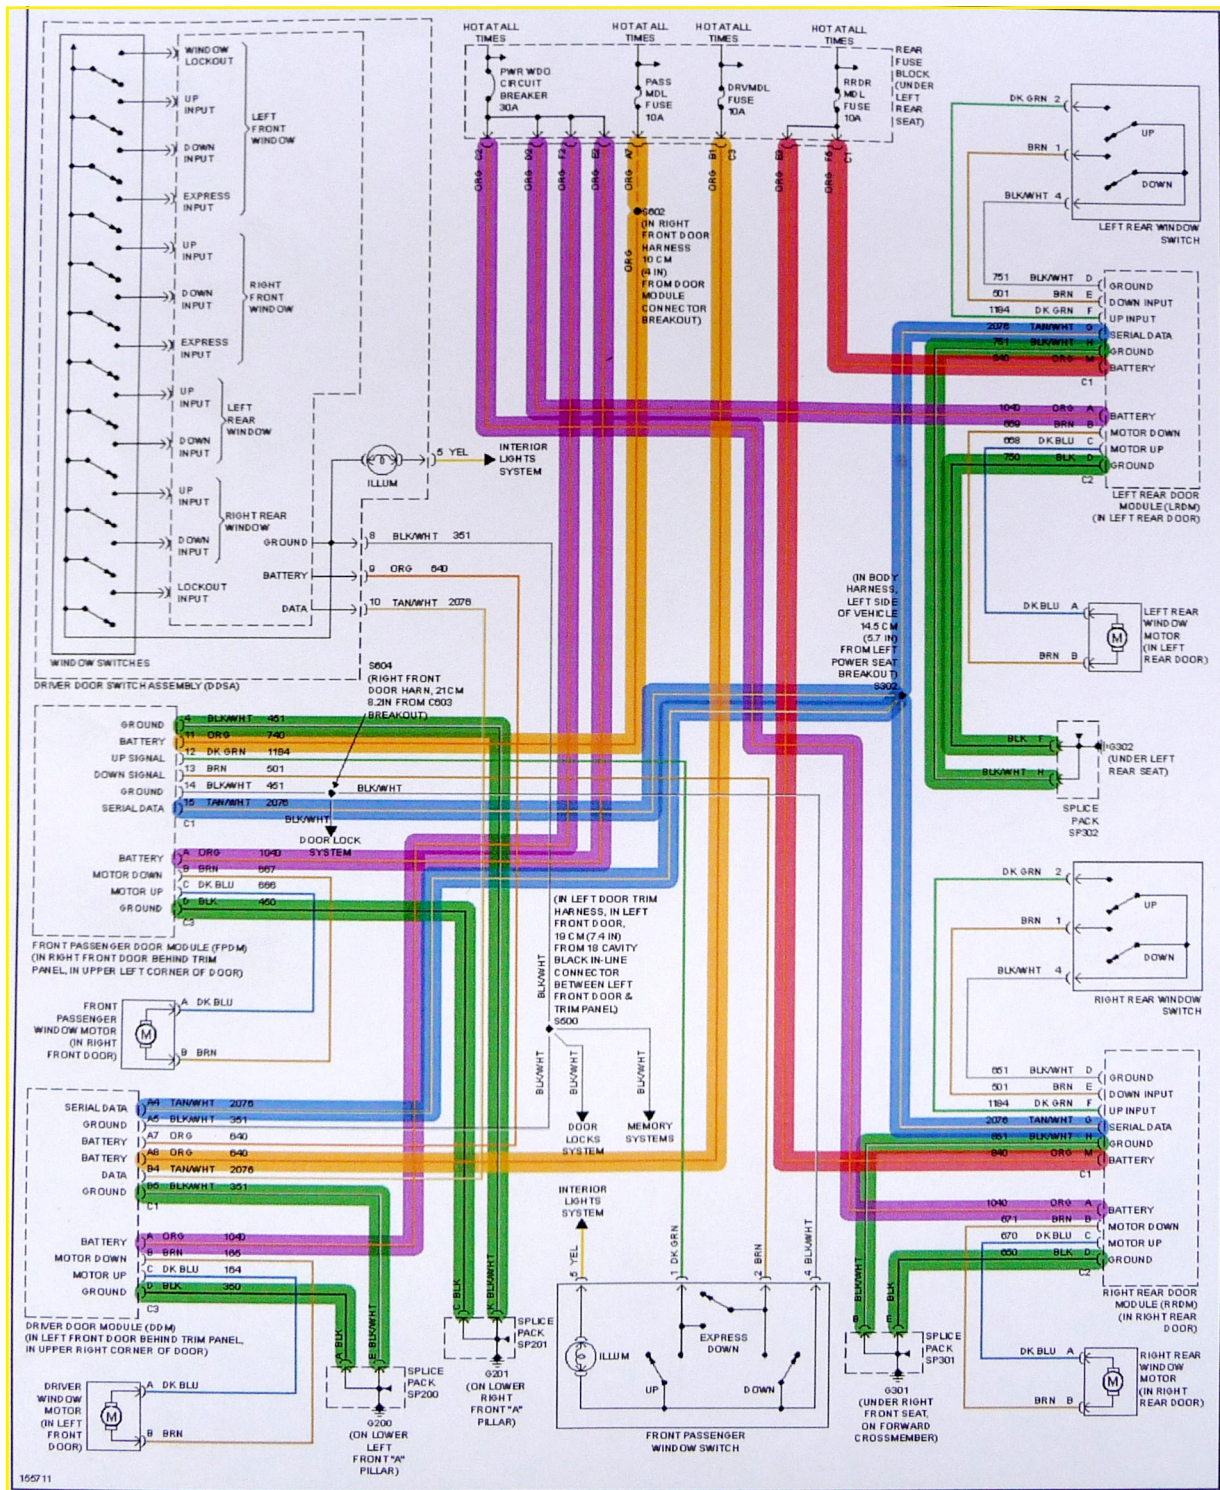
Figure 2: Wiring diagram, color coded: Green = Ground; Purple = High-current Circuit Breaker Feed; Orange & Red = Low-current Battery Feed.

I used my Paintbrush function in Mitchell to color-code the wiring diagram. I chose green for the grounds, purple for the high-current circuit breaker feed, orange

and red for low-current battery feed (Figure 2). The ground feeds for each door module were at different locations, so it was hard to believe that the system had

four open grounds. The rear door modules shared the same low-current battery feeds, but the front door modules had two other separate low-current battery feeds, so here too nothing seemed common to all four door modules. Looking a little closer at the diagram, I could see that all four modules did share the same high-current feed from a 30 Amp circuit breaker, so this was the first place I wanted to look.

mainstream controllers all on one network as seen in the communication link diagram. The door modules had their own private UART network that was shared among them, as can be seen by the blue colored-coded lines in the Power Window Circuit diagram (Figure 2). This seemed like a possible culprit if there was damage to this private network.

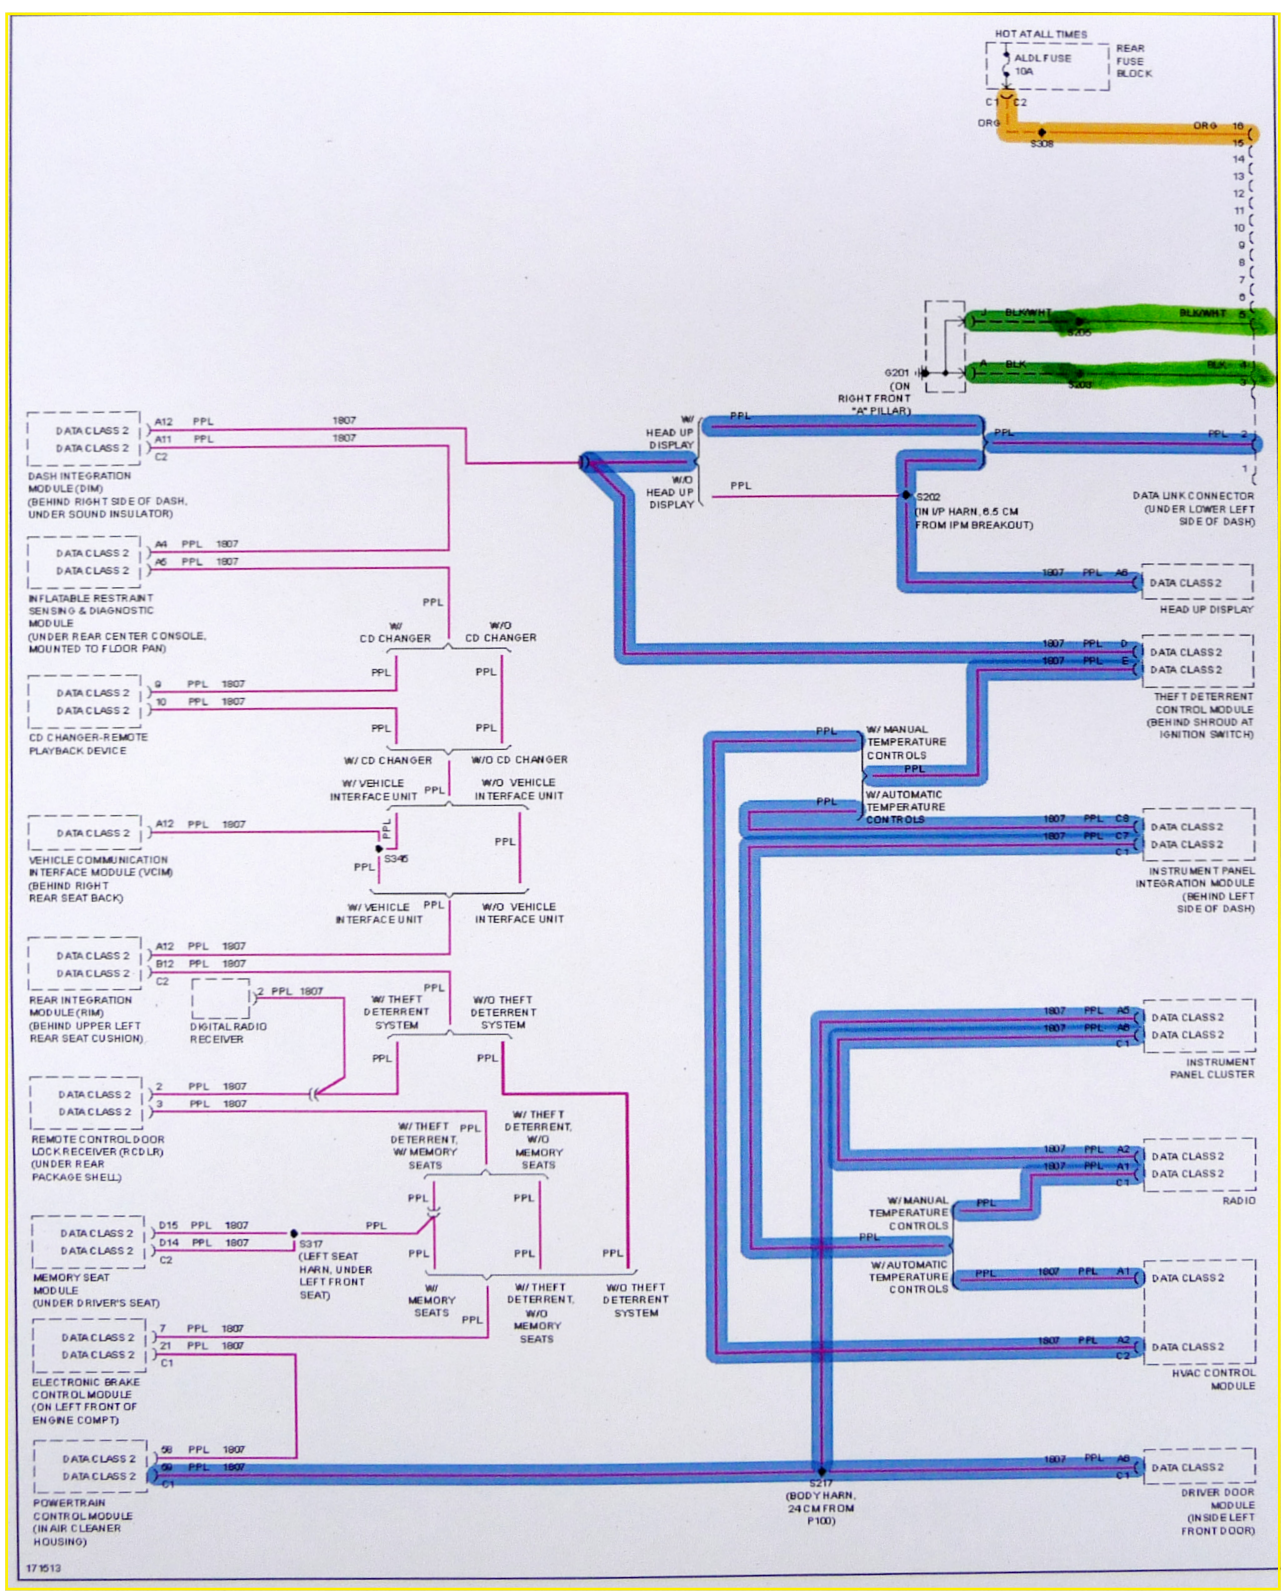
Figure 3: Data communication wiring diagram showing all the onboard controllers on the serial data network linked to the ALDL connector.

I discovered that the driver door module had the ability to communicate with a scan tool by looking at a data communication wiring diagram (Figure 3), which showed all the onboard controllers on the serial data network linked to the ALDL connector. So, I hooked up my GM Tech II scan tool to see if there were any trouble codes stored in memory that could lead me in the right direction. Looking at the scan tool, I pulled some "U" codes of interest (Figure 4). The codes U1161, U1162 and U1163 all pertained to the driver's door module's inability to talk to the other three door modules. There was no access for my scan tool to talk to the other three modules because it was only able to access the
