AUTOMOTIVE FORENSICS

Our man John tracks down what that DTC was really trying to tell him.

by John Anello, "The Auto Tech on Wheels"

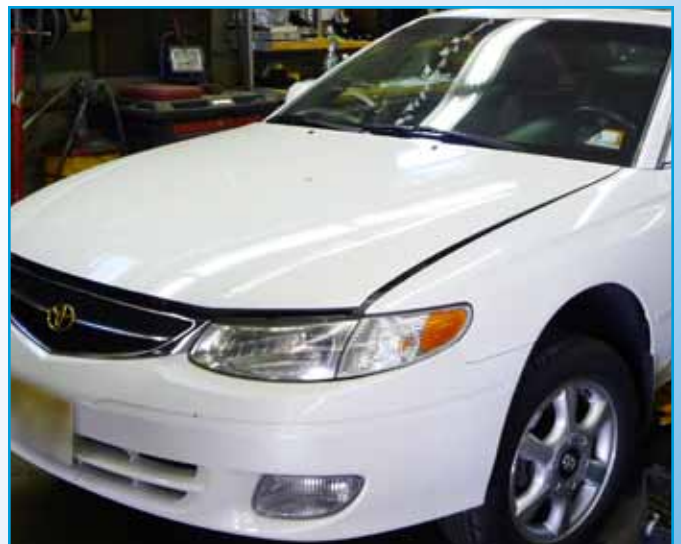
Figure 1: 2000 Toyota Solara

I was called in to a shop for a MIL-on (Malfunction Indicator Lamp, a.k.a. "CEL" for "Check Engine Light") situation in a 2000 Toyota Solara with the 1MZ-FE engine (Figure 1). The shop had replaced two air/fuel ratio sensors, but the MIL came back on after the vehicle was delivered to and driven by the customer. The tech had checked all the fuses, but could not locate the source of the circuit problem affecting the sensors so he wanted a second opinion to get this monkey off his back and down the road. It was bad enough that the shop had replaced parts that were not needed, but now the customer was putting pressure on the shop to get the car fixed, or he wanted his money back. We've all been down this road and it's not a good feeling because you know whatever turns up is going to have to be fixed at your expense and chalked up to the never-ending automotive learning curve.
