The Stuff You See

by Greg McConiga

Our man Greg relates some egregious examples of the things that can be done wrong during the building of a high-performance engine. You'll learn a lot of interesting stuff here.

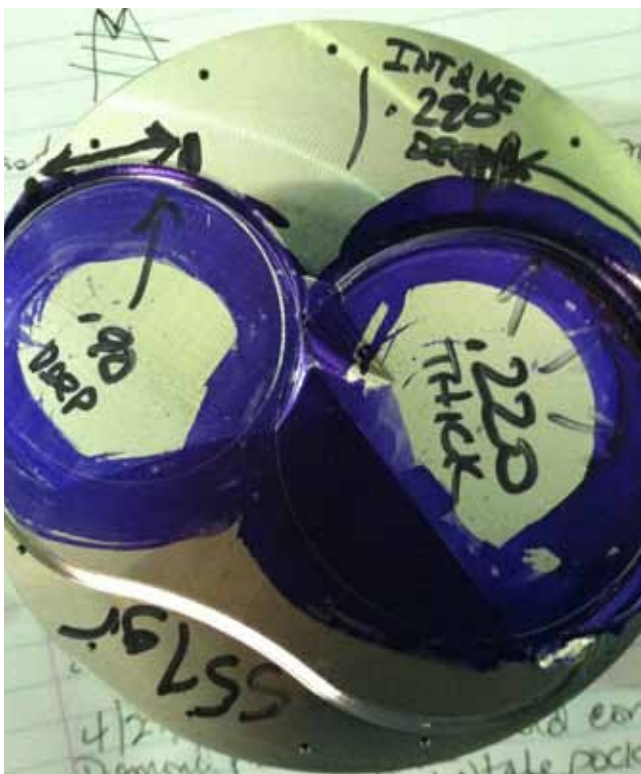
A little Dy-chem and a lot of patience is all it takes.

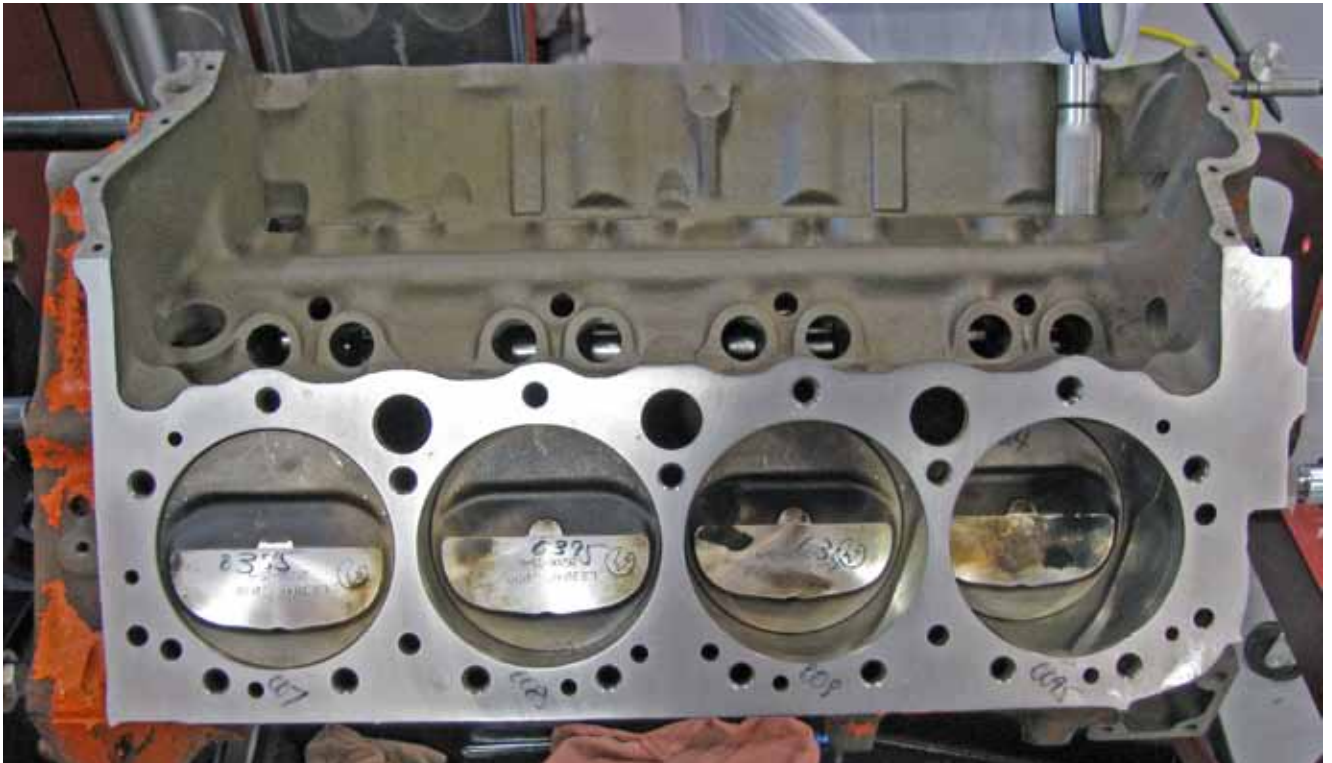
The pictures tell most of the tale. They had bored the block, installed the cam, roller lifters, stainless steel roller rockers and put it back together. Nothing fancy going on here... just gaskets and a few parts. It was originally an 11:1 engine, and that's just how it went back together. If you look closely, you'll see the original piston recession numbers on the pistons and the new recession numbers on

The numbers written on the pistons are how far down the bore the pistons were before we machined the deck. The numbers on the deck indicate where we ended up after machining... quite a difference! (Top: Driver's side; Bottom: Passenger's side.)
