Nissan Technical Service Bulletins to help make diagnosing and servicing Nissan vehicles a little easier.

Title: ABS Self Check Noise

TSB: NTB10-077a

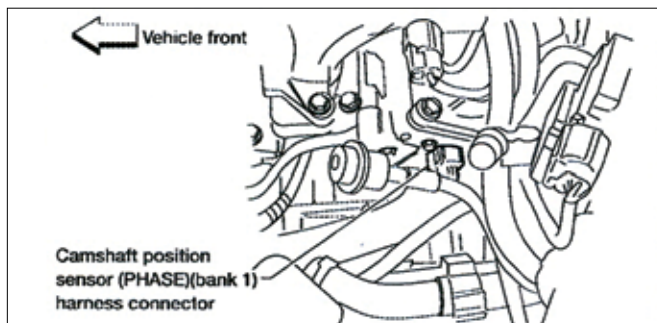
- If you have DTC P0340, replace only Bank 1 CMP (Camshaft Position) Sensor.
- If you have DTC P0345, replace only Bank 2 CMP (Camshaft Position) Sensor.
- If you have both codes, replace both sensors.
- For a "hard to start warm" incident, replace both sensors, even if you have no codes.

Refer to the correct service manual for sensor replacement information. If replacement of the sensors does not solve the problem, further diagnostics are needed.
