# 2015 Golf trunk floor replacement

*To help minimize potential weakening of adjacent panels, reinforcements, corrosion protection, and other critical body elements, Volkswagen recommends partial replacement of the Golf luggage compartment (trunk) floor pan if it has received collision damage. Here you'll find detailed examples of steps in the sectioning and replacement procedures for a 2015 Golf.*

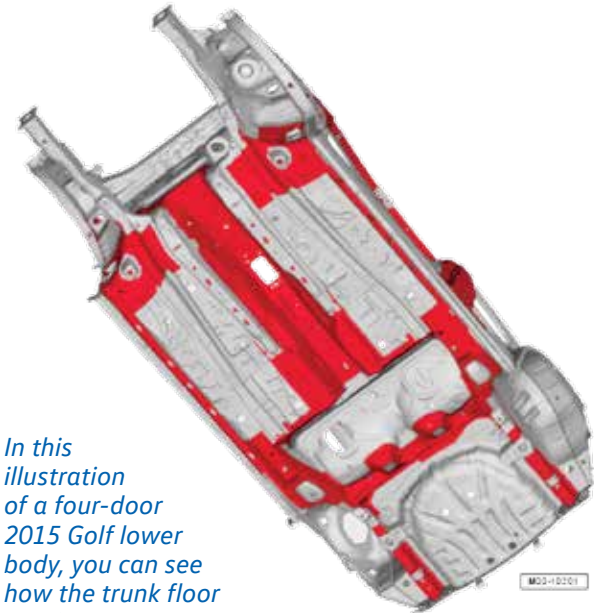
*In this illustration of a four-door 2015 Golf lower body, you can see how the trunk floor pan (bottom of the illustration) attachment to the rear crossmember, frame rails, and rear cross panel (not shown) completes the enclosure and helps support the structural rigidity of the lower rear end.*
