# Camshaft Control Systems Part IV: Timing Chain Guides & Tensioners

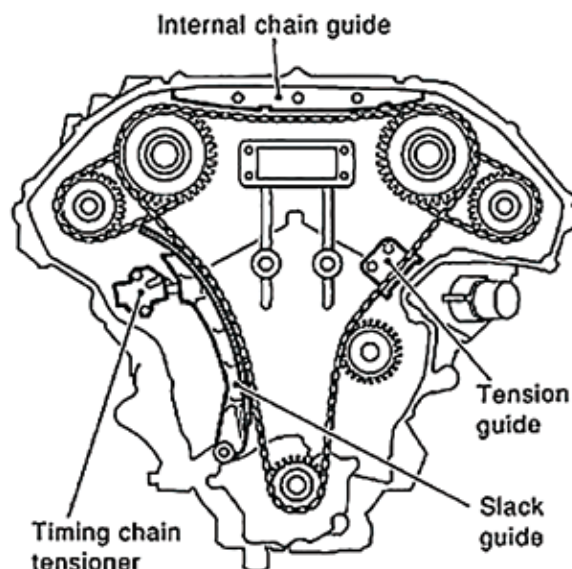
Here we see the main timing chain guides on a Nissan VQ35. All the V6 engines have similar guides.

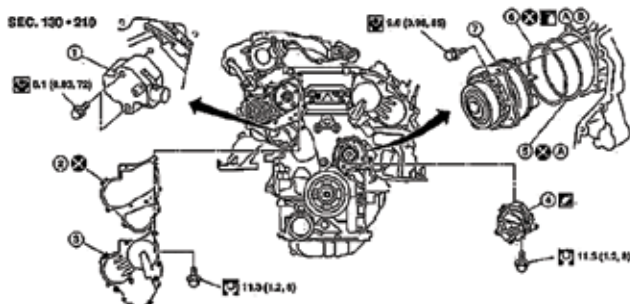
In this image we can see the location of the water pump, primary tensioner, and their covers in relation to the rest of the VQ35 engine.

Excessive wear to the tension guide will typically result in a higher pitched whine from the upper left of the engine, similar to the secondary tensioner whine. A noisy water pump, in contrast, will usually rattle, screech intermittently, or produce a wheel bearing type droning sound from the pump. Probe it with a stethoscope and try to determine if the sound is louder at the water pump cover or just above it. If there is a noise from the area, but you aren't sure if it is the pump or the tension guide, there is a fairly quick way to rule out the water pump. Set the engine to TDC compression for cylinder #1. Remove the water pump cover and primary tensioner cover or the valve timing control cover bank 1, which covers the tensioner on the newer engines. Release the tension by pulling the lever on the tensioner body downwards, pushing the tensioner plunger into the body, and then locking the lever using an Allen wrench. Then remove the tensioner bolts and the tensioner. Now that there is some slack in the chain, turn the crankshaft pulley approximately 20° counter clockwise. This transfers the slack to the water pump side of the engine so the pump can be removed. We do not need to remove the pump for this test, however, simply free it from the timing chain so it can be spun by hand. If any grittiness or roughness is felt, then the water pump is the problem. If the water pump feels normal, then the tension guide is likely the source of the noise.
