Impaired Automotive

2002 BMW X5 4.4i and Murphy's Law

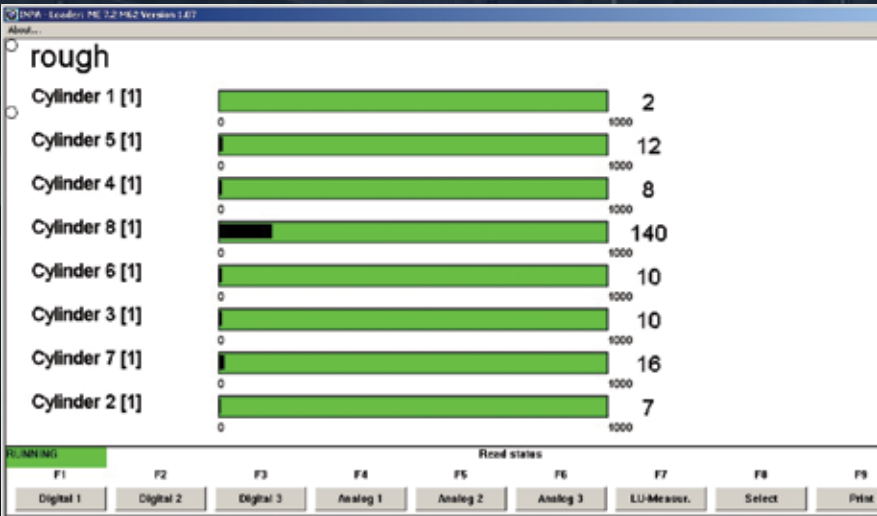
In the bay, there was no throttle control at all. With INPA running, that fault code was deleted, and we noticed that engine harmonics and RPM did change and we did feel the throttle react until the key was cycled again.
