VW 01M SPEED SENSORS

We had this unusual case with a 2000 Beetle 2.0L with the 01M 4-speed automatic transmission. This particular transmission is also used in the Golf/Jetta versions and we still see them in service. The “unusual” part to this transmission mystery isn’t the transmission itself; it’s how it ended up at the repair facility.

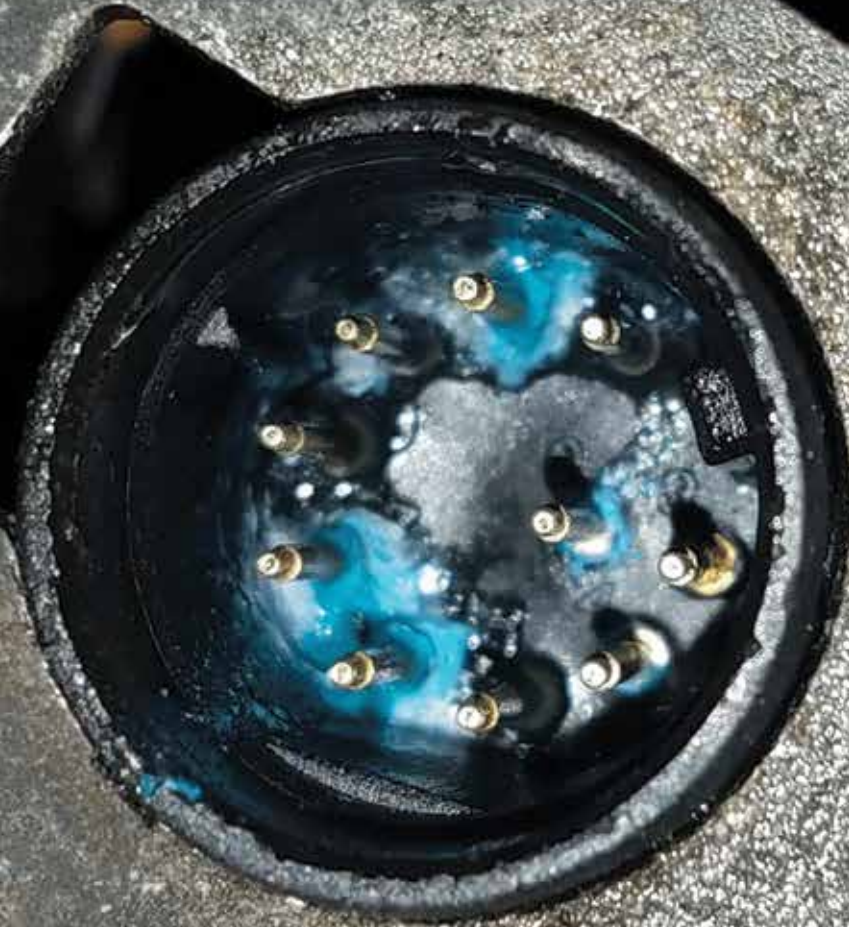
So what did we see? A BIG transmission leak on top on the case, dripping on the floor with a few nuts and bolts missing. What caught my eye were the missing bolt that held a two piece bracket holding speed sensor G68 and the solenoid harness together. This transmission was NOT going to be road

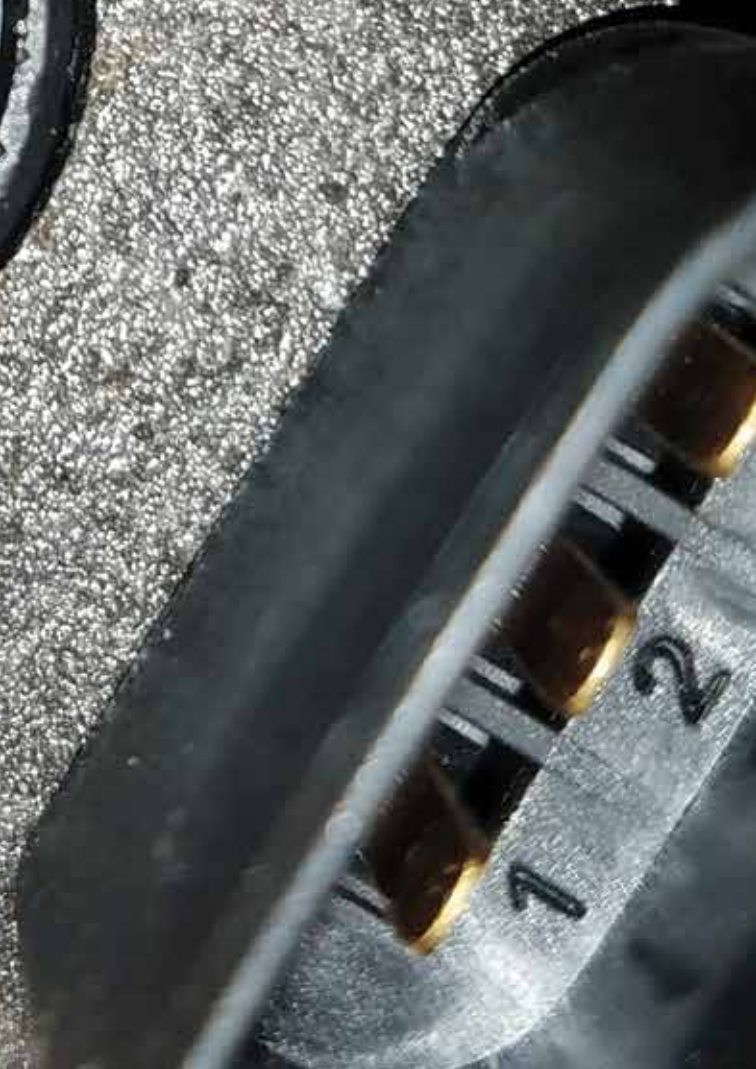
Recording these parameters, we moved onto the transmission to find the leak (washed it) and viewed the data at normal operating temperature. Oddly, when looking at the transmission temperature sensor, the value would quickly toggle between 80 and 110 degrees C. Remember the missing bolt that held G68 and the solenoid harness together? Before that was re-attached, we looked at the solenoid harness (of course the retaining clip was missing).

Opposite Page: There is NO possible way a "NEW" harness is in this condition.

We cleaned the harness on both ends and used a high quality synthetic grease to re-assemble the harness and bracket with a new bolt. Do you think this may cause the unusual transmission temperature readings at idle? Definitely for sure and if the transmission reads the temperature hotter than it should be, this transmission will definitely go into limp mode for self survival. There is so much more to this.
