# derFIX<sup>®</sup>

Technical Knowledge for Volkswagen<sup>®</sup>, Audi<sup>®</sup>  
and Porsche<sup>®</sup> Service Professionals

**VW 01M  
SPEED SENSORS**

**2.0L BEV ENGINE  
WITH AUTOMATIC  
TRANSMISSION**

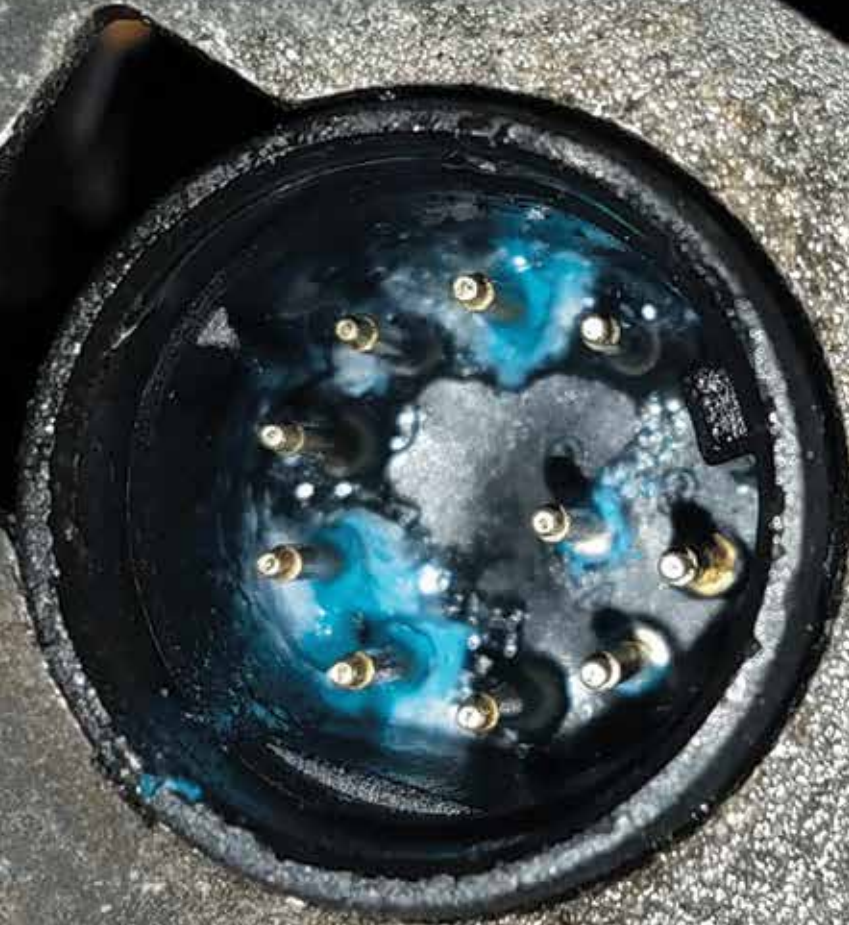
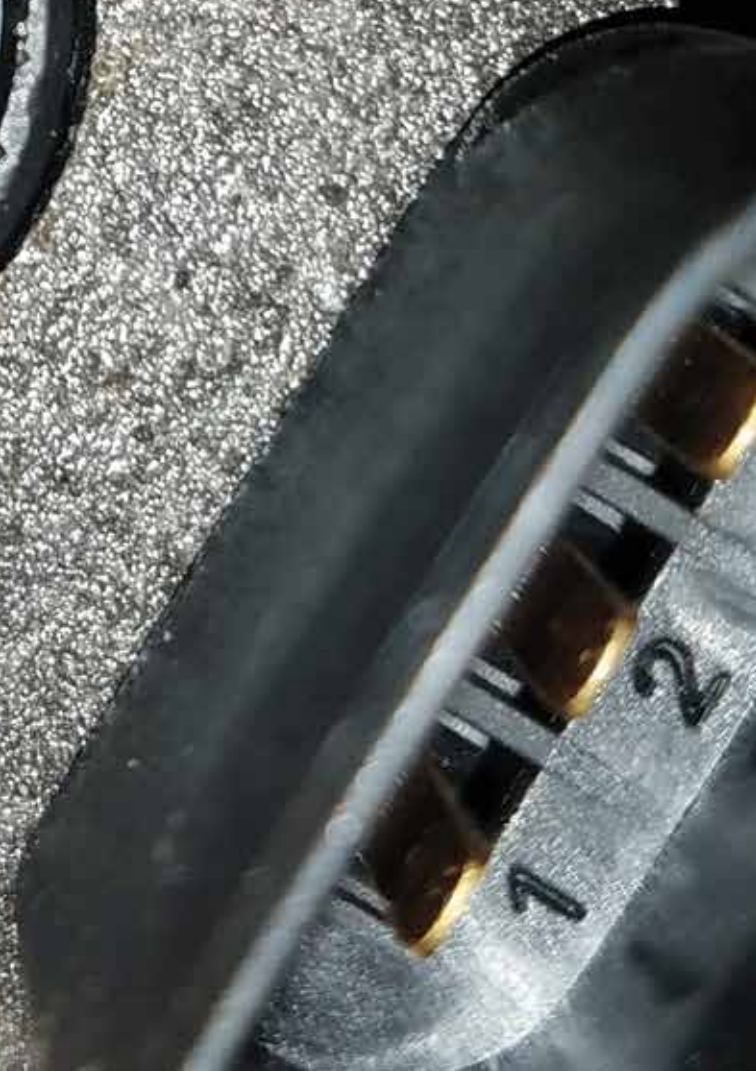
So what did we see? A BIG transmission leak on top on the case, dripping on the floor with a few nuts and bolts missing. What caught my eye were the missing bolt that held a two piece bracket holding speed sensor G68 and the solenoid harness together. This transmission was NOT going to be road

Opposite Page: There is NO possible way a "NEW" harness is in this condition.

We cleaned the harness on both ends and used a high quality synthetic grease to re-assemble the harness and bracket with a new bolt. Do you think this may cause the unusual transmission temperature readings at idle? Definitely for sure and if the transmission reads the temperature hotter than it should be, this transmission will definitely go into limp mode for self survival. There is so much more to this.

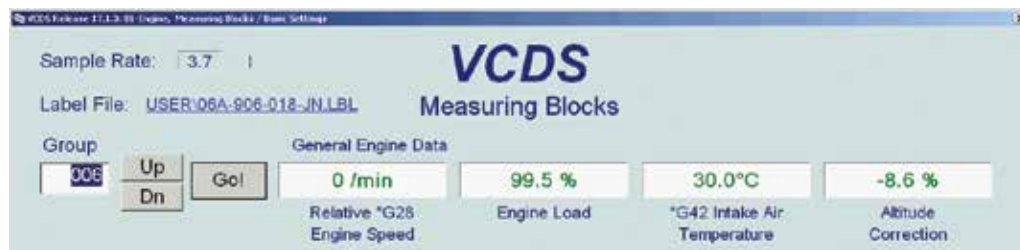
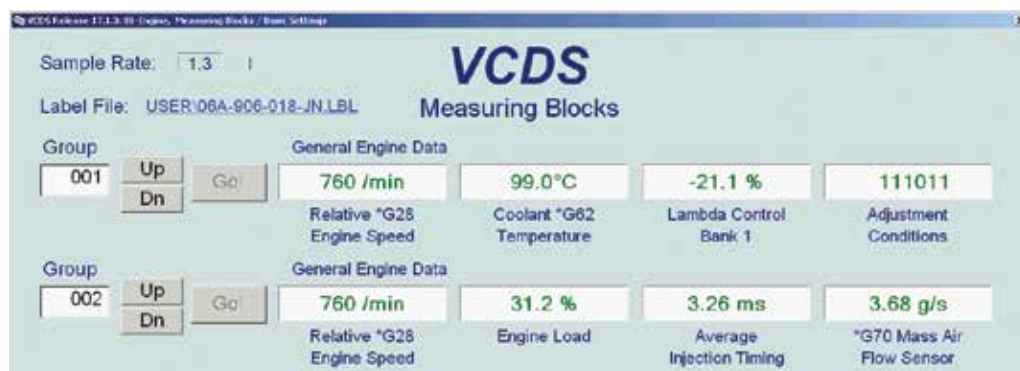
At the same time, we looked at running parameters for the engine up to normal operation temperature. In view are groups 001 and 002 for Mass Air Flow and Lambda Control.

Have a look at the earlier complaint 16486 for MAF; Lambda control is skewed to a large minus number but MAF is reasonable for the moment.

Marie Antoinette ran out of cake and so did I. On a side note, the MAF question, Lambda Control and Altitude Correction issues were repaired with a MAF sensor that fit the correct year, make and model. ■

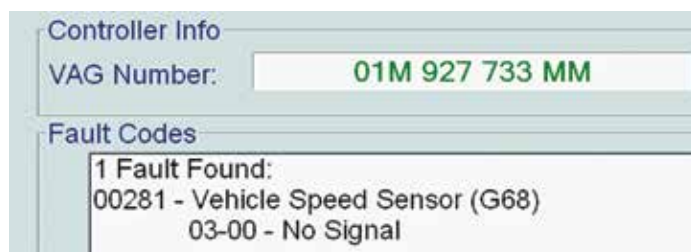
This fault was never recorded earlier and is immediate. The following images lead us to believe that the transmission was missing "road speed."

The fourth field is road speed. It is the output shaft speed at G68. With an open circuit and since the output shaft speed is not being read, the transmission sets limp mode, harsh gear engagement and starts out in 2H while in D with the wheels spinning at about 10 mph for a short period. The view is TCM group 004, field 4 and also found at TCM group 003 field 1.

Chasing the road speed signal to the TCM added more coffee and more cake. The driver's side transmission mount requires removal and G68 is on order. Bench testing the original part, we found an open circuit. I need to interrogate the vehicle

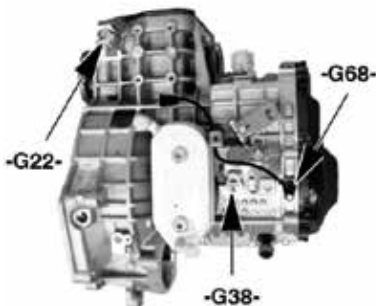
This image shows the correct name and position of speed sensors.

does NOT provide road speed for the TCM.

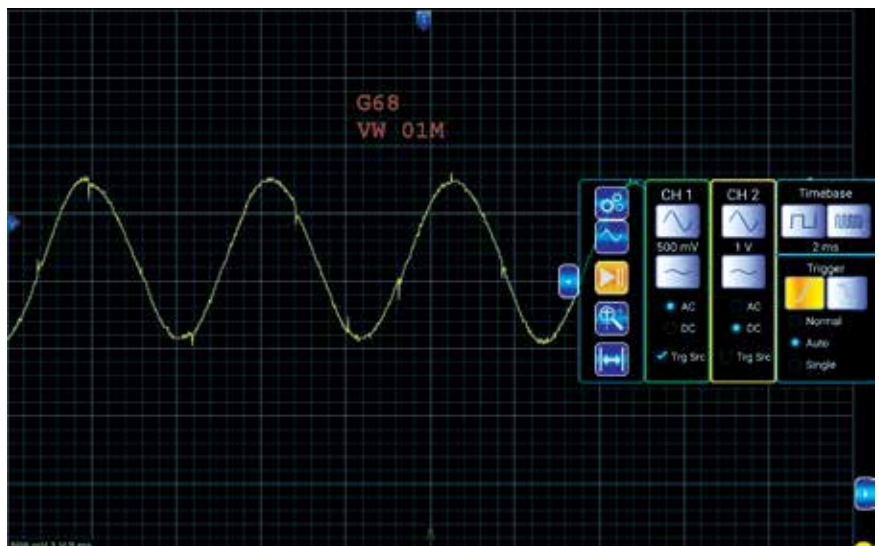
This is the one the transmission uses to measure road (vehicle) speed. Measured in D at idle.
