VIN: 3VWJM31K68Mxxxxxx

Part No SW: 07K 906 032 BJ Component: 2,5l R5/4V

3 FAULTS FOUND

HISTORY

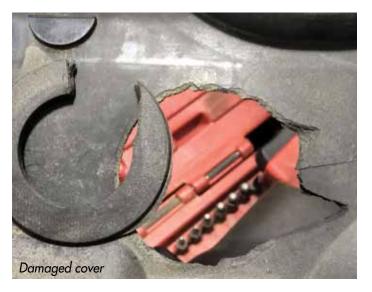
This view of the air filter leads to the assumption that the previous service facility was a little "rough" with the cover that was housing the air filter.

An attempt was made to use a two part metal epoxy to repair the cover and minimize the damage to the air filter. The attempt included affixing the rubber grommet to the stays/pins on the valve cover.
