Technical Knowledge for Volkswagen®, Audi® and Porsche® Service Professionals

November 2019

This Audi Diagnosis Was Bad Timing for All

2005 Jetta 2.5L PCV/Vacuum Leak

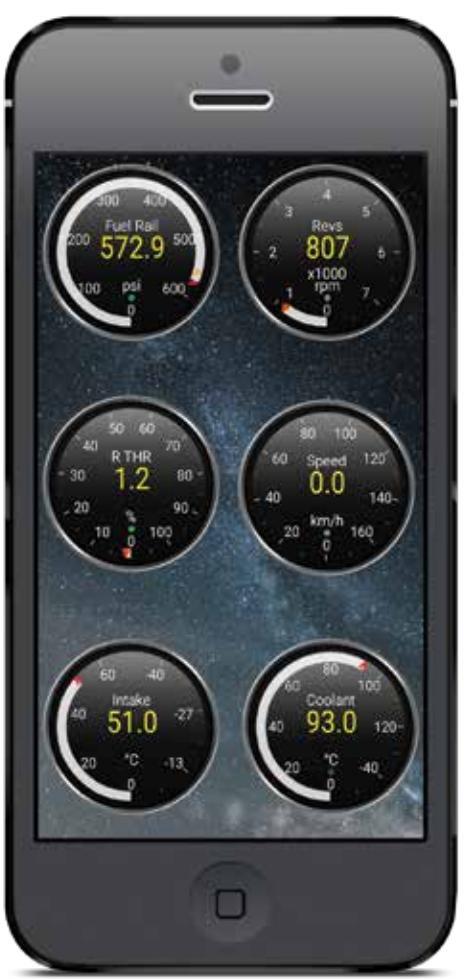
Android psi

For this short running time and viewing the screen capture after the engine was shut down, there are some questions about the replacement high pressure fuel pump.

Warm engine
