Technical Knowledge for Volkswagen®, Audi®
and Porsche® Service Professionals

VW COOLING SYSTEM CONUNDRUM

How a Seemingly Simple Radiator Replacement Leads
to Three Weeks of Technician and Customer Frustrations

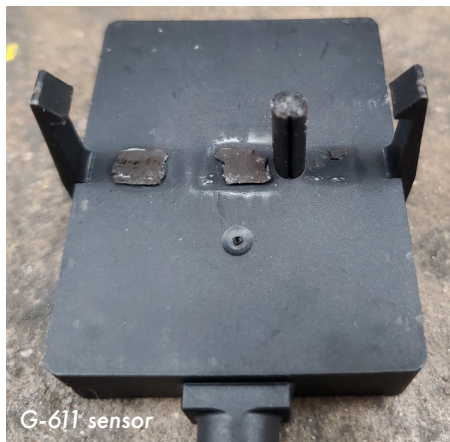
Upon scope checking the physical sensor again, you notice that the power and ground circuits are working properly. You have full voltage, no voltage drop on the ground circuit, and then the signal circuit catches your attention. It seems that the "sensor signal" circuit is actually signaling more like a communication line, rather than an analog sensor return circuit. Huh? Interesting!

Here we see the oscilloscope waveforms for the Golf's DOR sensor mounted in the radiator.
