Module Updates Do Fix Shifting and Slipping Problems

Don't rush to replace that transmission, check for service bulletins and updates first! We present some cases where problems were solved with control unit updates or replacements.

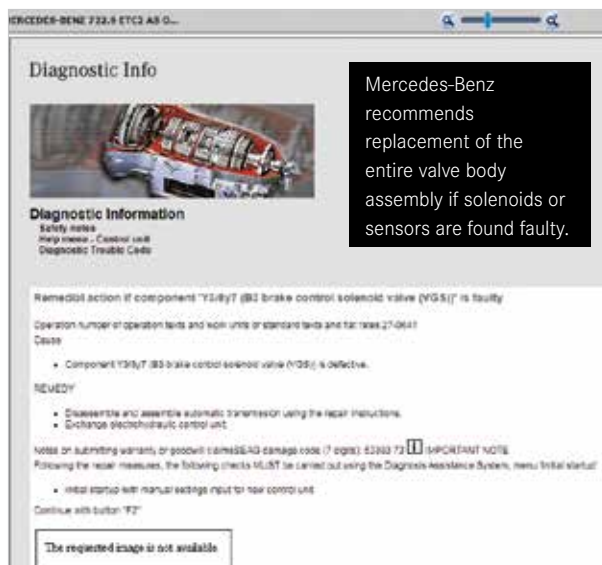
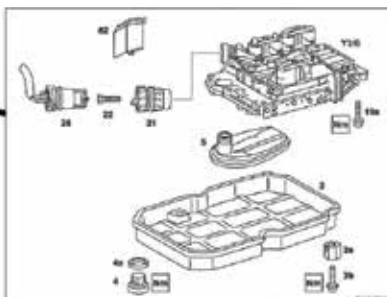
Here's a layout of the typical components in a 722.9 transmission oil pan.

Before starting work, the area around the valve body separation point on the transmission must be thoroughly cleaned, we call it surgically clean: Even the slightest dirt particles introduced into the hydraulic components can lead to malfunctions or even a total failure of the transmission.

After installing the replacement valve body and control unit, along with a new filter and fluid (remember: those aluminum bolts are stretch bolts and must always be replaced), the technician used his XENTRY Diagnostics machine to perform an initial startup, flash in the latest TCM software, reset the adaptations, and perform SCN
