Technical Knowledge for Volkswagen®, Audi®
and Porsche® Service Professionals

TOUAREG 09D WITH TIPTRONIC SHIFTER

By: Augie Ferron

The victim
is a 2008
Touareg
with VR6
FSI, 09D
automatic
with
4-wheel
drive

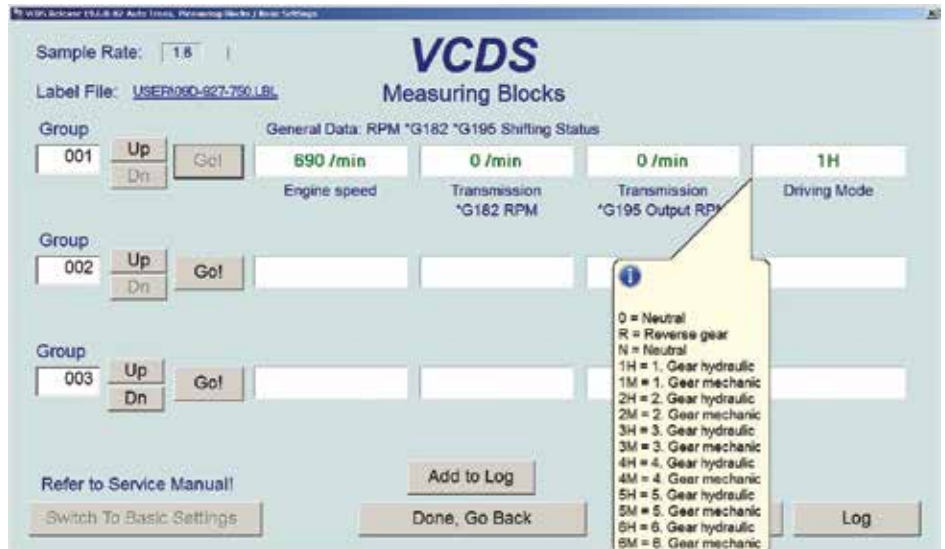
Primary group

With the surface and highway test, and with our being a little rough with the shift lever, nothing happened!

All data was normal and the technician took the time to view the recorded images and videos.

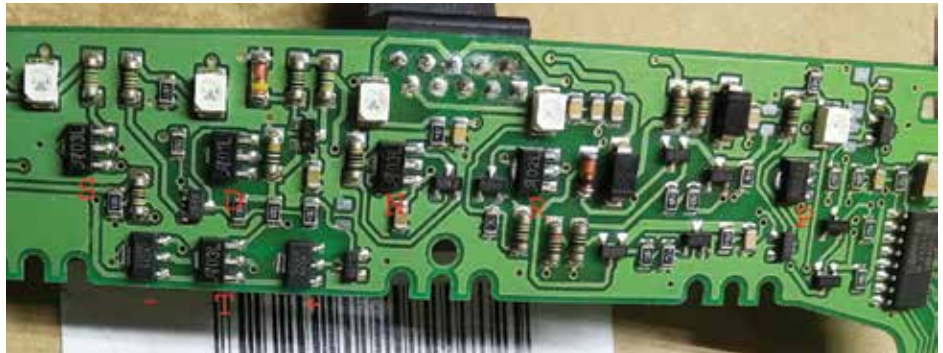
The three magnetic sensors at the bottom represent: Minus - Tiptronic - Plus

The replacement was the cure — no faults returned, and no abrupt shifts were evident.
