## **BODY SHOP MISTAKES - As If, PART 2 & 3**

**The Victim: 2008 Touareg  
with VR6 FSI**

## BODY SHOP MISTAKES – AS IF! (PART 2)

## REAR LIFT GATE HARNESS – AS IF! (PART 3)

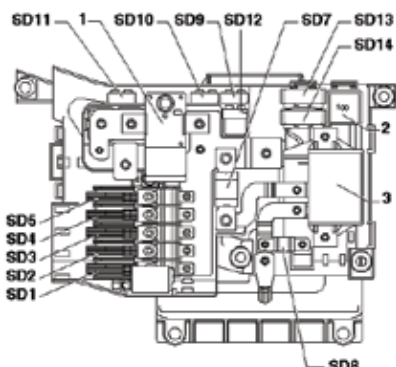
Fuse and relay location

SD9 is designated as a 5 amp fuse for J519 Vehicle Electrical Control Module Terminal 30.

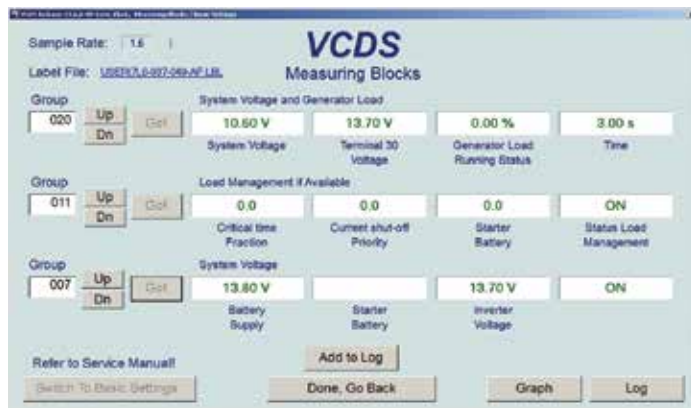
*Proof KOEO with power supply*

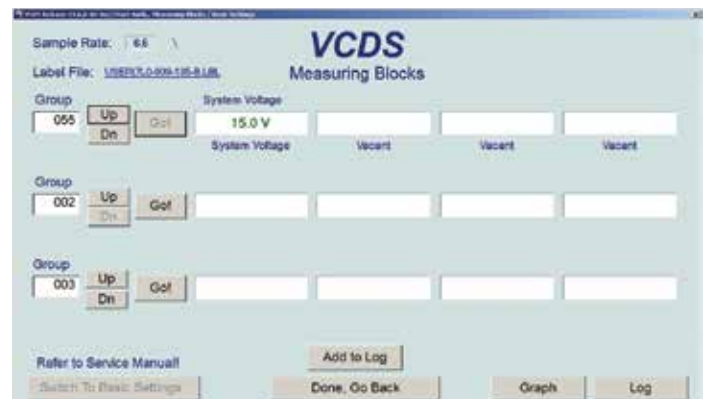
*Address 05: KESSY correct voltage KOER*

The measured value at group 055, field one was normal compared to 17.7 V. Look at the very first image related to the KESSY (Address 05 Start Authorization).

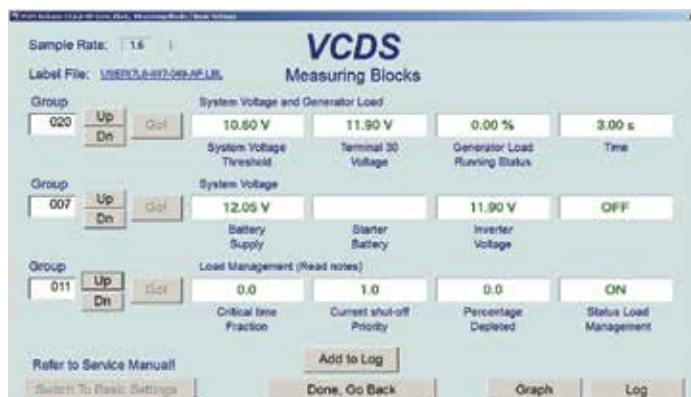
*Low battery, engine not running*

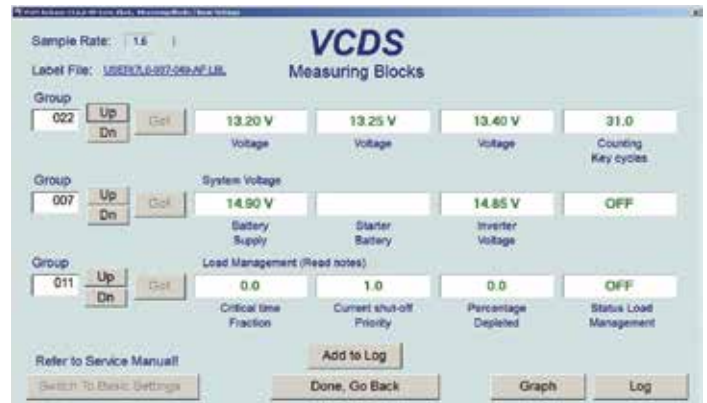
*Address 09: Central Electrics correct voltage*

The measured values at group 022 with fields 1 to 3 were also normal compared to 17.75 V. Look at the earlier images and match these known good values to the defective values in the earliest part of the article.

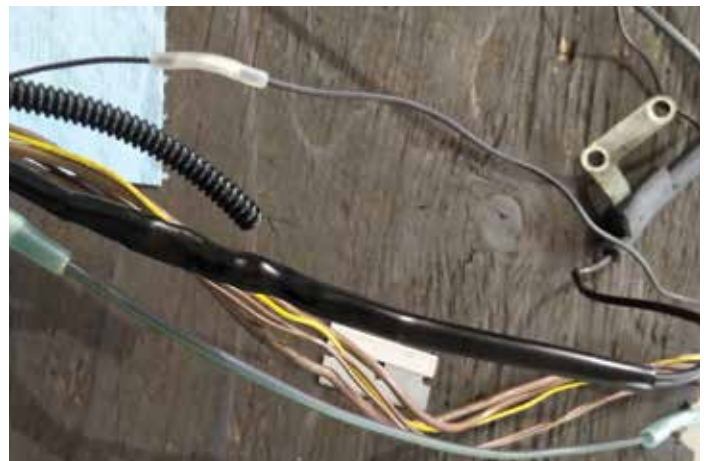
*Roof harness*

The radio harness does not follow the curve of the hinge. The harness travels straight into the body and resides under the spoiler. The washer tube also follows from the interior body and under the spoiler. The washer connection is directly attached to the rear center brake light assembly via stainless tubing.

Why did this harness become damaged? At the hinge there is a rounded plastic protector clipped to the hinge, but it also has an exterior cover that keeps the shape of the harness and holds it in place. That plastic piece was lodged between the protector and the hinge.

With the correct dimension wire and crimp/shrink splices, the pieces that bend at the hinge were replaced. Using the photos, the correct tape positions were an aid and definitely helped to install the harness with minimal effort.

The radio harness (antenna for Comfort Control) is a coaxial component and can be repaired. The choice was made to attach the center core with the clear/white 22 - 24 AWG crimp/shrink splices. The grounded weaving was attached at either end with crimp barrels and wrapping new copper wire. A long piece of shrink tubing was slipped over the harness and heated after the repair was accomplished.
