der **Fix**

MISLEADING VALVE TIMING FAULTS

GO DEEPER AND FIND THE MYSTERY

By: Augie Ferron

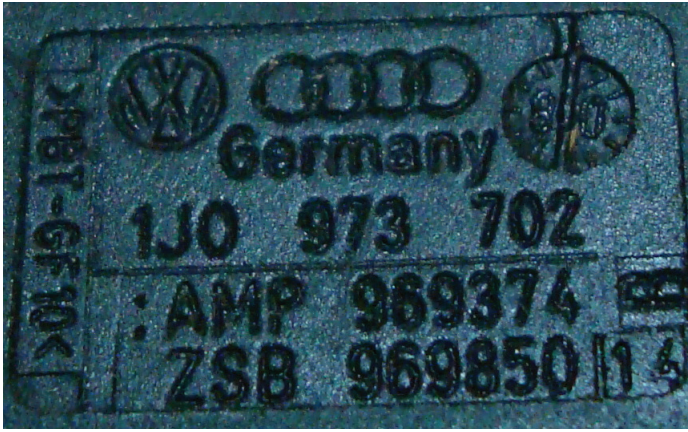
Part number

Look at the differences in Group 001, field 4, Basic Setting Requirement. Notice the changes applying the throttle and how the scan tool displays the "requirements" the engine management system is reading.

With the replacement shell (1J0 973 702) and personal stock of the correct diameter wires with crimp/shrink connections, the final test is the three basic settings that are required to have the engine run in factory condition.
