# der **FIX**®

## AUDI A6 LIN

By: Augie Ferron

### PART 1: ALARM FAILURE

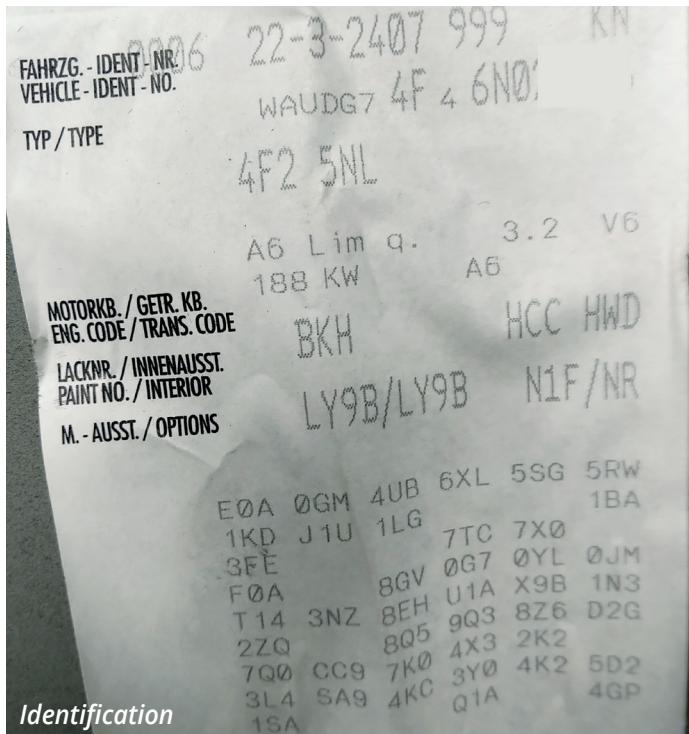
Identification

This model was later started after the initial scan was saved. In the "Lab" and attaching the 90 amp power supply to the "new previously replaced" battery, offered one hint. There was an earlier article about another "Tips and Tricks with a 2008 Audi A6 3.2L no crank/no start" that was remembered.
