A IMPORTA SERVICE

testing with HDS with parasitic battery tests and generator AC ripple

Shown here: EGR stuck open A co-worker made a mention about a rough running 2006 Honda Accord, 2.4L DOHC 16V and 5-Speed Automatic and added the comment, "The car seemed hard to start." Hard to start didn't mean the battery or starter had a defect; rather, the engine speed took a short while to climb to normal. It was time for a lesson for the learning technicians.

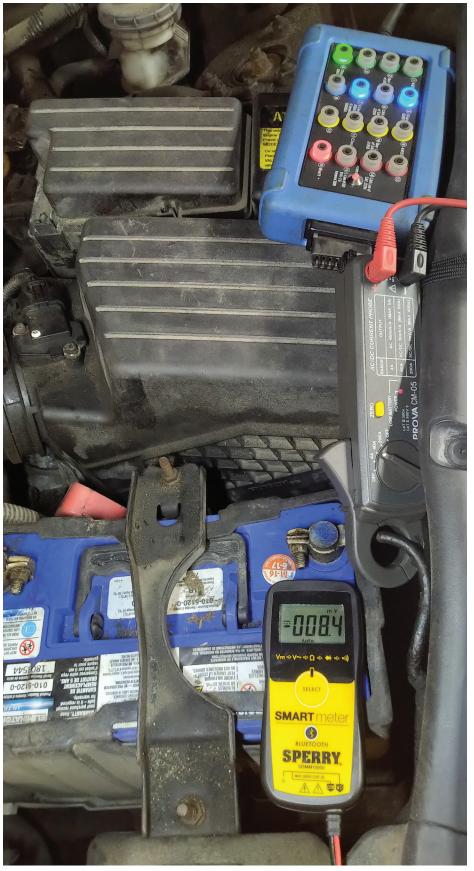
The oscilloscope waveform may express excessive AC spiking at the alternator. Constant AC voltage spikes of over one volt may be the root cause of adaptation problems and corrupt data transfer. A decent scope setting can be between 30 mA and 50 mA (per division) at one ms timebase.

- Scope red lead to B+ of the alternator.
- Scope black lead to the negative of the battery or alternator frame.
- AC spikes of up to 800 mV are somewhat safe, but overall AC ripple should be within 50 mV and 100 mV (peak to peak).

The capture at 200 mV (above) and at one ms timebase offered another view if AC ripple spikes were evident.
