BMW High Mileage Service

By Augie Ferron

2004 BMW X3 2.5i with M54 and manual transmission.

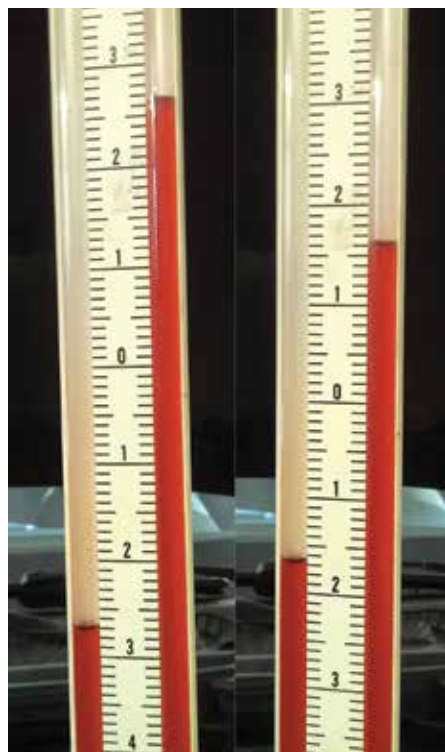
The original measured value was about 3.29 g/s at a hot idle condition.

The expected value should be close to 5.0 g/s and was after repairs.

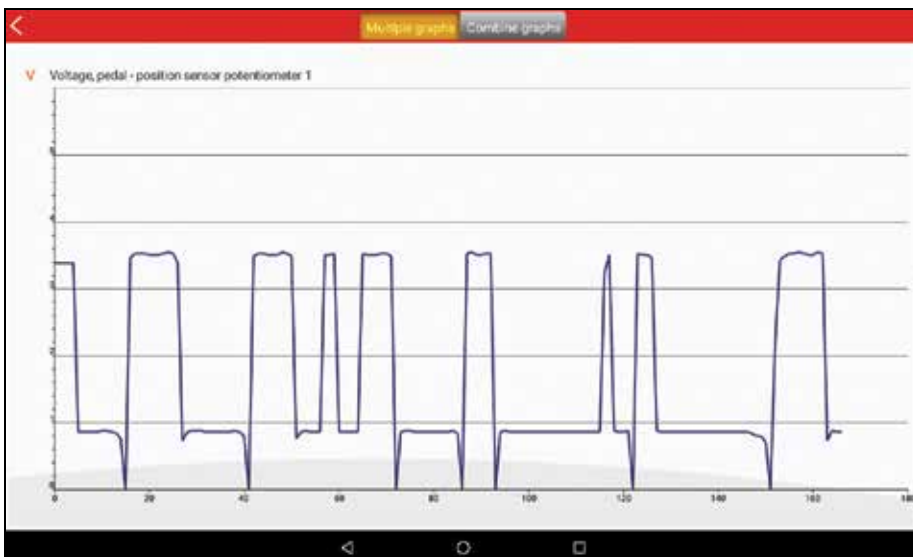
Sensor 1

Added to the Android that's in service is screen video recording software with playback ability. This Android version, however, does NOT include bi-directional control compared to ISTA.

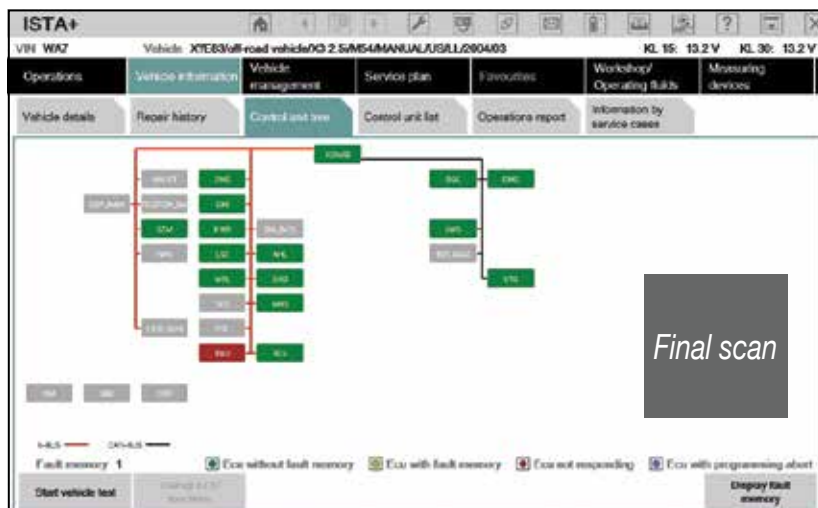
Complete scan

Automatically Search	
System Name	State
ECM (Engine Control Module - DME/DDE)	Find Fault Code 6
EWS (Elec. immobilize system)	No Fault Code
VTG (Transfer case)	No Fault Code
ABS (Anti-lock Braking System - DSC)	No Fault Code
LEW (Steering-angle sensor)	No Fault Code
AIC (Automatic Interval Control)	No Fault Code
AC (Air Conditioning - IHKA)	No Fault Code
IC (Instrument Cluster - INSTR)	No Fault Code
LSZ/LCM (Light switching center)	No Fault Code
MFL (Multi-function steering wheel)	No Fault Code
SHD (Sliding/tilting Sunroof)	No Fault Code
SRS (Supplemental Inflatable Restraint System - AIRBAG/SGM-SIM)	No Fault Code
ZKE (Central body electronic)	No Fault Code
SZM/BZM (Switching/Control Center, Center Console)	No Fault Code
