# TOYOTAtech

## Diagnosing Toyota Tacoma Speed Sensors

February 2021

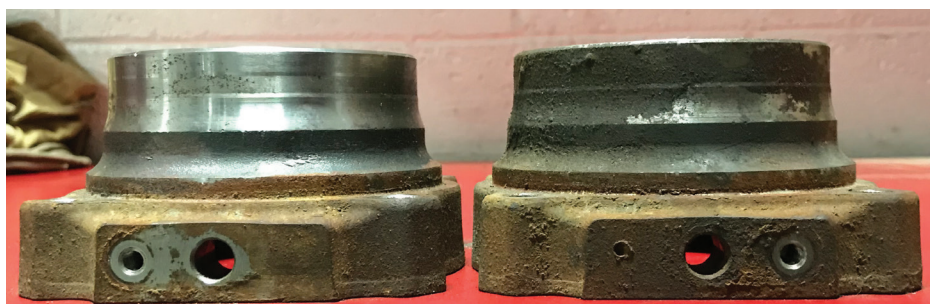
*Rear axle shaft puller*

Larry had easily diagnosed the failed wheel bearings. The repair, however, hadn't been so easy. Larry didn't have the rear axle bearing press adaptor, which makes this job much easier. Pressing the old bearings off and the new ones back on took a lot of extra time, and the job had dragged into Wednesday. The owner was anxious to begin his drive back to his hometown, and then, just when the job was nearly complete, disaster! Larry had installed the left bearing on the right axle than the right bearing on the left axle.

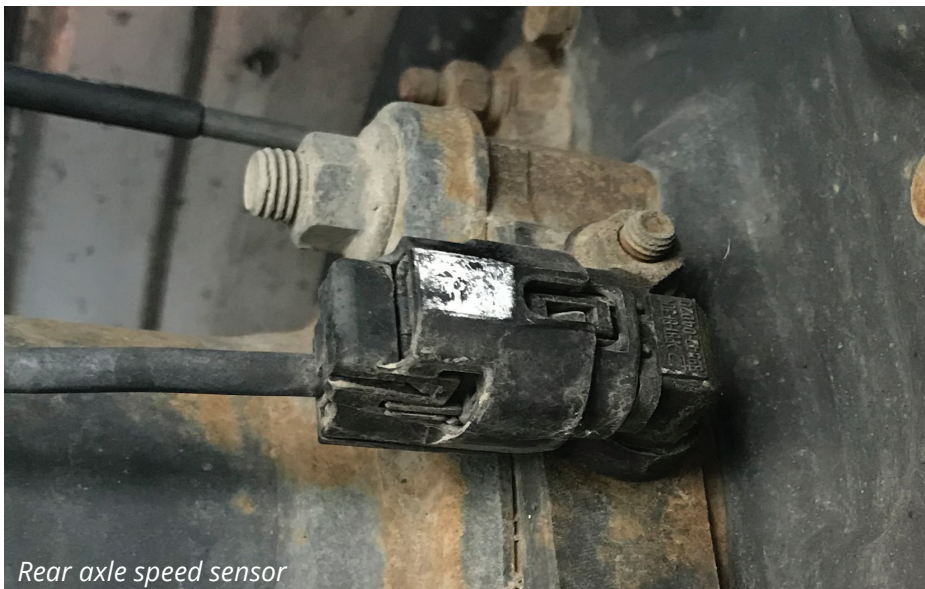
Rear axle speed sensor

Reviewing the DTC Detecting Conditions from Toyota service information shed some light on the situation. The code table showed that both the C0210 and C0215 faults can be caused by a reverse rotation signal for 1 second or more at 62 mph or more!

I now had all the data I needed, and all of my questions answered. The ABS faults were setting because the rear wheel bearings were installed on the incorrect sides of the vehicle. This caused the wheel speed sensor signals to show the rear wheels were rotating in reverse when they were moving forward.

I presented all my findings to the service manager who estimated wheel bearing replacement for the owner. The owner was going to contact the shop in Alaska that performed the original repairs, but he approved the work in the meantime.

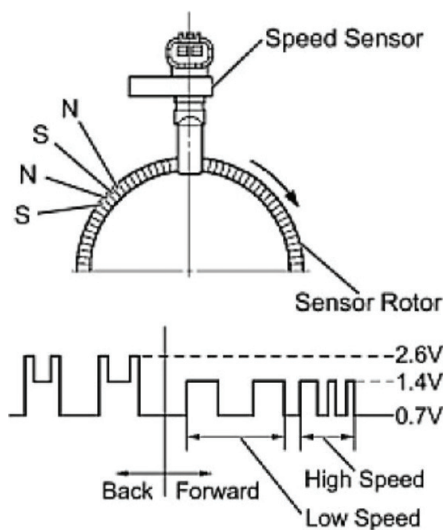
Speed sensor operation

This truck doesn't have a limited-slip differential so by spinning one of the wheels in a forward direction the opposite wheel would spin backward. The scope capture clearly showed both voltage signals the MR sensors can produce.
