How
Volvo
Turbo
Systems
Work

CASE STUDY 2000 VOLVO C70 2.4 L TURBO WITH LOW TURBO BOOST COMPLAINT

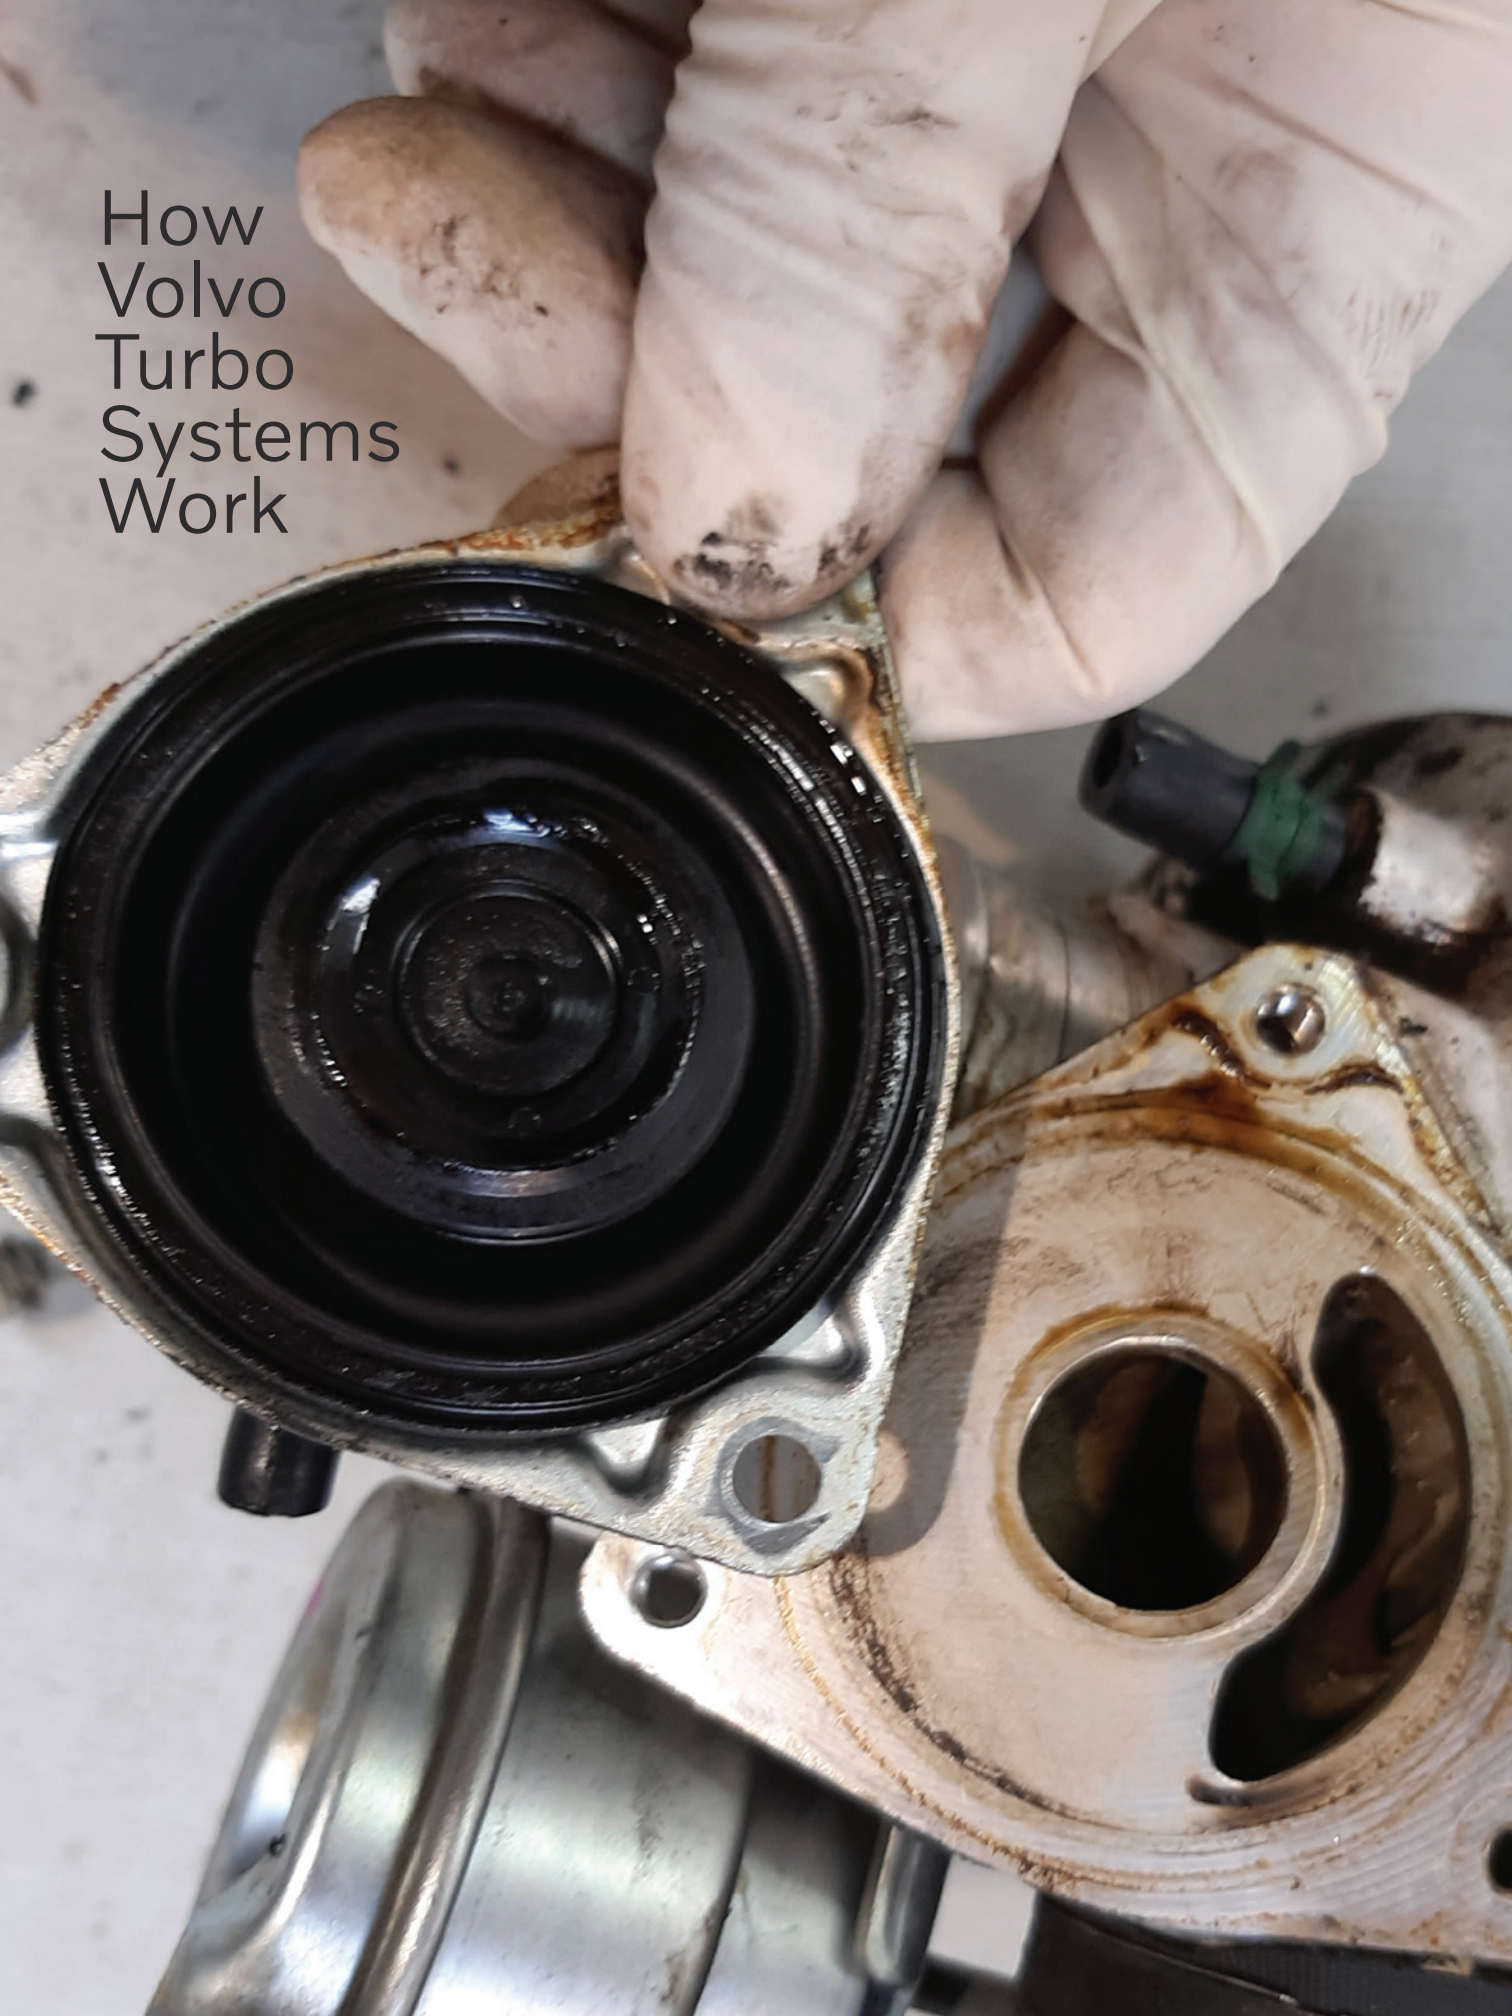
Opposite Page: If you have a car that has low turbo boost, make sure to test and visually check the turbo's bypass valve (sometimes called a blow off valve). The vacuum diaphragm inside can crack and leak, causing some of the intake pressure to go around the turbo fan.

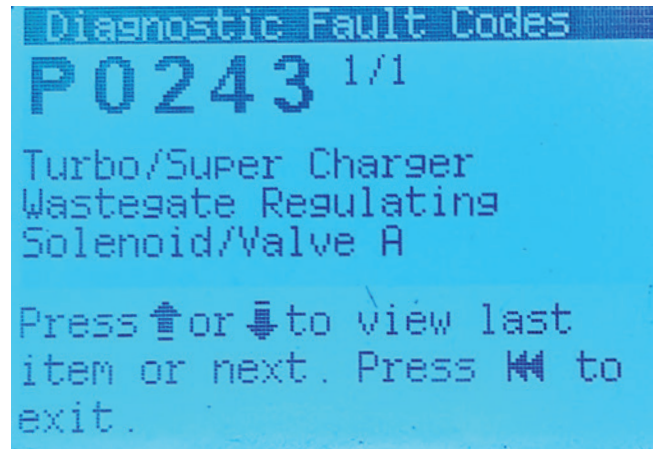
One of the most common turbo control issues you will see on older Volvos is caused by small leaks in rotted vacuum control hoses.
