TechNews

The Case of the Reluctant Titan

The file contained notes and documents for a 2006 Nissan Titan with a 5.6 L V8 engine and 180 K miles on the odometer. This Titan had an issue of intermittently not being able to accelerate.

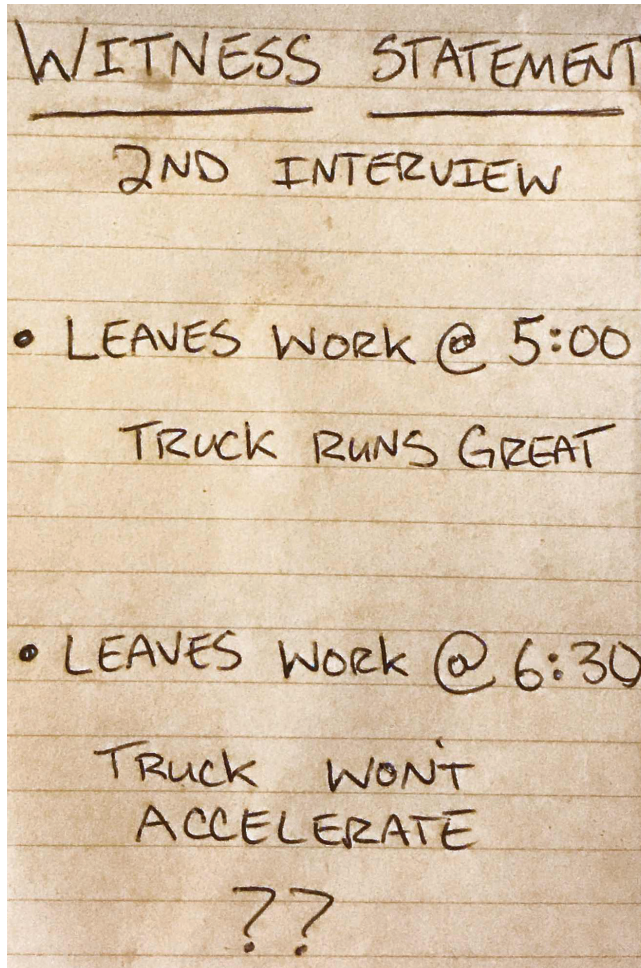
Our super sleuth decided it was time to question the witness again. This second interrogation proved to be quite informative. The witness revealed valuable details about when the truck would act up. The witness stated that if he left work right at 5:00 PM, the truck ran great. But if he had to work late and left for home at 6:30 PM, the truck would act up and not be able to accelerate.
