Automatic Transmission Perfection

Get ahead
of shifting
complaints

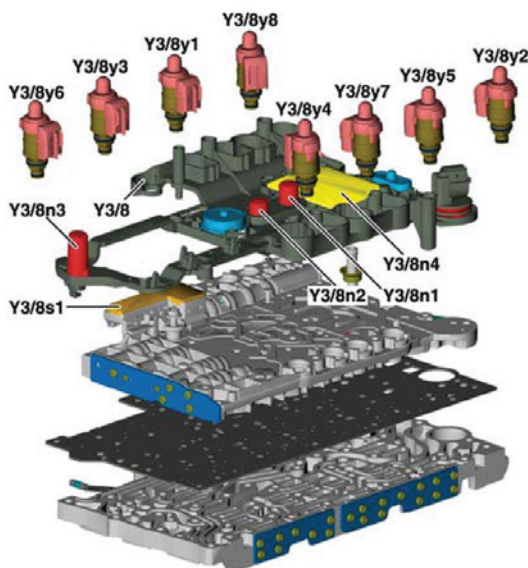
The inner working of the VGS control unit (Y3/8). Don't mix up the solenoids when servicing!

Follow the guided test steps in XENTRY and you may be directed to replace the electrohydraulic controller unit. It should be noted that in some cases there is a repair kit available when directed to do so, which is detailed in Mercedes-Benz WIS (Workshop Information System) document AR27.19-P0220B. It is also important always reinstall the solenoid valves to their original positions, otherwise the calibration mismatch will trigger poor shifting. If you have to replace a solenoid, re-learning the solenoids along with proper programming will have the transmission shifting properly again.

The transmission control unit and sensors are part of the valve body. Replacement requires an online connection with Mercedes-Benz to perform module coding and flashing of the control unit software. Replacement of just the control unit per the service bulletin differs from a complete valve body replacement as the adaptation data, coding and valve body calibration data can be transferred from the old VGS control unit to the new VGS control unit. This data from the old VGS control unit is temporarily stored in the XENTRY Diagnosis unit by processing one of the above codes, and by using the same XENTRY system to perform initial startup of the new unit the data is transferred. Failure to do so will result in the necessary data not being transferred and improper transmission function.

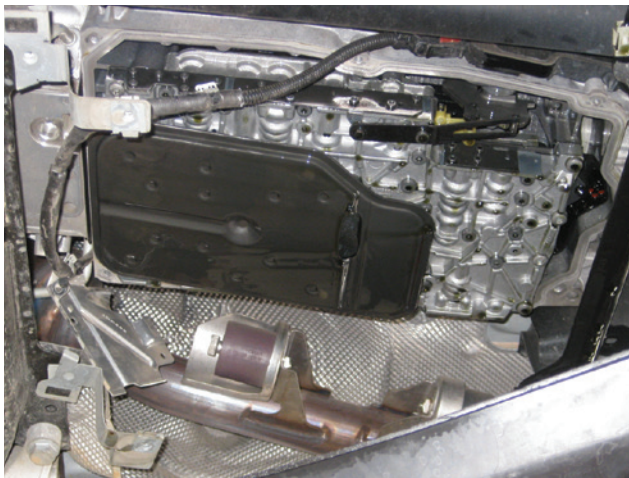
The VGS control unit is accessed by removing the transmission oil pan. Follow the replacement instructions in WIS to ensure a leak- and problem-free job.
