May 2021

TechNews

The
Infamous
U1000
Code
A Study in
Nissan Network
Diagnostics

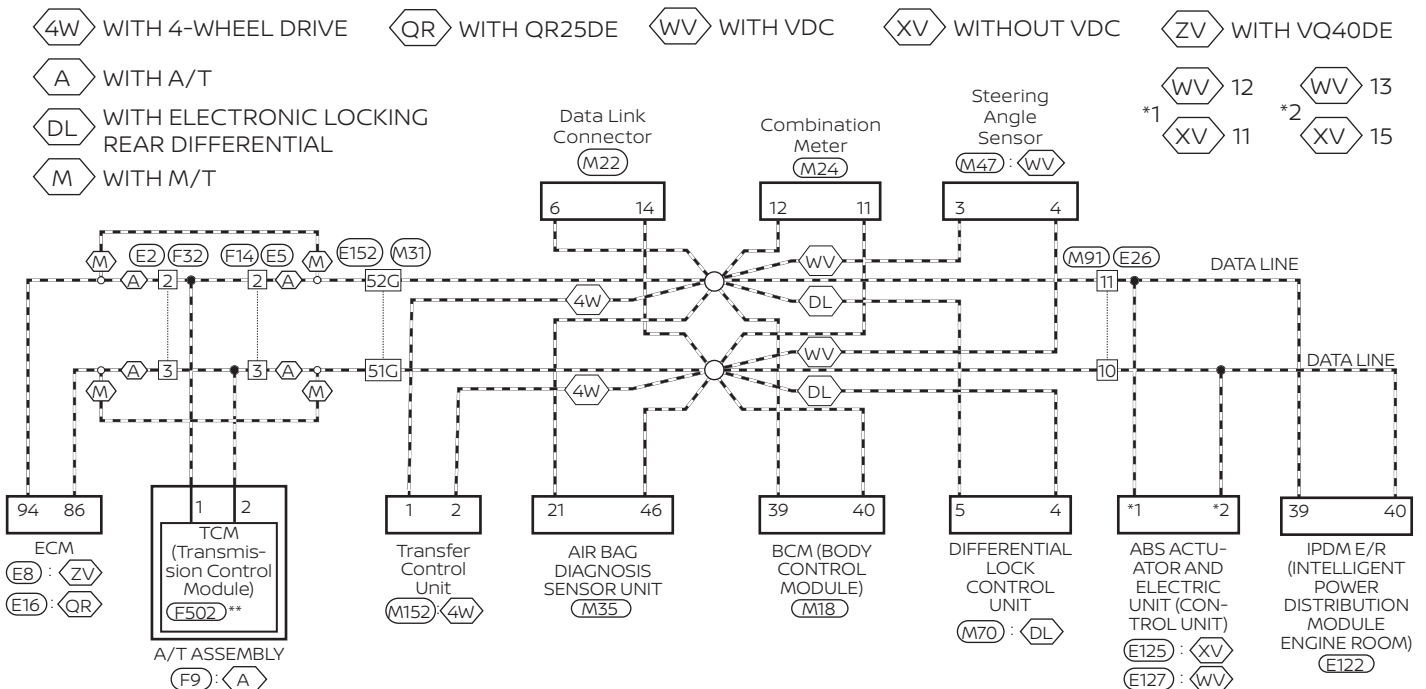
Figure 1: 2010 Nissan Frontier 4x4 CAN system network diagram

Note that this vehicle is equipped with what we call a "star network." In other words, each module on the bus is connected to the others and to the DLC via a common splice, so that every module has an independent path back to the splice and then a shared line back to the data link connector.

Unfortunately, Nissan does not locate the 120 ohm resistors in the diagram, but in our experience (and as we will see

on both vehicles we analyze in this article), one of the resistors is always located in the ECM. An alternative configuration, used by Nissan in a “hybrid” (combination of more than one type of topology), is the linear topology, preferred by some manufacturers such as GM. Figure 2 is a typical linear topology as found on a 2014 Chevrolet Malibu.

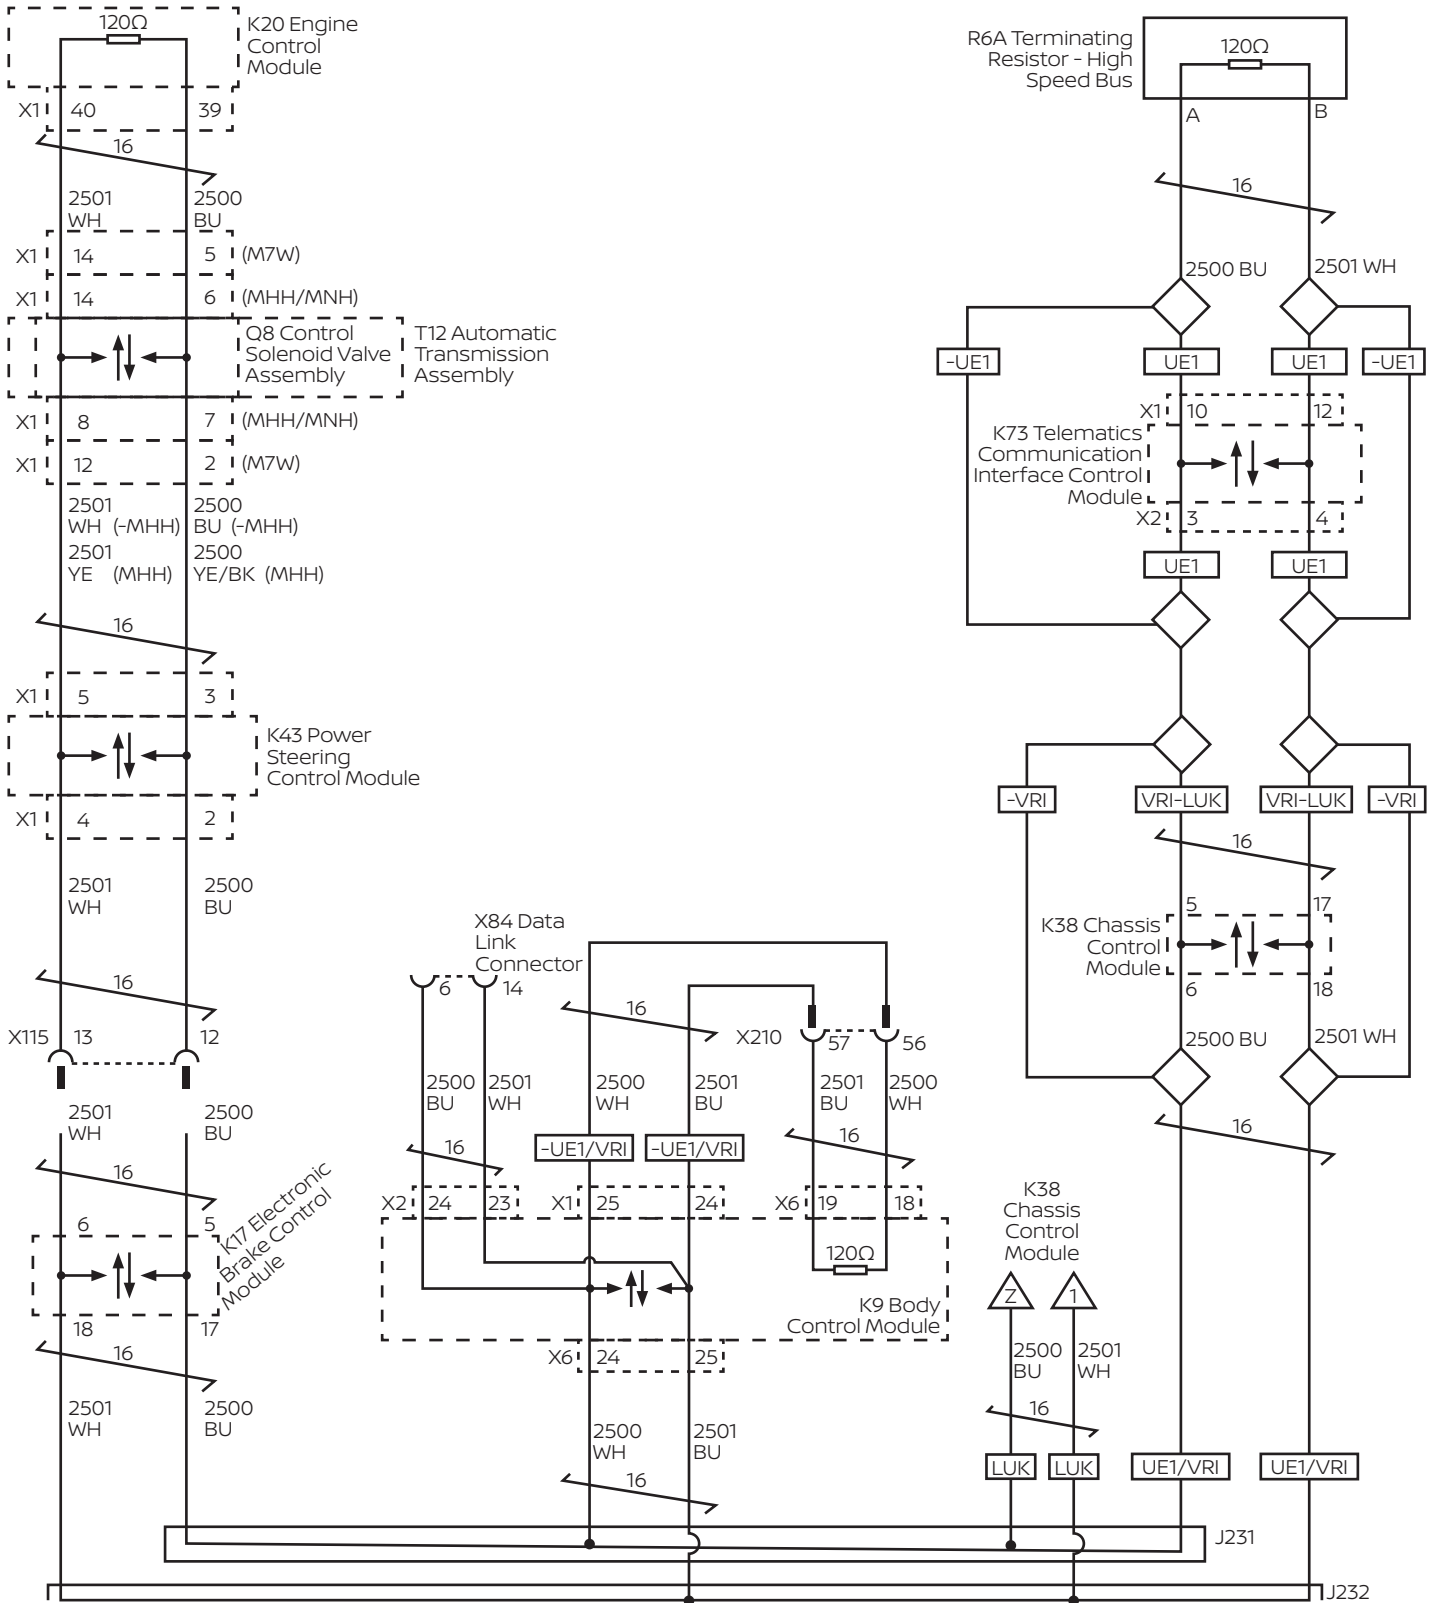
Figure 2: 2014 Malibu CAN BUS diagram

The reason the topology matters for troubleshooting purposes is as follows: If the ECM on the Malibu needs to communicate with the BCM for purposes of validating the key code, for example, that communication must pass through the TCM, PSCM, and EBCM. There is no alternative; so, if an open exists in one of those three modules, the vehicle will not start and communication may be lost with several modules. However, on the plus side, GM sets module-specific communication codes which can be a great help.

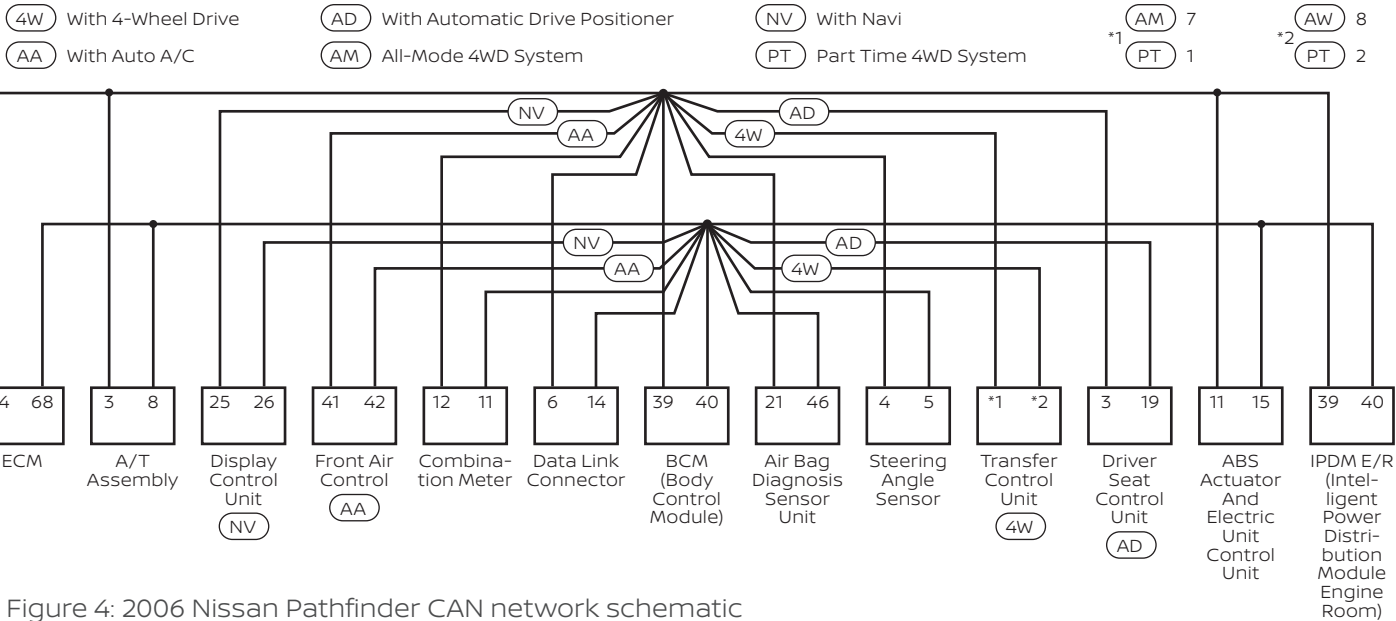
The “scan all modules” function on our Pathfinder scans four modules, three of which have codes.

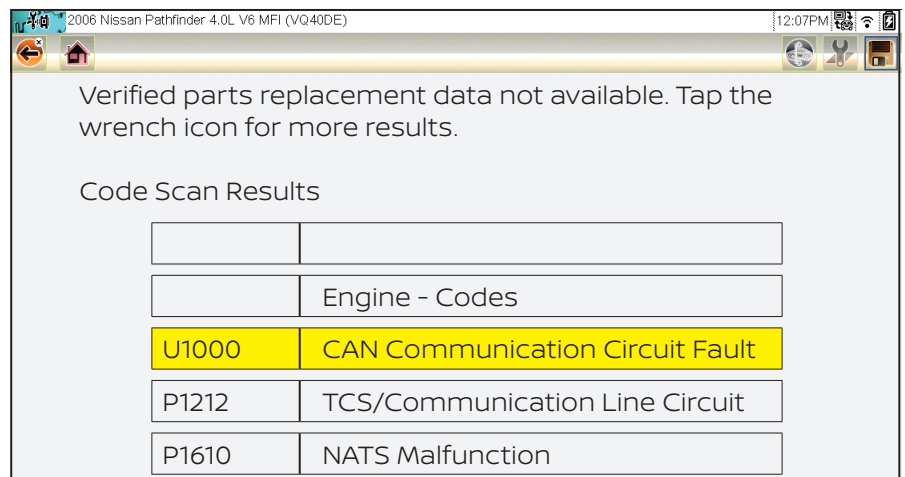
Figure 5: ECM codes

the trouble diagnosis for DTC U1000...” Thinking it through, traction control is executed when the ABS module detects wheel slip on acceleration and has to interface with the vehicle ECM in order to reduce throttle plate position, or possibly retard the spark, or even shut down injectors. When there is a communications fault, obviously this system would be disabled and therefore these “sympathy” codes will set.

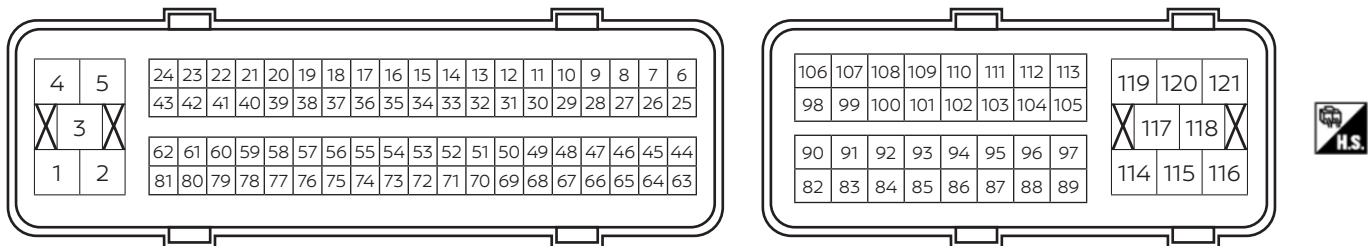
Figure 16: ECM power and ground pins

Of necessity, we have to add one additional step before we spring for the ECM replacement; confirmation of the powers and grounds. Missing grounds can distort the ECM CAN bus signal and it just isn't worth the risk to skip this step. We did not do that step on the previous vehicle because a missing power or ground would have had no effect on the resistance reading, and recall that we had abnormally low resistance. Figure 16 (page 9) is the table used to check powers and grounds (which were found to check OK).
