TOYOTAtech

Toyota Camry Crank No-Start 2GR-FE or not 2GR-FE

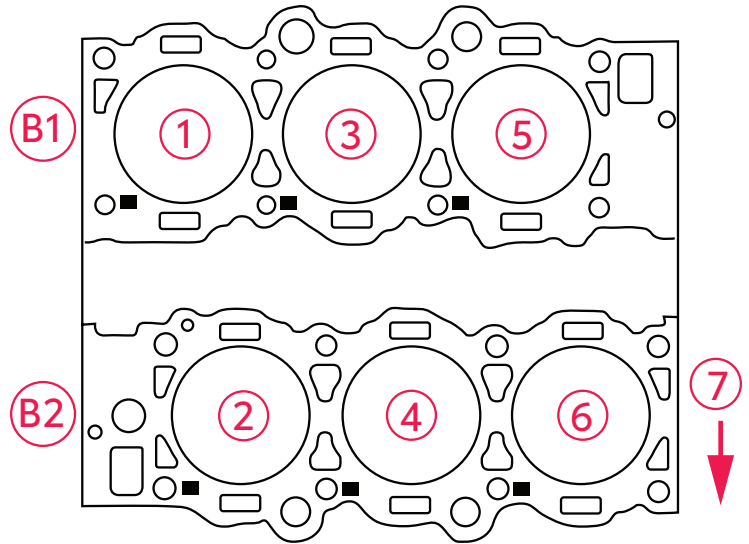
Engine Bank Identification: 2GR-FE, 1MZ-FE, 3MZ-FE

By utilizing PicoScope's multi scope views, reference waveforms, and rotation rulers, I was able to compare my no start Camry waveform with the donor Sienna capture on the same screen. After comparing both cam/crank waveforms, it was clear that the Bank 2 camshafts were way out of alignment on the Camry.
