# Volvo MOST Networks and Infotainment Systems Problems and Solutions

## SiriusXM Radio inop or NO Sound on SAT

| REF: No: TJ 34021.1.1 |

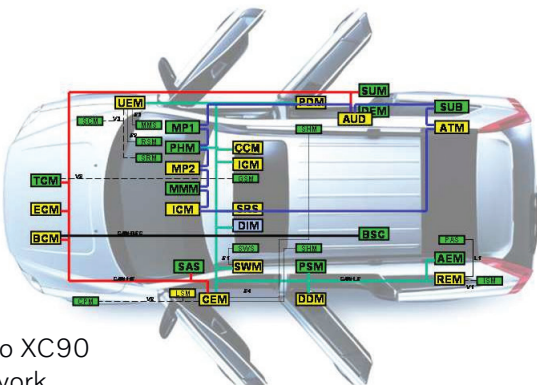
Volvo XC90  
network

If the fault is intermittent, it has been registered previously but is no longer present. Intermittent faults can be caused by interference at start-up of the MOST network (ECM), or can be a different type of fault which occurs on different occasions. The fault is evaluated depending on how it occurs. If the fault recurs, fault trace for permanent faults.

An intermittent fault may be difficult to diagnose using ring break diagnosis because a condition for this is that the fault occurs while the diagnostics program is running. If the fault is permanent, perform a ring break diagnosis to locate the open circuit.

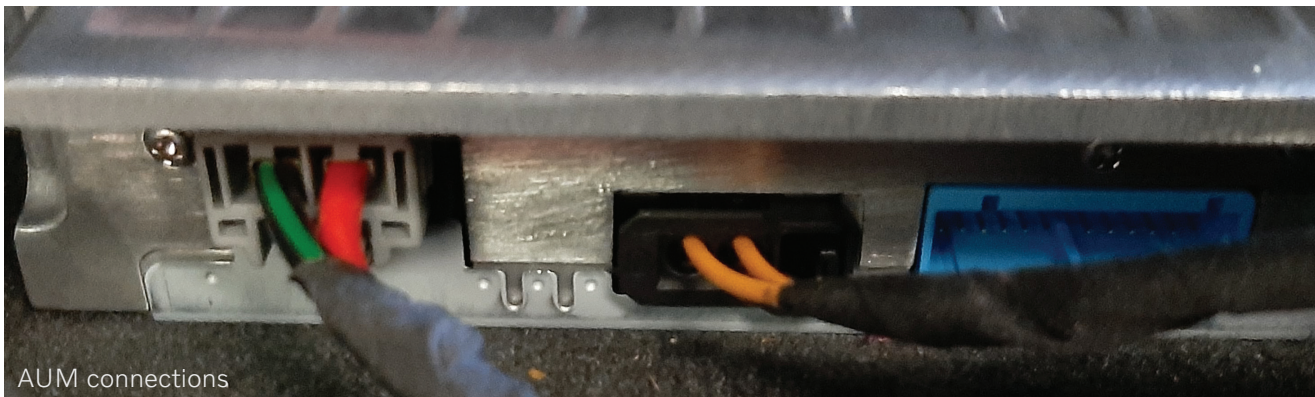
AUM connections

optic terminal pin has been pressed back in the connector.

- A bridging connector has come loose or is damaged.
