# TechNews

## Troubleshooting the Infiniti IQ X56

Shown here: Infiniti QX56

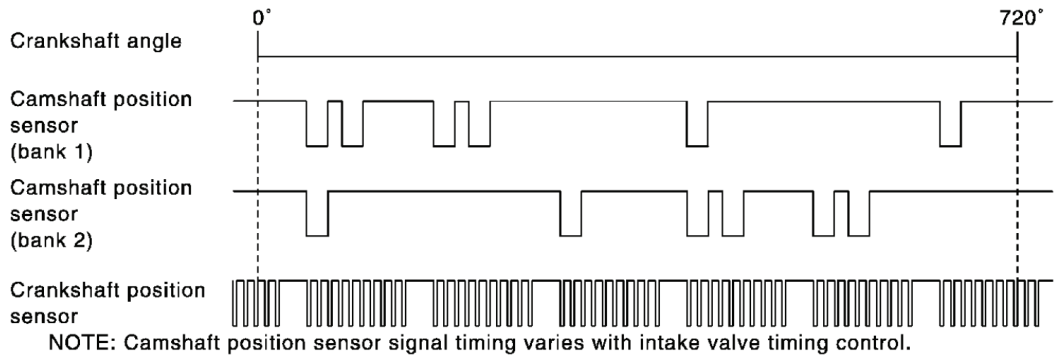
Relative Compression Zoom

Due to the no start condition, a relative compression test was an easy and logical next step. With a high amperage current probe clamped around the negative battery cable and a second lab scope channel attached to the cylinder 1 ignition coil as a reference, the engine was cranked over again. The resulting waveform shed some light on the health of the engine, but it also raised a new question about the ignition system.

At this point in the diagnosis it seemed very likely that the camshaft timing had jumped on bank 1 of the engine, resulting in valve damage and four cylinders with low compression. The lack of spark was still a question mark though.
