Curing the BMW N54 30FF Fault Code

Understanding the BMW twin turbocharged N54 engine operation and diagnosing and repairing failure points

BMW N54 engines have been setting a 30FF fault code ever since the vehicles hit the dealerships in 2006. "DME: Turbocharger, charge-air pressure too low." This fault code can lead you down many different paths. On this specific 2009 BMW 535xi we start with the basics.

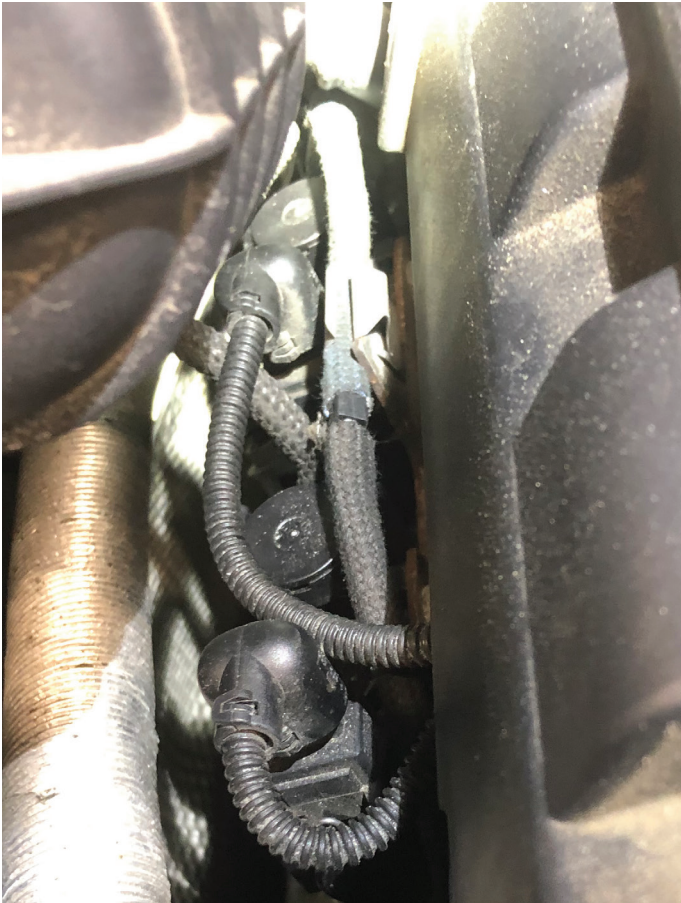
Electric control to activate turbo wastegate

pressurizing the system, activate the solenoid. You should hear and feel the solenoid activate, but also see it with the smoke. We performed this test and found both control solenoids activating correctly. By activating with the BMW tester, we know the wiring is good and the DME is supplying and grounding the solenoids as it should.

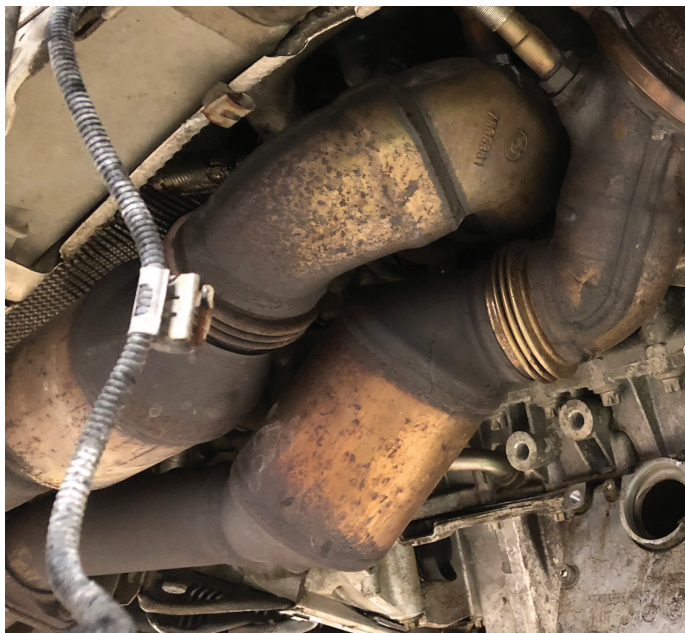
Catalytic converters mounted to turbochargers with subframe removed

With the catalytic converters out of the way, we discovered a very obvious issue. The wastegate valves on both turbos were incredibly loose. When actuating the wastegate diaphragm with our trusty hand vacuum pump, the valve barely touched the exhaust port on Bank 2. And Bank 1 wasn't much better. The turbines spun free on both turbos and showed no signs of wear.

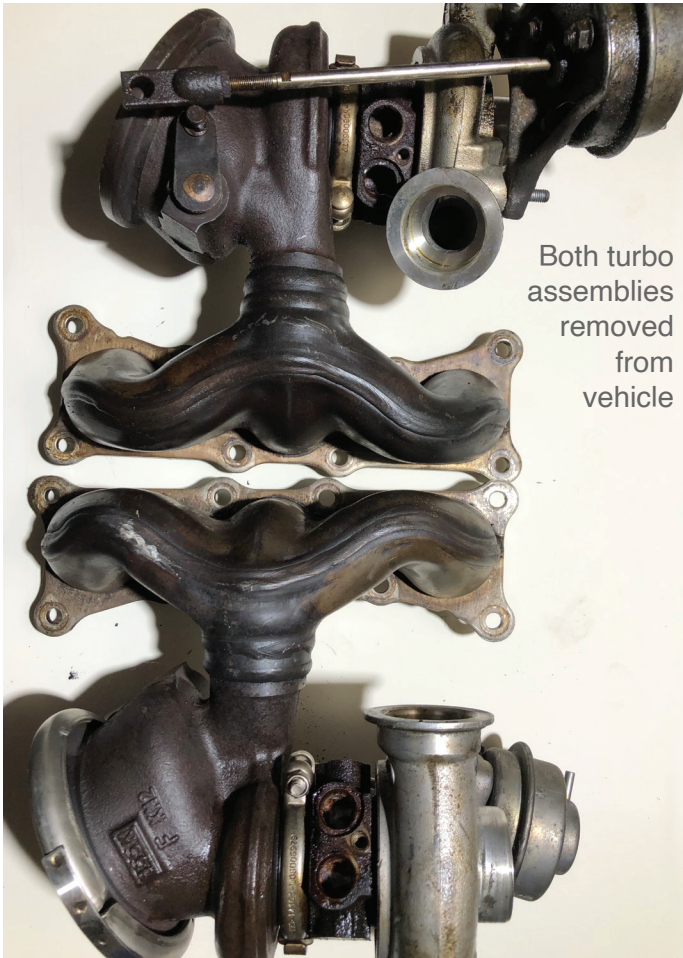
Both turbo assemblies removed from vehicle

After double checking the integrity of our turbo assemblies, turbine bearings, and overall condition, we decided to simply replace the wastegate actuators and adjust correctly. Parts are readily available and affordable. The diaphragms had aged and worn out with heat cycles of the engine. All the coolant lines were in rough condition and were replaced as well. The oil feed lines appeared to be in good condition, but we felt it would be best to replace those while we had everything apart.
