September 2021

the bimmer pub[®]

Diagnosing BMW BSD & LIN Networks A Tale of Two Vehicles

By Jordan Hill

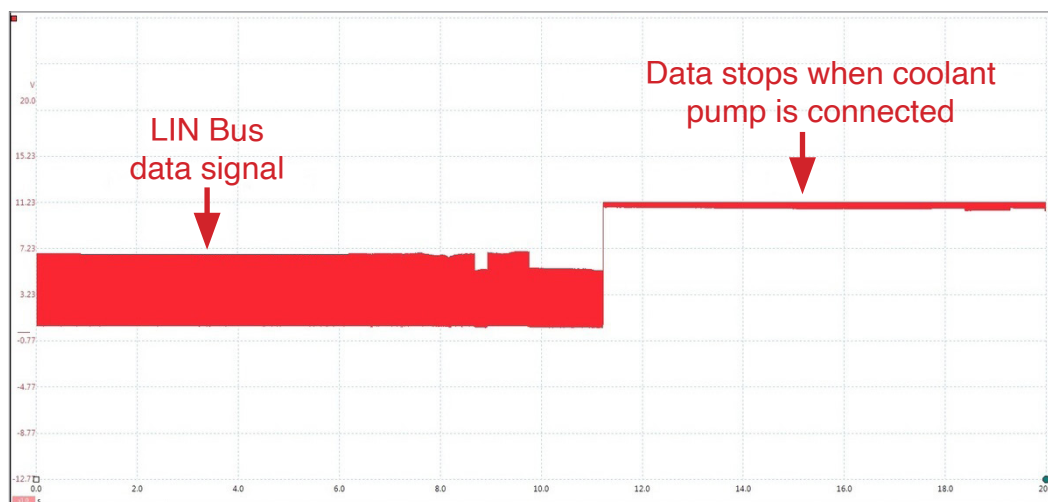
LIN BUS PicoScope

I connected PicoScope to the power, ground, and communication wires to the coolant pump. The power and ground circuits both tested good. On the communication wire I found that there was activity when the coolant pump connector was disconnected, but once the connector was plugged back in all activity stopped. This is where I made my second mistake. I assumed that this meant the coolant pump was faulty and when it was plugged in it was bringing down the communication line.
