TechNews

Diagnosing Nissan No Starts

By Jordan Hill

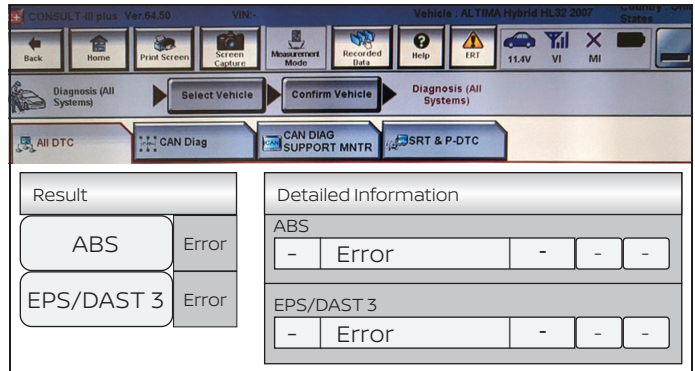
With the hybrid off of the tow truck and pushed into the shop, the first step was to verify the symptoms. When the Start button was pressed the vehicle would not Ready On, and the internal combustion engine did not start either. There was power present, however, as all of the warning lights were displayed in the instrument cluster and the engine cooling fan was running at high speed. The cooling fan running any time the ignition was switched on was a strong indicator of a communication issue. That is a default strategy that is often used when engine temperature data is not being transmitted

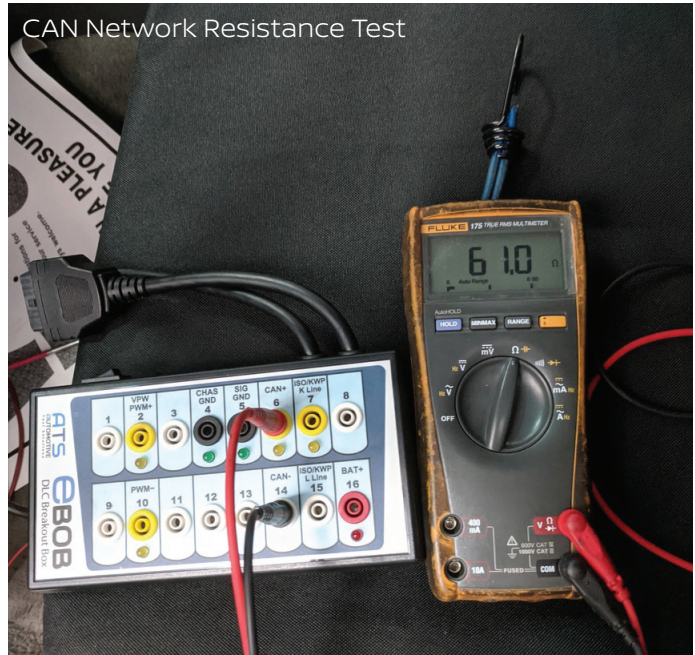
CONSULT III All Systems Scan

correctly between modules. A fault scan confirmed that there was indeed a communication issue present on this Altima.

There were only two modules registering when the All Systems Diagnosis scan was run with the CONSULT III. The ABS and EPS modules were present, but they could not communicate correctly either. At this point, the health of the network communications needed to be checked. A breakout box was connected to the Data Link Connector to test the resistance of the CAN communication bus. The bus resistance was found to be 61 Ohms, an acceptable reading. This is quick test to establish if the terminating resistors are damaged or if the CAN lines are open or shorted.
