TOYOTAtech

15-Minute Toyota Diagnostics

By Jordan Hill

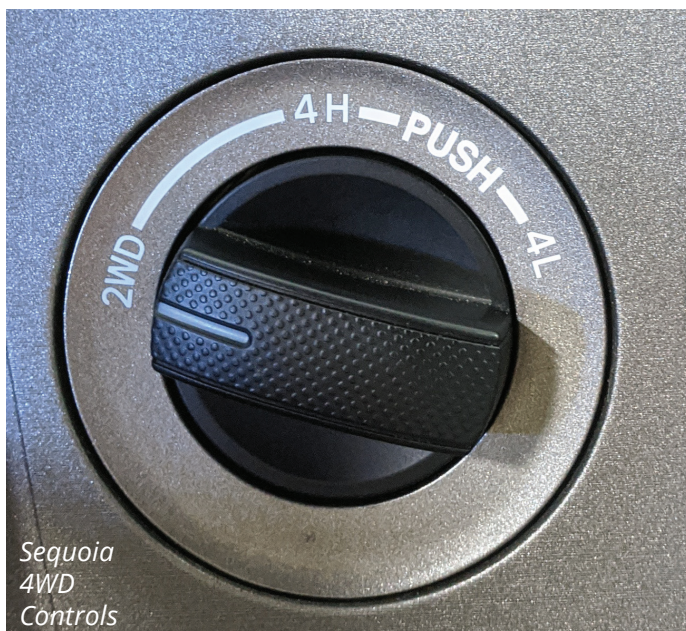
the owner's complaint, which is always a good first move. The 4WD indicator light was always on when the engine was running, and moving the selector knob made no difference.

A brief inspection of the transfer case, axles and driveshaft confirmed what the transmission repair shop had found: there were no obvious mechanical issues with the Sequoia either.

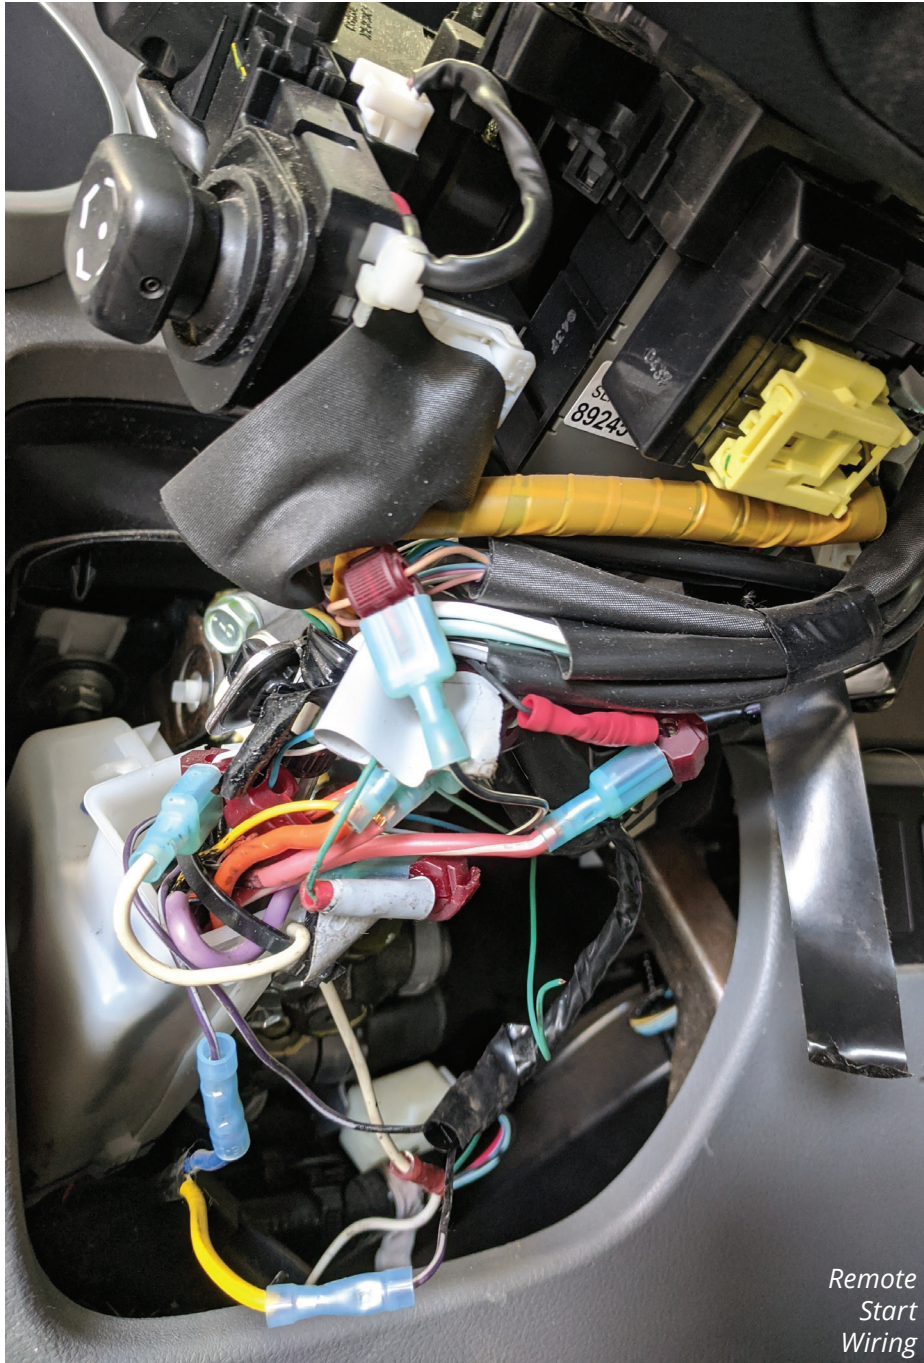
The steering wheel! That had to be it. The truck has a power telescoping steering column. With the power steering column fully extended the no crank no start was easily duplicated.

With the steering column covers removed, the problem was easily identified. The remote starter wiring was spliced into the immobilizer wires at the ignition switch. When the steering column was moved all the way out, the wires were being pulled tight causing an open connection.

With the remote start system removed, and the damaged wires repaired, the truck started every time, no matter what position the steering column was in.
