**SUBARU
BOXER
HYBRID**

Subaru
Cross-Shrek-trek

By Jordan Hill

Multiple faults for several different systems on Subaru Crosstrek requires prioritizing and working through one at a time.

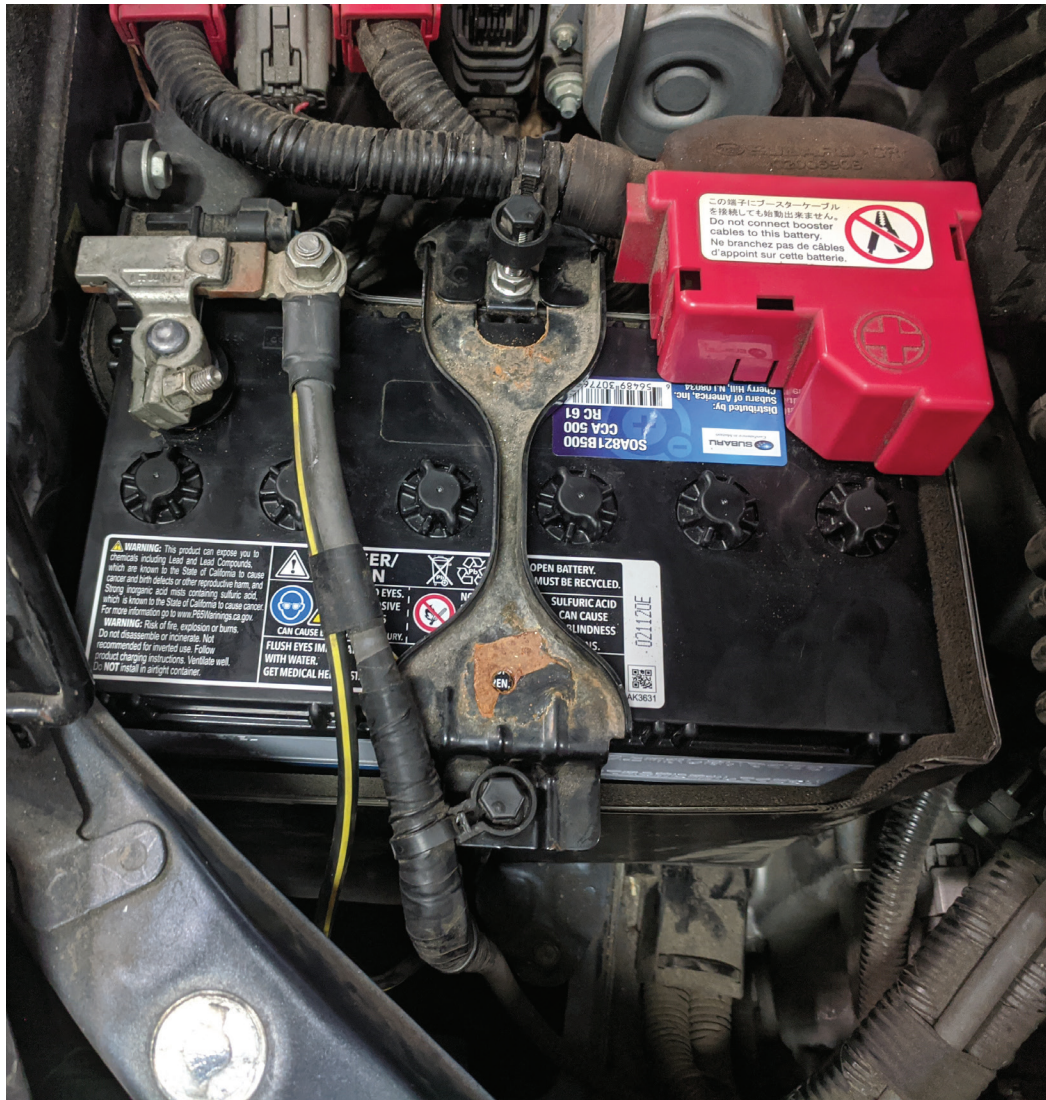
The P1C22 fault stated that the auxiliary battery voltage was low, so the logical place to start was testing both of the under-hood batteries. The auxiliary 12V battery tested OK, but the restart 12V battery on the right side of the engine compartment failed testing with a bad cell.

Restart Battery Failed Test

12V Restart Battery

There were several important installation notes for this battery listed in the replacement procedure. The battery sensor located on the negative terminal needs to be disconnected briefly to reset the learned memory. Furthermore, after the battery is installed, the ignition needs to be turned on for at least ten seconds before starting the engine and the brake pedal needs to be released. This allows for two things to occur: the initial testing of the electronic throttle valve and position learning of the brake pedal stroke sensor.
