Technical Knowledge for Volkswagen[®], Audi[®]
and Porsche[®] Service Professionals

2013 PORSCHE CAYENNE ALARM FAULT

A Porsche Cayenne owner offers an interesting story about the 2013 model that seemingly has a mind of its own when it rains or is washed.

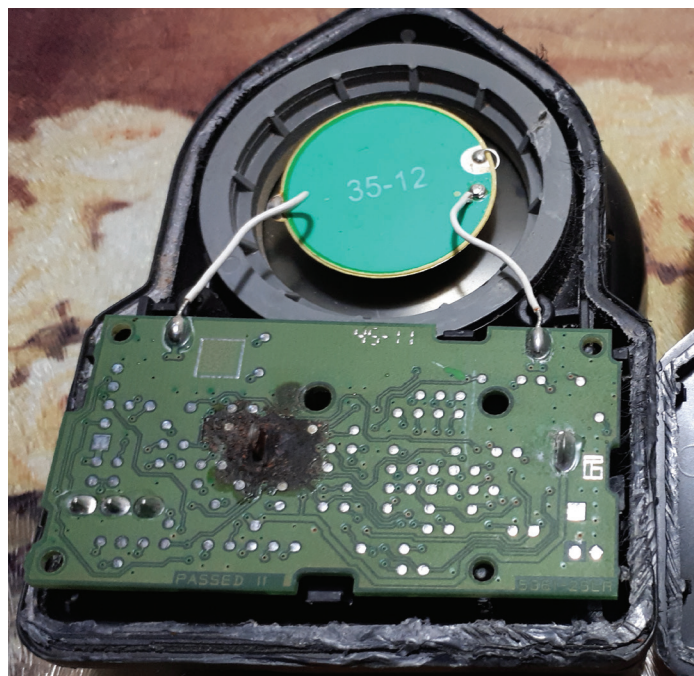
Burned circuit 1

activity. The powdered substance appears to not originate from the battery but from the burning IC's circuit board and melted solder.

A battery solder point melted, but a close inspection indicates that one of the ICs also failed and melted. That major failure melted/arced one of the battery solder points. The combination destroyed the IC board and surrounding circuitry and traces. Refer it to a cascading failure.

Original LIN Alarm: With the correct tools and some patience, the original LIN module was removed and the replacement installed. Follow the instructions within the document but at least test the LIN messages with an oscilloscope.

The battery was de-soldered and wiped of all debris, indicating no leakage.
