# TOUAREG TECH ASSIST SOMEONE TO LEAN ON

One such tech line call involved a 2014 Touareg R-Line equipped with the 3 liter turbo diesel powerplant. The owner of the MPV reported an issue with the console display. He stated that the information console would cut in and out randomly with the screen going dark and then turning back on. This had been going on for a couple of weeks and had been getting significantly worse.

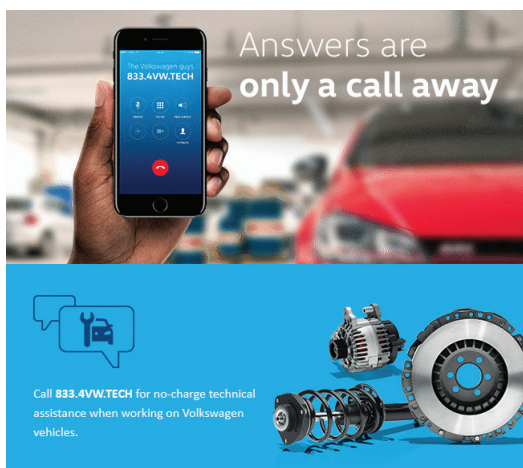
**VW TECH Assist available at 833.4VW.TECH for no-charge technical assistance.**

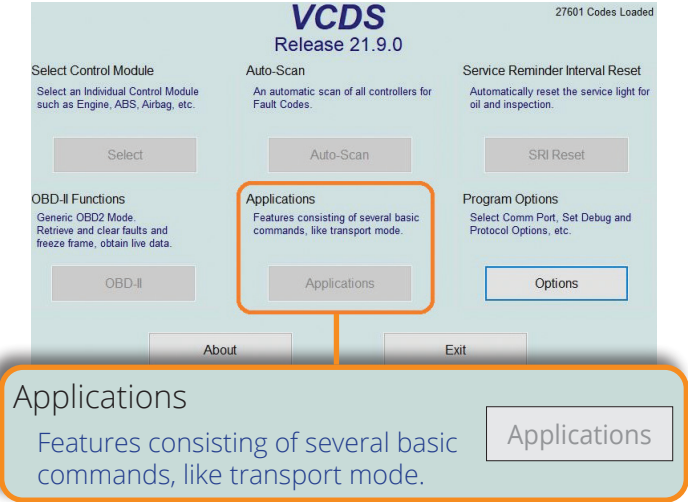
VCDS Applications Display

frequently, that when Robert tried to retrieve the software data, he was unable to hold the Setup button for ten seconds without the screen going black. This really did not sound like a software issue to Jim, but a hardware problem instead.

The Installation List results show that the CAN Gateway is online, but the next module on the MOST bus, the 5F module, is not communicating, and therefore the other modules downstream cannot be reached. The 5F module is also the module in control of video and imaging processes, so when the module acts up it causes the display screen to go black for a few moments.

All the power and grounds were good to the module and all the connectors were securely in place. The 5F module was going to need to be replaced.

Jim also provided Robert with the final piece of the repair. There was a Tech Tip Bulletin from Volkswagen titled "Replacing a -J794- Information Electronics Control Module 1." There are several steps that are required after replacing the 5F module, steps that require the latest software level of ODIS. Unfortunately, the shop did not have ODIS available, so they would need to call their mobile programmer to come in and perform the software configuration after the new module was installed.
