TOYOTAtech

Diagnosing Prius Hybrid Battery Pack

Sometimes They Come Back...

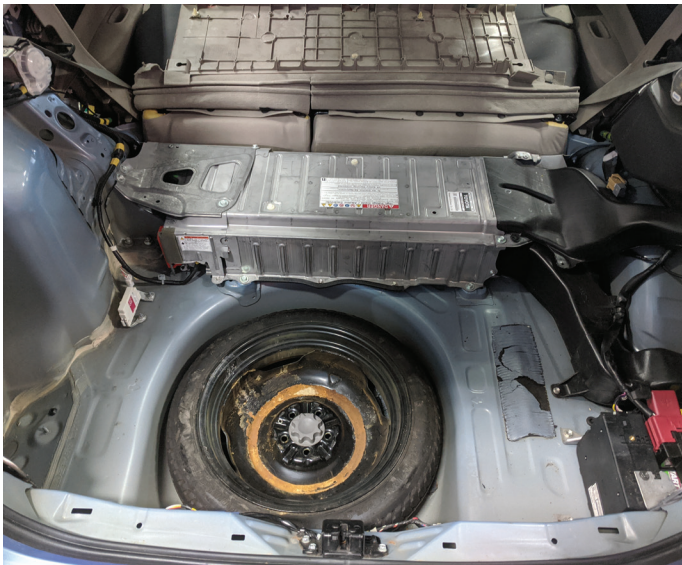
Hybrid Drive Battery

Jim removed the DC cables to the inverter from the system main relay terminals in the battery pack.
