TOYOTAtech

15-Minute Diagnostics on Toyota Vehicles, Part 2

By Jordan Hill

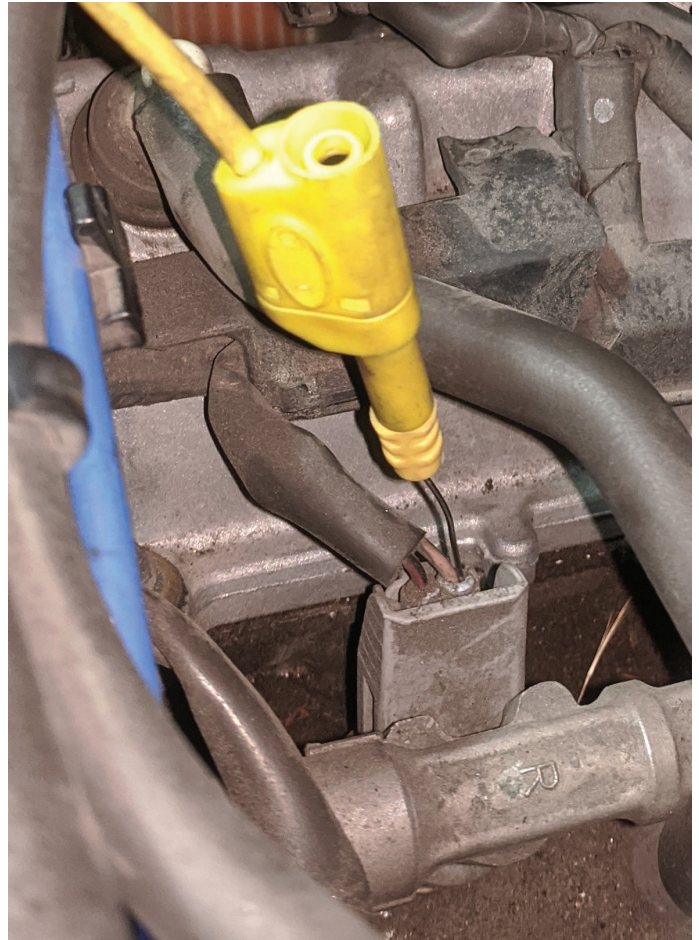
The ignition wires and spark plugs had recently been replaced, so the suspicion was initially placed on the fuel injectors. A lab scope was connected to the vehicle using a pulse sensor on the fuel pressure regulator vacuum port, and the control side of the cylinder one fuel injector.

The engine was run until it was at operating temperature and then shut off. With the hood shut, the vehicle was left to heat soak for 15 minutes. Upon restarting the engine, the misfire was present and the following scope capture was collected. With five full

Sync Channel on Fuel Injector #1

The owner of the 4-Runner decided to replace all six injectors due to the high mileage. After the injectors were replaced with new O-rings and plenum gaskets the codes were cleared and the hot soak condition was recreated once more. This time the SUV started after sitting for 15 minutes and didn't misfire at all.

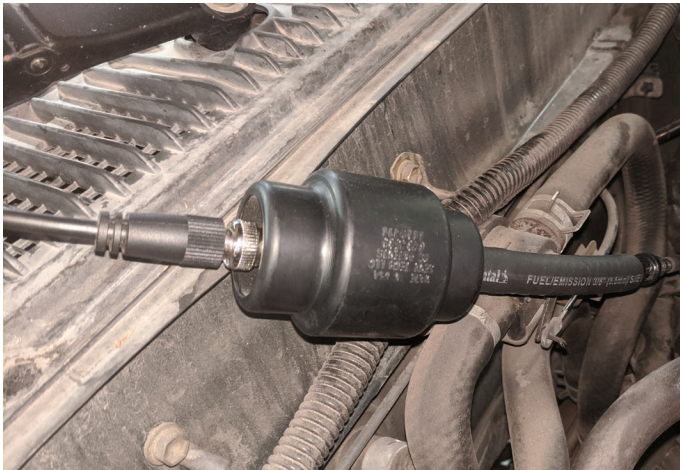
Pulse Sensor on Fuel Pressure Regulator
