Energy Management | Fuel Delivery | N54 Engine | N52 Oil Leak | Carbon Buildup

So, here you are reading an article about BMW energy management. You have to admit that this is not a very sexy subject. But the topic is intriguing enough that you are taking the time to find out what this is all about. In this article you'll find a comprehensive overview of BMW energy management strategy, the components involved, how to use that information in service, and some service best practices.

Troubleshooting Mixture Codes on the N54 Engine

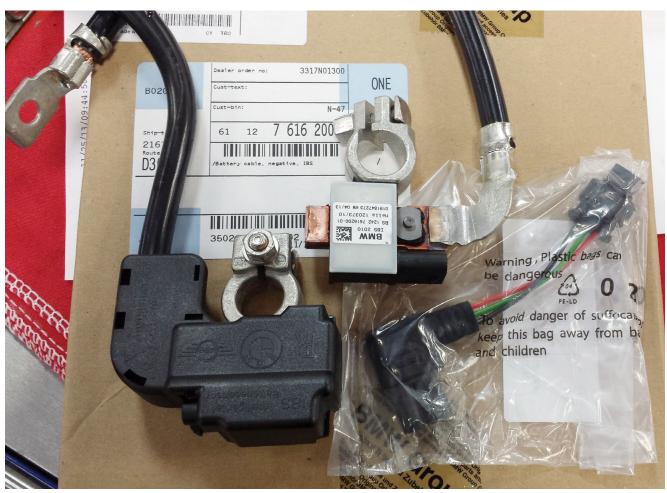
New generation IBS next to the old generation IBS.

connection to the B+ terminal of the battery. It has the function of measuring battery voltage in, battery voltage out, current in, current out, and battery temperature under all operating conditions.

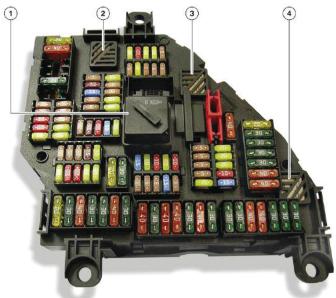
External view of the rear fuse carrier in the F01/F02

As well as the fuses, a few relays are plugged in here or soldered to the circuit board. If one of the soldered relays is faulty, the rear distribution box must be replaced as a whole unit. The connection port of the battery cable is located on the rear of the fuse carrier.

Index	Explanation	Index	Explanation
1	Relay terminal 30B (plugged in)	3	Relay terminal 15N (soldered)
2	Relay terminal 30F (soldered)	4	Relay for the heating element in the rear window (soldered)

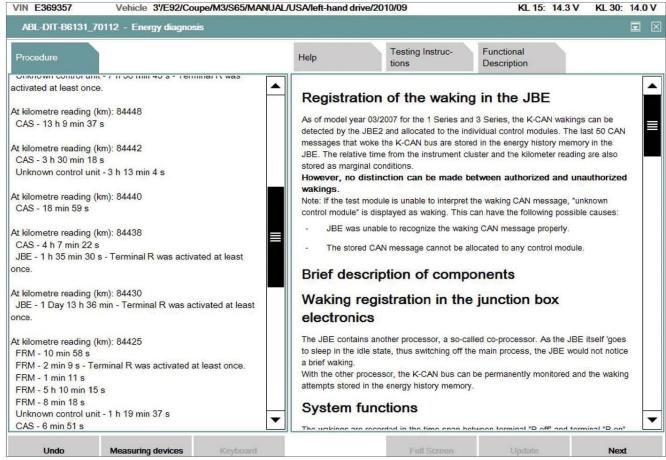
This example shows unusual wake up activity from the FRM.

The KOMBI periodically wakes up to check the ambient temperature as a function to optimize cold start emissions and energy management calculations. When analyzing unauthorized wake up, focus on the modules that are waking up at regular intervals. If there are multiple modules waking up the vehicle, try to determine if there is a common denominator — i.e., common power/common ground switch contacting the sensory input etc. If the focus is on a single control module, all of that control module's inputs need to be ruled out as the root cause prior to replacing the control module. These can include power and ground, corrosion-free connections, and wiring harness integrity

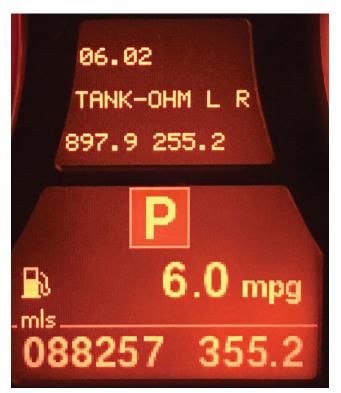
Using test 6 within the instrument cluster is an easy way to check the status of fuel level sensors. Some vehicles even allow the resistance values to be displayed. To avoid this problem and a dissatisfied customer, these adaptation values must be reset. This resetting is accomplished via test number 21 in the instrument cluster test mode. Remember, the cluster must first be unlocked. When asked to enter the unlock code, simply add the last five digits of the VIN together. For more information on cluster test mode, visit the BMWTIS website (https://www.bmwtis.com) and read the "Driver Information and Displays" section of the body electric training manuals.

When the replacement of a fuel lever sender is needed, either as a result of failure or as part of a replacement fuel pump assembly, there is an important step that is often overlooked. Because this is an analog signal being generated by a mechanical component, wear results in signal degradation. This problem is addressed using adaption values stored in the instrument cluster or appropriate processing control module.

Now if the sensor was bad, the software has been applying a lot of inaccurate adaptations to that signal. As a result, when the sensor is replaced, the signal will be modified to a point that it too is inaccurate. This can, and often times does, lead to the same symptom the vehicle first presented itself with until adaptations shift back to zero, which can take several full tank refills.

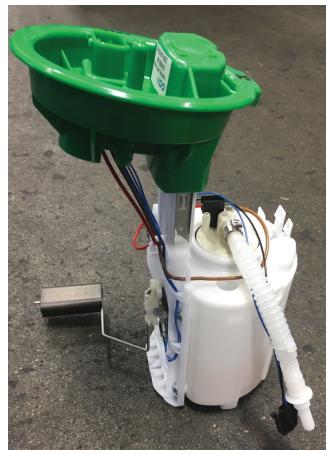
Because the fuel level sender is often incorporated into the pump assembly, remember to clear the adaptation values for the sensor circuit in the instrument cluster when replacing.

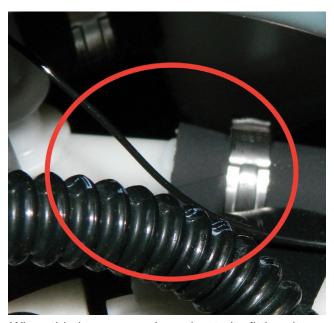
When this hose was crimped onto its fitting, it was not completely inserted. The result was an internal leak.

Another possibility is an internal leak. A hose in this siphon jet circuit can break or come loose at a service connection fitting. While the access covers are still off, activate the in-tank pump. In the case of a broken or disconnected line, there will be fuel spraying out from this leak. A disconnection due to improper installation may be repairable. However, a broken line will likely require the replacement of the entire tank. Some technicians are finding that the plastic corrugated lines used inside of BMW fuel tanks are starting to fail. This is probably a result of the ethanol content in today's gasoline.

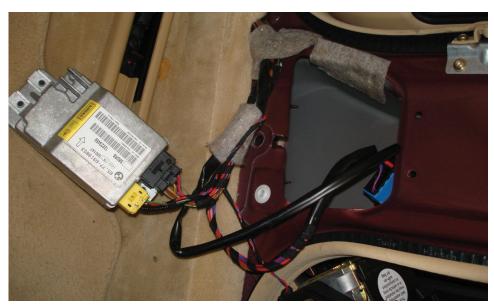
On the E65/E66 chassis, an airbag system control module, the SBSR, is used for EKP regulation. Because the SBSR incorporates accelerometers used for crash detection, do not manipulate it while the key is on. This is a common cause of fuel pump circuit failure.

The SBSR is on the Byteflight network. This means that the command path for fuel pump control goes from the DME over PT-CAN to the central gateway module, or ZGM. From there the activation signal is sent over Byteflight to the SIM and passed on to the SBSR. Suddenly the importance of a complete vehicle scan becomes clear. On all other BMWs with a dedicated EKP module, the module is on the PT-CAN. So the signal path is much less complicated. As a side note, the EKP module contains one of the two terminating resistors for PT-CAN.

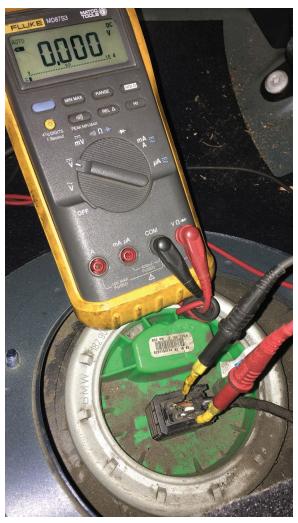
A DVOM and a solid understanding of voltage drop theory is all you need to fully analyze the fuel pump circuit.

Now that the circuit is complete, or commanded on via scan tool, perform a voltage drop test across the fuel pump connector under the rear seat. You should be measuring within half a volt of system voltage (some will be lost through various connections). If measurement is within spec, and you cannot hear the pump running, clearly the problem is in the tank. Remove the electrical connecter and visually confirm that the contacts are not burnt before proceeding with a pump replacement.

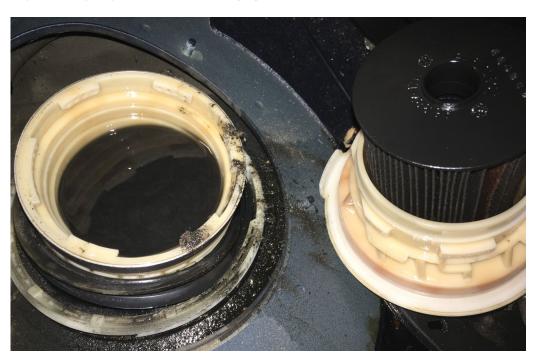
Always replace the fuel filter when replacing a faulty pump. This in-tank filter has become heavily contaminated after less than 120,000 miles of use.

When replacing a faulty fuel pump, you should always replace the fuel filter too. If the repair requires replacement of the EKP module, it will likely need coding or programming. If you are replacing the SBSR, after coding and programming don't forget to restart the system time for the passive safety system.

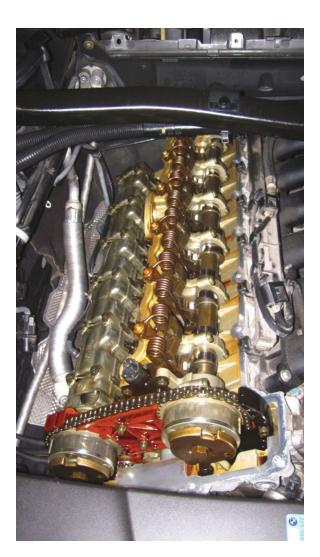
The N52 engine uses three aluminum bolts securing the cylinder head to the timing cover. This is where our problem starts for this oil leak. These aluminum bolts tend to break; the one you can see with a quick glance is the bolt located behind the oil filter housing.

This bolt is relatively easy to replace. The procedure involves removing the intake manifold and cutting a small slot in the bolt; it will then back out rather easily. This however is not where you should stop. If you find this bolt broken there is a strong possibility that there are other bolts broken under the valve cover as well.

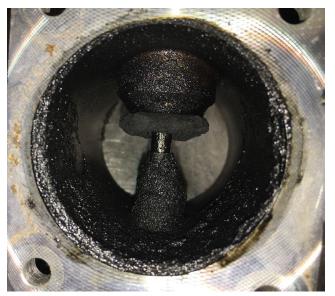
Here you can see how much carbon can develop on the EGR valve mechanism.

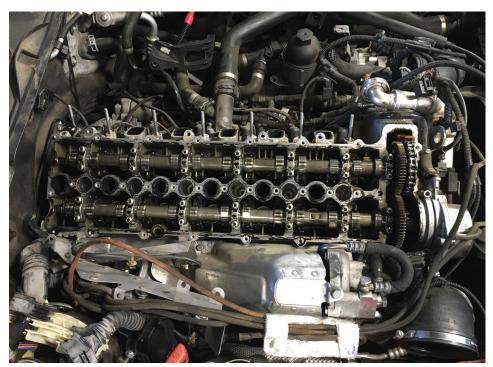
M 57 engine with intake manifold and valve cover removed

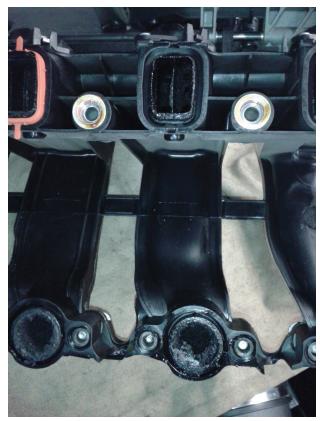
Massive amounts of carbon can build up in intake manifold runners, compromising performance and economy.

If you thought carbon buildup in the intake was bad on gasoline direct injected engines, imagine what happens when soot from the EGR system mixes with the oil from crankcase ventilation on a diesel. This is becoming a major problem. This issue takes place over a period of time ranging typically between 40,000 and 80,000 miles depending on vehicle operation and maintenance habits. The resulting reduction in performance is gradual, so not usually noticed by the driver. However, the disruption in air delivery will eventually be recognized by the engine management software in the DDE. This will result in the illumination of the "Malfunction Indicator Lamp" or "Check Engine Light."

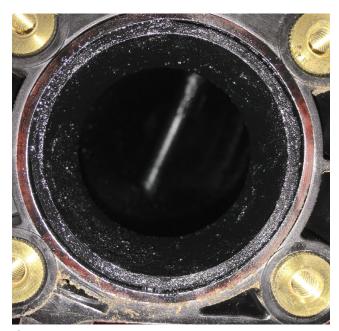
Carbon can also build up at the throttle body connection, further impeding the flow of incoming air.

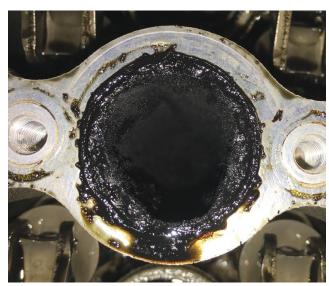
Carbon can build up in cylinder head swirl ports in addition to other places within the induction system.

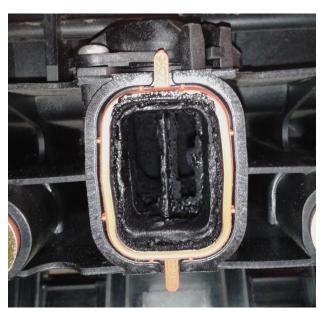
Other places where carbon can build up include the tangential ports on the intake manifold and the tangential ports on the cylinder head.

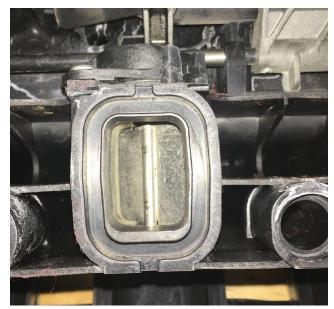
This is a tangential port on an intake manifold with swirl pot closed after soda blasting.

The intake manifold is also going to need to be cleaned Many service centers are simply replacing the intake manifold with a new one. However, the intake manifold can be successfully cleaned using a soda blaster. This is a blasting cabinet that uses baking soda as the abrasive media. Soda is soft enough to not cause any damage to the plastic or even the impregnated rubber seals on the swirl ports.

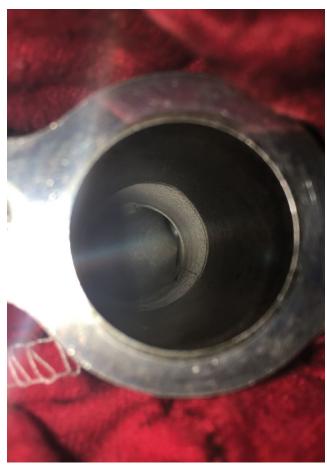
The swirl ports on the cylinder head can look like this after cleaning.

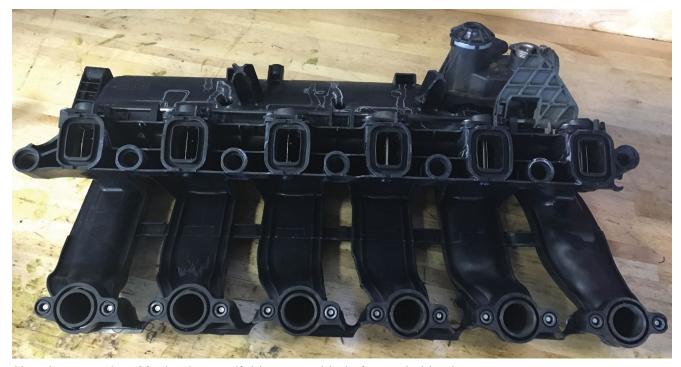
Here is a complete M57intake manifold reassembled after soda blasting.

If you choose to use this method, completely disassemble the intake removing all the swirl pots, sensors, hardware, actuators, and replaceable gaskets before cleaning. You will need to clean the throttle body and EGR valve before reassembly. You can also use the soda blaster for this or use a good throttle body cleaning chemical. Be sure to keep any chemicals from flowing along the actuation shafts and entering the electronics.
