HONDA CAM SEAL REPLACEMENT

HONDA DISTRIBUTORS

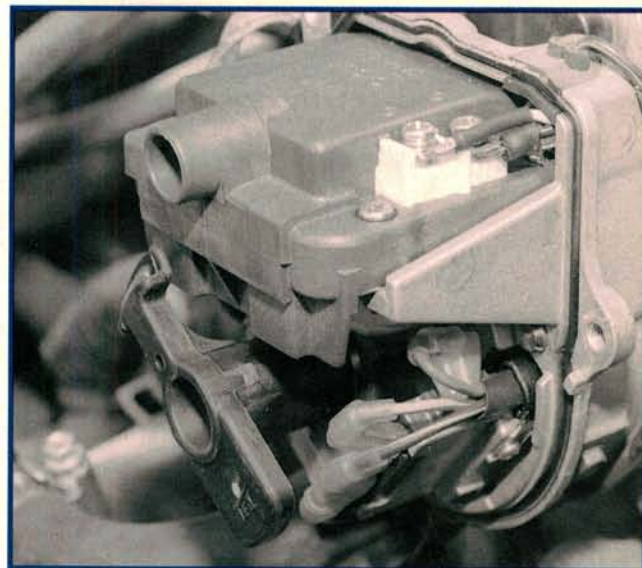
About 90 percent of all 1988-90 Honda Civic no-starts are caused by bad distributor ignitors. Make sure you don't create another problem while you're diagnosing or replacing the ignitor. The carbon button in the center of the distributor cap can be very easily damaged if you're not extremely careful when removing and installing the distributor cap.

If you break the distributor cap button, the car will probably run fine for a few weeks. But eventually it will come back with a burned up distributor cap, rotor, coil, and pulse generator. The total cost of the damage to the distributor is approximately \$450.00.
