# 2.5 Liter Twin Cam Timing Belt Replacement

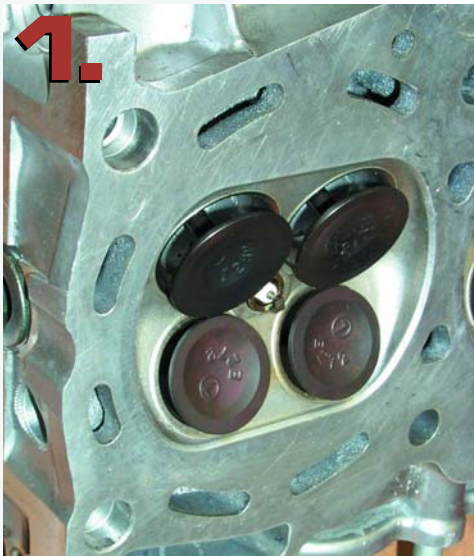
We've removed a 2.5 cylinder head to show just how crowded it is in the combustion chamber area. Each intake valve has its own cam lobe. The intake valve timing is slightly staggered, so one intake valve begins to open and close slightly ahead of its partner. If the intake and exhaust cams are allowed to get out of time in relation to one another, intake and exhaust valves will collide in the combustion chamber area. Intake valves in four-valve heads are necessarily small, and more easily damaged than similar components on two-valve engines. A collision between valves, even when the engine is not running (during a timing belt replacement for example), can cause valve damage. The object is to finish the job with the engine running at least as well as it was before you started, which is why it's so important to approach this job with the necessary caution and the proper tools.

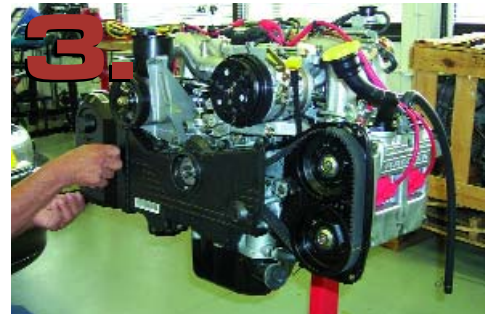
The covers are designed to seal out dirt and they must be properly reinstalled to do their job. Inspect the rubber gaskets which seal the inner to the outer covers. If they have become swollen due to oil leakage, find the source of the oil leak and replace the damaged gaskets before reinstalling the covers. Even a small amount of road grit inside the timing covers will act as an abrasive that will make short work of the timing belt, resin cam pulleys and other timing components.

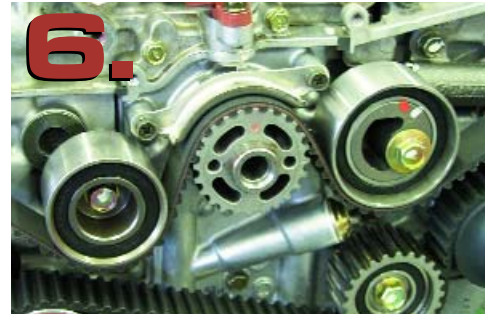
We'll start on the left side of the engine. Make sure the single timing mark on the left intake (upper) camshaft pulley is aligned with the notch *at the top* of the inner timing belt cover (12 o'clock).

Moving to the left exhaust (lower) camshaft pulley, the single timing mark on the camshaft pulley should be aligned with the notch *at the side* of the inner timing belt cover. That's the 3 o'clock position when facing the front of the engine.

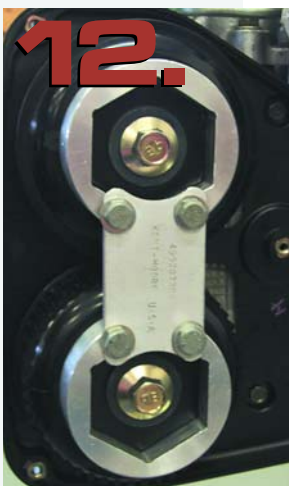
So do you put it all back together and close the hood? No. Not if you've got the proper tools. This tool fits over the large hexes on the upper and lower camshaft sprockets on the right side of the engine. The tool effectively locks the two sprockets together, keeping them from turning as long as it's in place.

Things are even more interesting on the left side of the engine. This is the side of the engine where things really want to move when the timing belt is removed. This tool locks onto the upper and lower sprocket bolts using small set screws. Jam nuts at the top and bottom of the tool are used to lock the cam pulleys in place, while loosening them allows the pulleys to be moved independently using a hex wrench. Everything should be locked down solidly to prevent pulley movement before removing the timing belt.

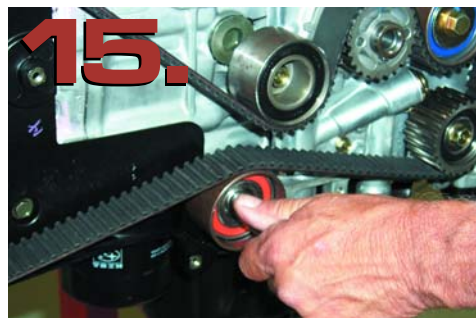
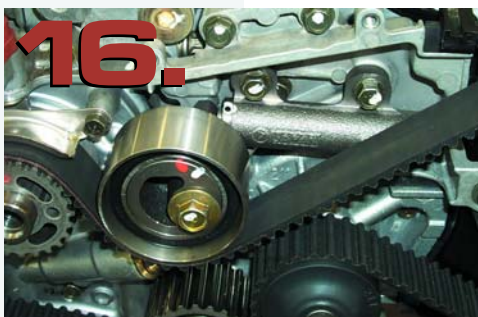
With the old timing belt out of the way, the next order of business is the timing belt tensioner. Two different types of hydraulic belt tensioners have been used on this engine. The early style is shown here. This is the same tensioner that was previously used on the 2.2 and 3.3 liter engines. Remove the tensioner from the engine, then carefully compress its adjuster rod in a vice equipped with soft-faced jaws. Use a small pin to hold the adjuster rod in its compressed position. The pin stays in until the timing belt installation procedure is complete.

The new style cambelt tensioner was first installed during mid-1997 vehicle production. This tensioner requires careful handling and some special tools to retract its adjuster rod. A lateral vise *must not* be used to retract the tensioner's adjuster rod or damage will result. The tensioner and pulley are a single unit. The automatic belt tensioner assembly incorporates an adjuster rod, wear ring, plunger spring, return spring, check ball and silicone oil. Remove the mounting bolt, then remove the tensioner assembly.

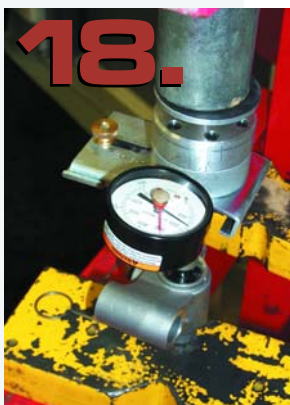
The tensioner rod must be compressed using a hydraulic press. The pressure exerted on the rod must not exceed 66 pounds. Exceeding this pressure may bend the tensioner rod. This will keep the rod from extending fully when it is reinstalled on the engine. If the rod cannot extend fully, excessive slack may develop in the timing belt, causing it to jump teeth. Jumped teeth can mean bent valves or damaged pistons, something you'll certainly want to avoid.

- Secure the tensioner in a press. This photo shows the recommended setup. An ABS brake pedal force gauge is inserted between the press rod and the adjuster piston. A small pin fits between the force gauge and the adjuster rod, assuring that all press force is directed to the adjuster rod. Use press plates to make sure the tensioner assembly is square and that no press force is directed to the tensioner pulley assembly.
- Slowly press the adjuster rod down to the end surface of the tensioner surface. Repeat this motion two or three times.
- Allow the adjuster rod to extend fully, then apply a pressure of 66 psi to the rod. Check the tensioner for resistance.
- If no resistance is felt and the adjuster rod moves down freely, replace the tensioner with a new one.
- Release the press and allow the adjuster rod to move up.

- Measure the extension of the adjuster rod beyond the body. Replace the tensioner if it is beyond the specification of 6.0 mm  $\pm$ 0.5 mm.
- Check the condition of the tensioner and pulley contact surface, bearing operation and grease leakage. Replace the tensioner if any abnormality is found.
- If the tensioner passes inspection to this point, slowly move the rod down with a force of 66 pounds. Up to 10 minutes of slow pumps on the press lever may be necessary to fully retract the adjuster rod. Pump the lever until the pressure reaches 66 psi, then allow the pressure to drop before giving it another slow pump.
- Stop when the adjuster rod is fully retracted (flush with the tensioner body). Pushing beyond this point will damage the tensioner. A 2 mm retaining pin should fit easily through the holes in the tensioner housing and adjuster rod.

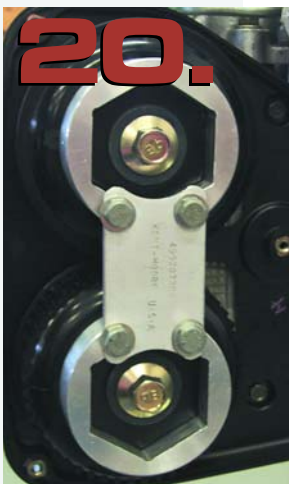
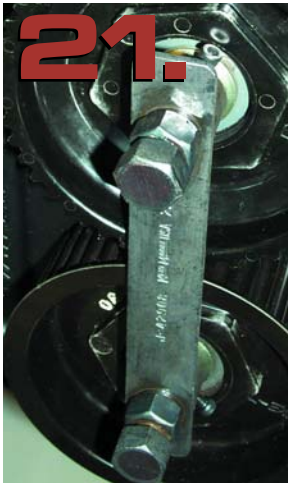
The holding tool on the left side of the engine is adjustable. Adjustment on this side of the engine is necessary because the tensioner is on the left side. Until the tensioner locking pin is removed, most of the belt slack will also be on this side of the engine. Counting the belt teeth and lining up the sprocket timing marks may produce what looks like a slightly ‘wrong’ lineup on the twin facing timing marks between the left cam sprockets. The problem is further aggravated by the fact that the holding tool blocks your view of the twin timing marks between the cam sprockets. If you’ve counted your teeth properly, all of the marks should come into alignment following the next couple of steps.

Everyone develops his own method of installing the new belt. Some techs prefer to start from the left side of the engine and work to the right — others just the opposite. There is no 'right' way, as long as the belt ends up properly installed and timed. The right side of the engine is far less finicky because the right side cams are not under tension when the timing marks are properly lined up. That's why the locking tool makes no provision for moving the pulleys when the tool is in place.

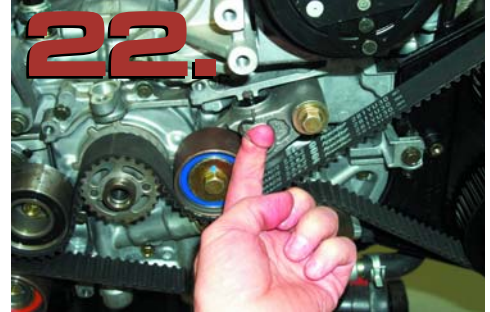
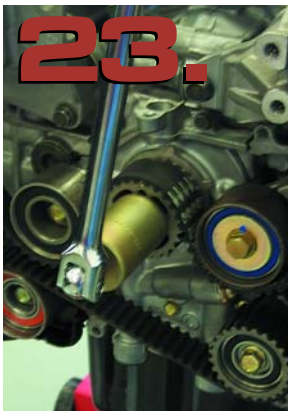
Remove both cam sprocket holding tools, then install the crankshaft turning socket. Turn the crankshaft 90 degrees counterclockwise, then 180 degrees clockwise, before returning the crankshaft sprocket to its alignment mark. This combination of movements allows the tensioner to take the slack out of the new belt and normalizes its position on the assortment of sprockets and idlers.

Reinstall the lower right idler pulley, then give your timing marks one last look. If you’re confident that everything is where it’s supposed to be, remove the timing belt tensioner adjusting rod retaining pin. The pin will begin to push outward to take up any slack in the timing belt. The tensioner assembly is not locked into place and has the freedom to pivot on its mounting bolt to take up for any additional stretch as the belt wears.

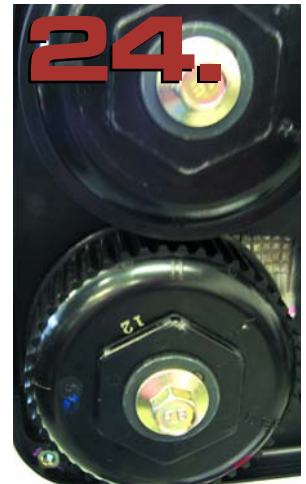
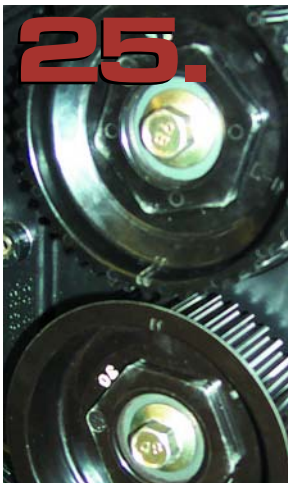
The timing marks on this engine lined up everywhere but here at the left cam sprocket match marks. After normalizing the belt by rotating it, the upper and lower pulley match marks didn’t line up quite as precisely as we would have liked. The four marks didn’t line up like four fingers pointing directly at each other. Rather, they lined up like four fingers pointing ever so slightly away from each other.

Subaru training instructor Joe Stoffa assured us that this was as close as we were going to get on this engine. Remember, four of the engine timing marks are simple notches in the inner timing cover plastic. Due to manufacturing tolerances and assembly variations, these notches may not end up in precisely the right spot. A slight variation here or there can add up to the slight misalignment we saw on our engine. Moving either of the pulleys a full tooth in either direction would not have corrected our perceived misalignment; it would only have made it worse.

The moment of truth! Check the timing mark alignment at each of the seven spots on the engine. If you’ve made a mistake by a whole tooth or more, it should be fairly obvious. There’s no way to fudge it. If it’s wrong, it’s got to be done again. A mistimed engine will run, but it will use more fuel, will lack performance and will be harder to start. A severely mistimed engine will self-destruct in just a few cranks of the starter. Get it right, now!
