Nissan & Infiniti Ignition System Service

Here's how to keep them dependable.

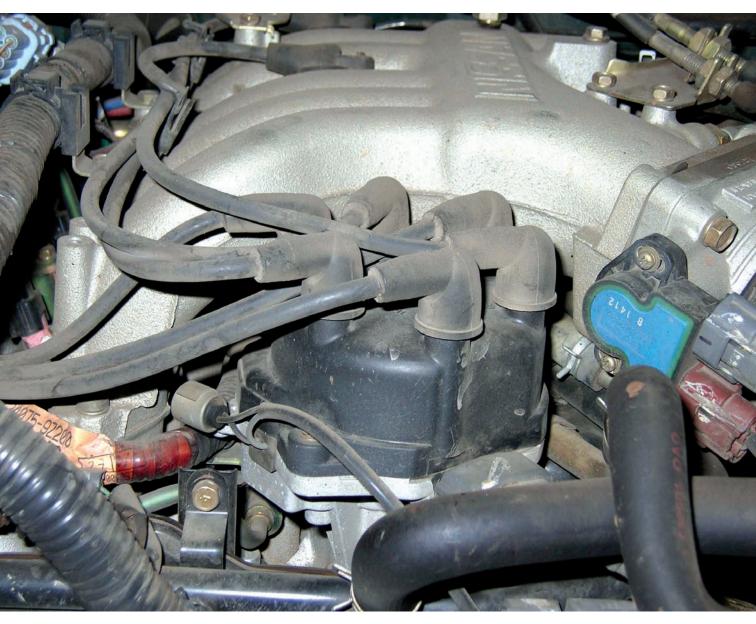
In pre-COP systems, the secondary components that handled high voltage were vulnerable, so they needed to be replaced periodically.

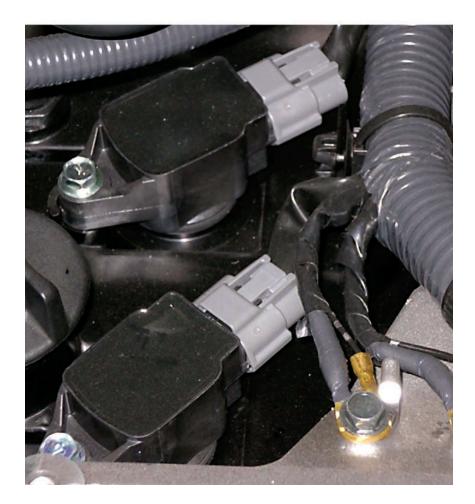
When the time is right to fire the spark, the ECM will send a signal to an ignitor circuit within the COP. The ECM monitors the current flowing to the coil during the dwell period and can detect an open or shorted coil. An ignitor is little more than a power transistor with some added circuitry to limit the maximum current flow through the primary side of the coil. Turning the transistor off causes electrical current to stop flowing through the coil, and a spark is generated as Nissan was one of the first carmakers to use Coil-On-Plug technology, which eliminates many of the components that were prone to problems.

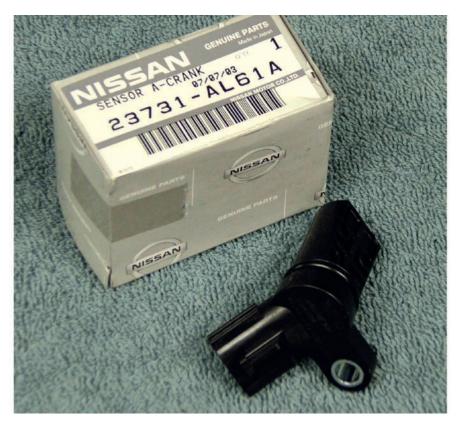
Since the crank sensor is such a critical component, you should probably think twice before installing anything but an OEM replacement.

Cam and crank sensors work the way most automotive sensors do, with a toothed ring sporting either one double-wide tooth or a double wide (Arkansas) gap for sync, a magnet, and a Hall effect sensor that can detect presence of tooth or gap. How can and do these sensors go wrong? For starters, heat may cause them to fail. Or, they may break down physically and allow oil to seep in.

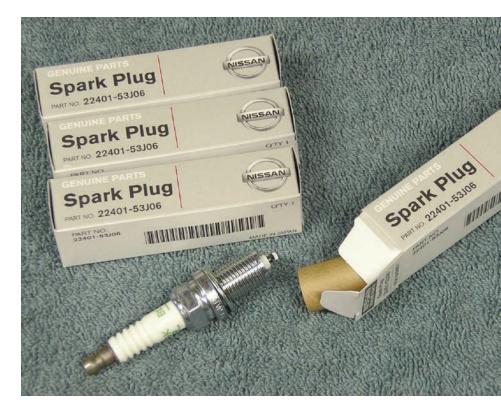
To avoid misfire codes and other possible issues, spark plugs should be original equipment specification. You can be sure of that if you go OEM.

spark plug wires, sensor impedance, coil resistance, etc. Even use of some aftermarket spark plugs can result in misfires and codes getting set, especially on supercharged engines. Some aftermarket COPs may sometimes set a P1320 right out of the box. A recent posting on iATN described a tech who installed two full sets of aftermarket coils (12) and continued getting a P1320; current ramping (as described above) and replacement of the questionable coils with OEM Nissan parts immediately cured the problem. Once again, the cost of a comeback far exceeds the few dollars that might be saved on a non-OEM ignition part.
