Understanding Camshaft Control Systems Part II

Servicing Timing Chains & Sprockets

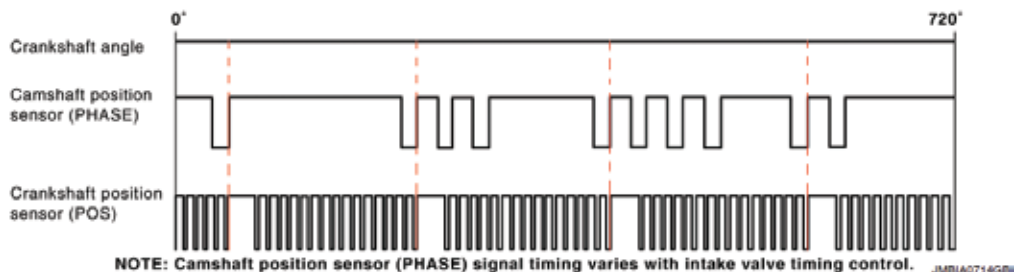
The QR25 trace should look like this. Notice how the pulses align with each other. If the camshaft pulses are shifted to the right, then the timing chain is excessively stretched.

For the QR25 engine, the leading edge of the crankshaft TDC pulse should line up with the trailing edge of the camshaft signal pulse. For the VQ35 engine, the trailing edge of the crankshaft TDC pulse should line up with the leading edge of the camshaft pulse. A stretched timing chain will cause camshaft timing to be retarded, and you will see the camshaft pulses later than normal. When graphed on the oscilloscope, they will be shifted to the right and no longer line up properly with the

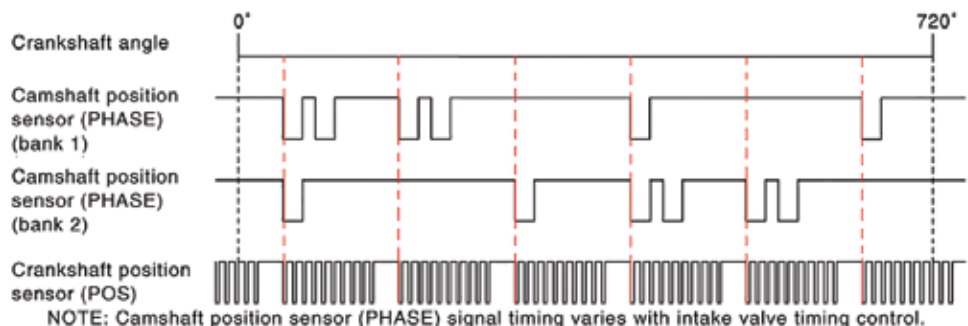
The VQ35 trace should look like this. Notice how the pulses align with each other. If the camshaft pulses are shifted to the right, then the timing chain is excessively stretched.

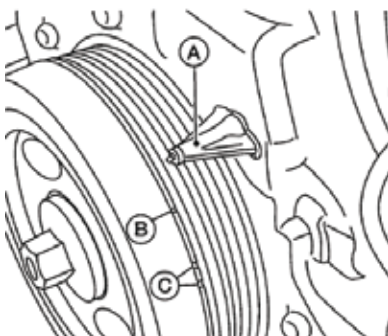
Cylinder 1 on the QR25 is at TDC when the single mark, B, is aligned with the timing pointer, A. Be sure to use the single mark, B, and not the white timing marks, C.

The QR25 pulley has a single unpainted notch for TDC, but also 2 white paint marks that are used for measuring timing. When aligned, the engine is at TDC on cylinder 1, but we don't know if the cylinder is on the compression stroke or the exhaust stroke. If the valve covers have been removed, the camshaft positions can be used to determine this. The QR25 engine will have the cam lobes on cylinder 1 facing outwards and away from each other when on compression. The VQ35 will have cylinder 1 cam lobes facing up and in toward each other on compression. If the valve covers have already been removed, this is the quickest way to determine if cylinder 1 is at TDC compression. However, removing of the valve covers is not required for servicing the timing chain.

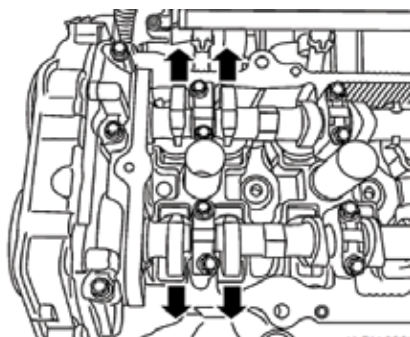
When cylinder 1 is at TDC compression with the QR25, its cam lobes will face out and away from each other as shown here.

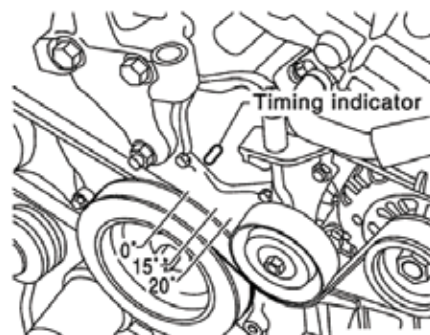
To find TDC for cylinder 1 on the VQ35, align the grooved line WITHOUT color with the timing indicator on the front cover.

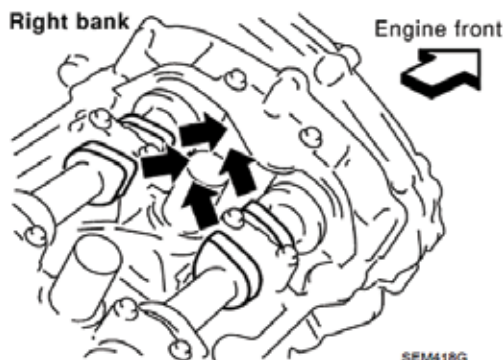
When cylinder 1 on the VQ35 is at TDC compression, its camshaft lobes will face up and in towards each other as shown here.

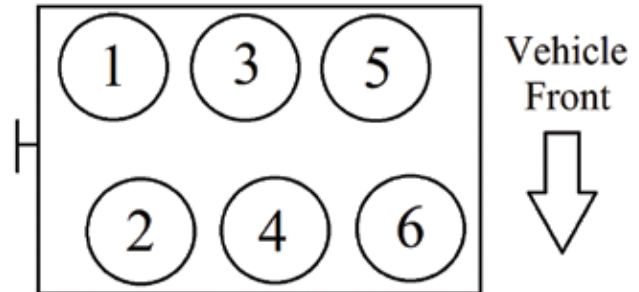
On the VQ35 engine, cylinders 1, 3, & 5 are on the rear bank and are covered by the intake manifold. However, cylinders 2, 4, & 6 are easily accessible. When cylinder 4 is at TDC exhaust, cylinder 1 is at TDC compression.

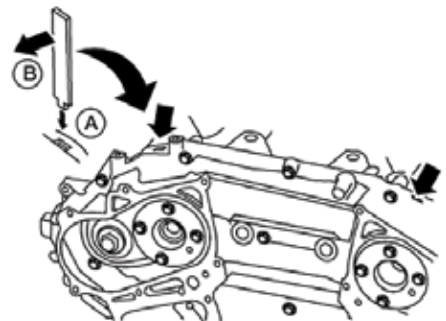
Pry the cover off by using a suitable tool inserted into the notches shown here.

Once all of the bolts are removed from the VQ35 front timing cover, it can be removed.

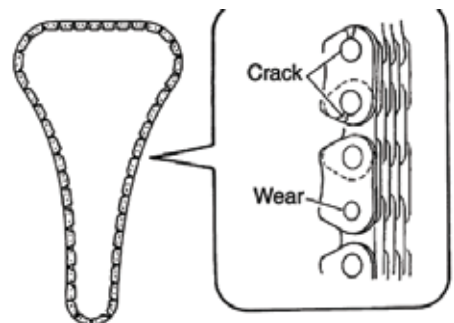
Carefully inspect the timing chain for wear if you do not already plan to replace it. Any cracks or looseness in link pins warrants replacement.

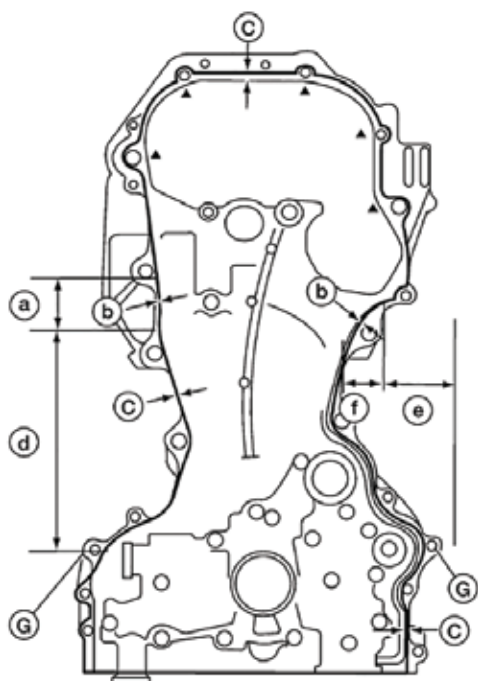
Here we see a diagram depicting the proper application of RTV on the front cover. Notice that the bead thickness varies, and is to be applied around the outside of some of the bolt holes. Be sure to follow the diagram for the engine you are working on.

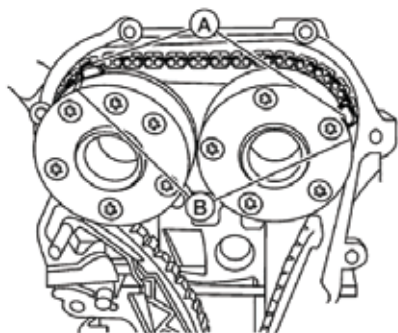
The colored links, A, of the QR25 main timing chain must be aligned with the mating marks, B, of the camshaft sprockets.

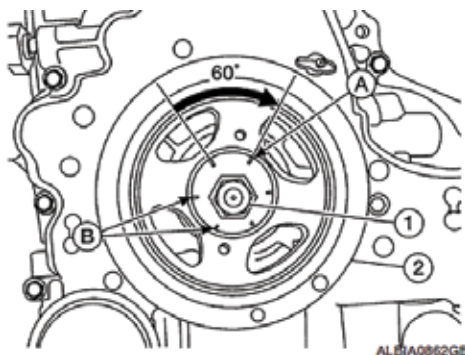
The QR25 crank pulley bolt must be tightened to 31 ft.lbs. and then an additional 60°. The bolt has six stamps on it, each 60° apart. Simply mark the pulley at one stamp then tighten the bolt until the next stamp lines up with the paint mark.

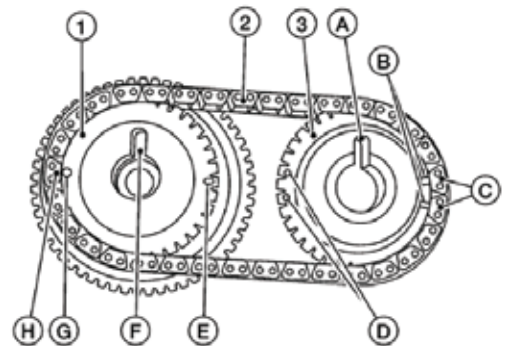
Here is a rear view of an as-assembled secondary chain for the right bank of

the VQ35. The colored links, H & C, must be aligned with the mating marks, B & G. The left bank secondary chain will be reversed.

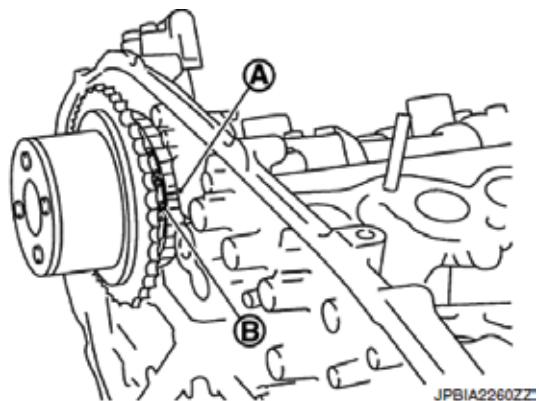
To make rechecking VQ35 alignment easier, make a paint mark extending from the mating mark to the teeth of the sprocket.

The VQ35 timing chain installation follows a similar procedure, however instead of a balancer chain, there are two secondary chains. The secondary chain installation is unique in two ways. The first difference is the fact that the secondary chain tensioners will be installed first. The second difference is the fact that the secondary chain must be assembled with the camshaft sprockets before being installed on the engine. The sprockets for the left bank are the same as for the right bank, therefore, they all have both mating marks. These marks are on the rear of the sprockets. The right bank will use the single circle mark on the intake sprocket, matched with the single colored link on the chain, and the double oblong marks on the exhaust sprocket, matched with the double colored links on the chain. The left bank will use the opposite marks. If this seems a bit confusing, just keep in mind that both dowel pin grooves should face upwards. As the mating marks on the camshaft sprockets are on the rear, they will not be visible once the sprockets are installed. To make rechecking alignment easier, a paint mark should be made extending from the mating marks up to the teeth of the sprockets.
