the bimmer[®] pub

Technical Knowledge for Independent BMW Service Professionals

Energy Management | Fuel Delivery | N54 Engine | N52 Oil Leak | Carbon Buildup

Energy Management

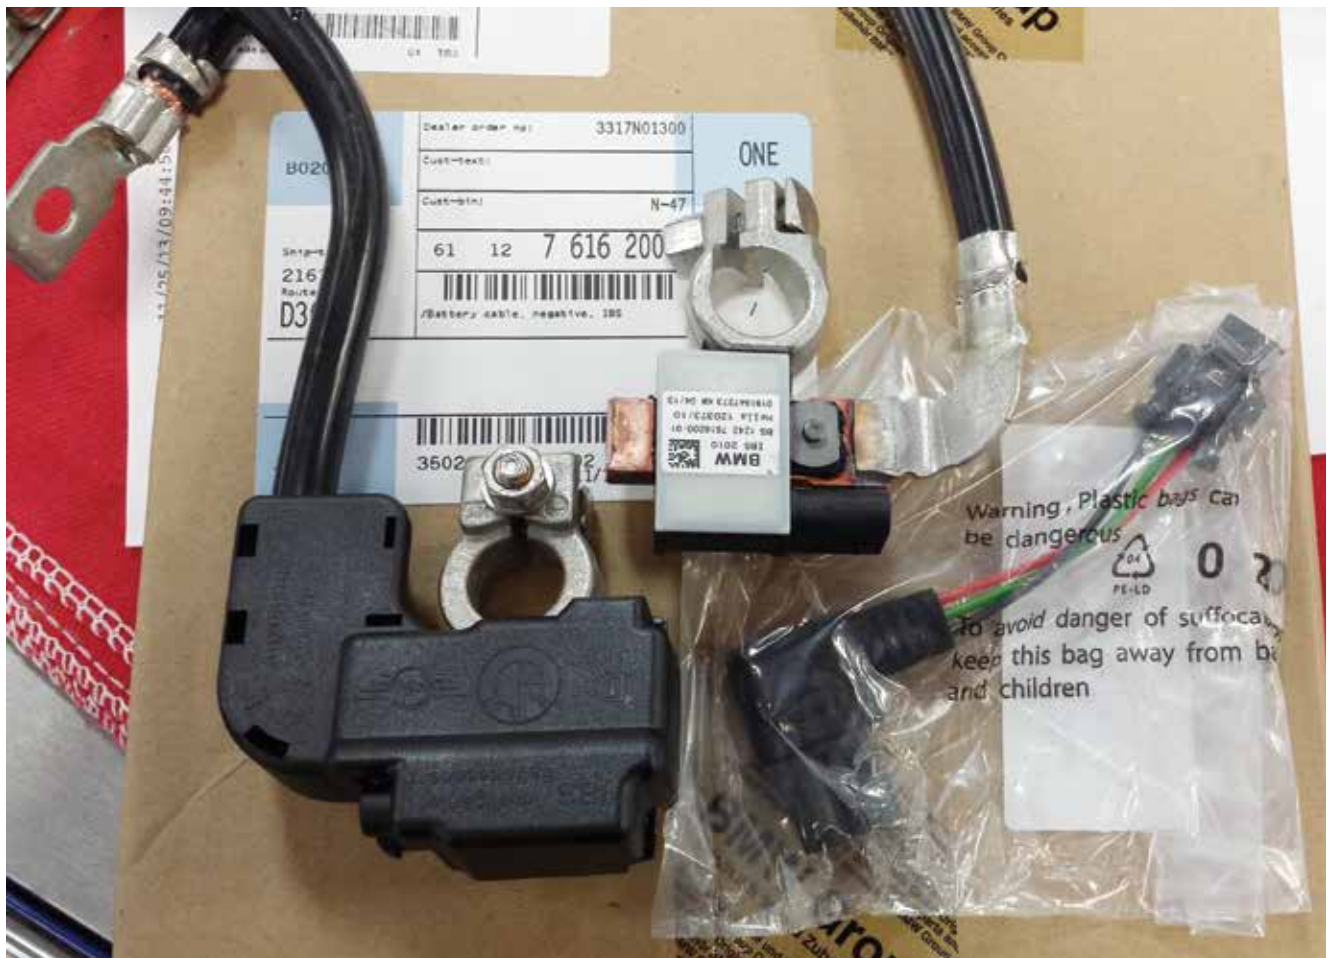
New generation IBS next to the old generation IBS.

Let's take a look at the first item — determining the battery condition. The DME is responsible for the majority of the calculations of the battery condition. It gathers the relevant data from a small sensor/control unit called the Intelligent Battery Sensor (IBS). Using the data from the IBS, the DME is able to increase or decrease the output from the alternator, increase the idle speed to assist with alternator output if needed, and request reduction or termination of nonessential loads if the demands on the electrical system are too great.

connection to the B+ terminal of the battery. It has the function of measuring battery voltage in, battery voltage out, current in, current out, and battery temperature under all operating conditions.

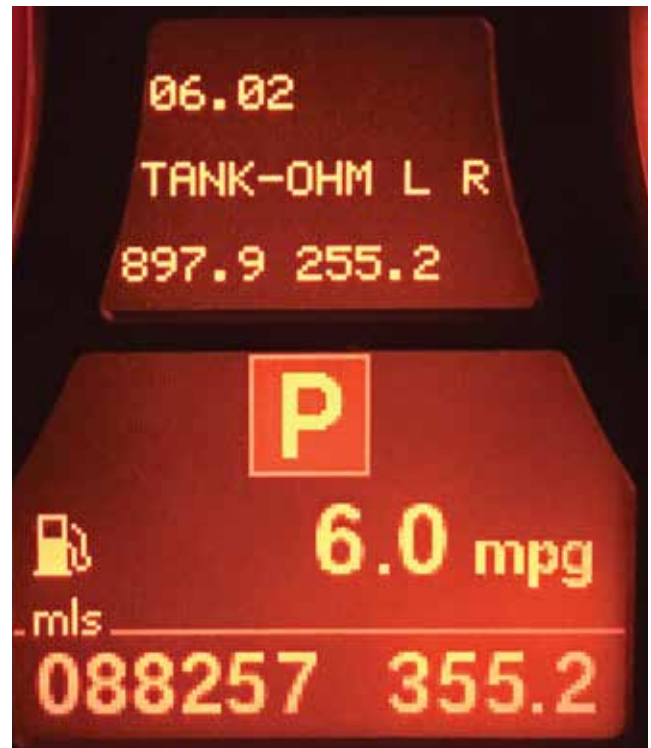
Using test 6 within the instrument cluster is an easy way to check the status of fuel level sensors. Some vehicles even allow the resistance values to be displayed.

To avoid this problem and a dissatisfied customer, these adaptation values must be reset. This resetting is accomplished via test number 21 in the instrument cluster test mode. Remember, the cluster must first be unlocked. When asked to enter the unlock code, simply add the last five digits of the VIN together. For more information on cluster test mode, visit the BMW TIS website (<https://www.bmw-tis.com>) and read the “Driver Information and Displays” section of the body electric training manuals.

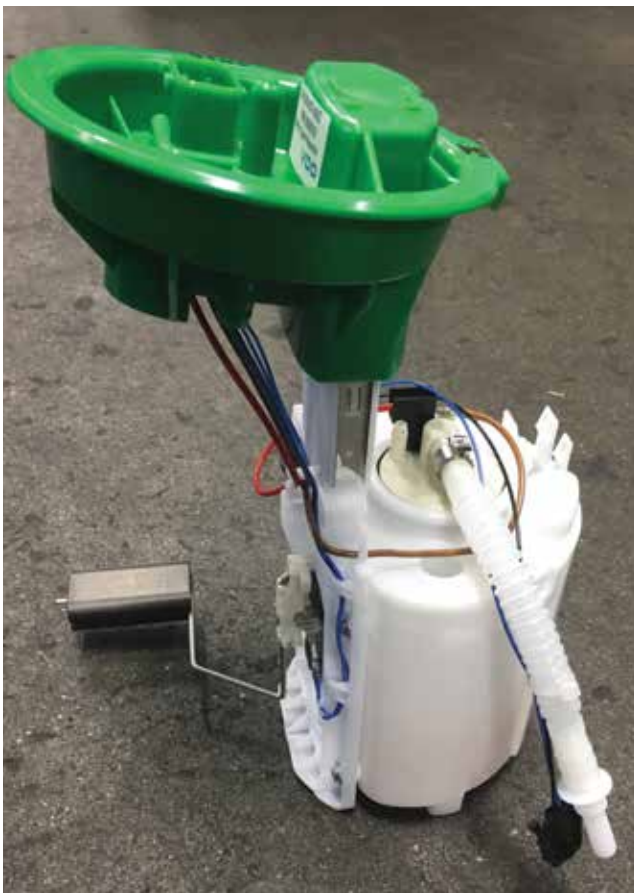
Because the fuel level sender is often incorporated into the pump assembly, remember to clear the adaptation values for the sensor circuit in the instrument cluster when replacing.

When the replacement of a fuel level sender is needed, either as a result of failure or as part of a replacement fuel pump assembly, there is an important step that is often overlooked. Because this is an analog signal being generated by a mechanical component, wear results in signal degradation. This problem is addressed using adaption values stored in the instrument cluster or appropriate processing control module.

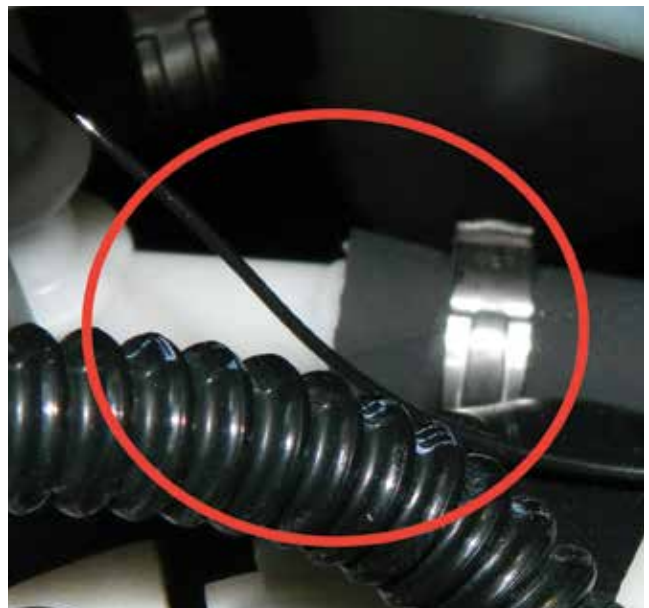
When this hose was crimped onto its fitting, it was not completely inserted. The result was an internal leak.

Another possibility is an internal leak. A hose in this siphon jet circuit can break or come loose at a service connection fitting. While the access covers are still off, activate the in-tank pump. In the case of a broken or disconnected line, there will be fuel spraying out from this leak. A disconnection due to improper installation may be repairable. However, a broken line will likely require the replacement of the entire tank. Some technicians are finding that the plastic corrugated lines used inside of BMW fuel tanks are starting to fail. This is probably a result of the ethanol content in today's gasoline.

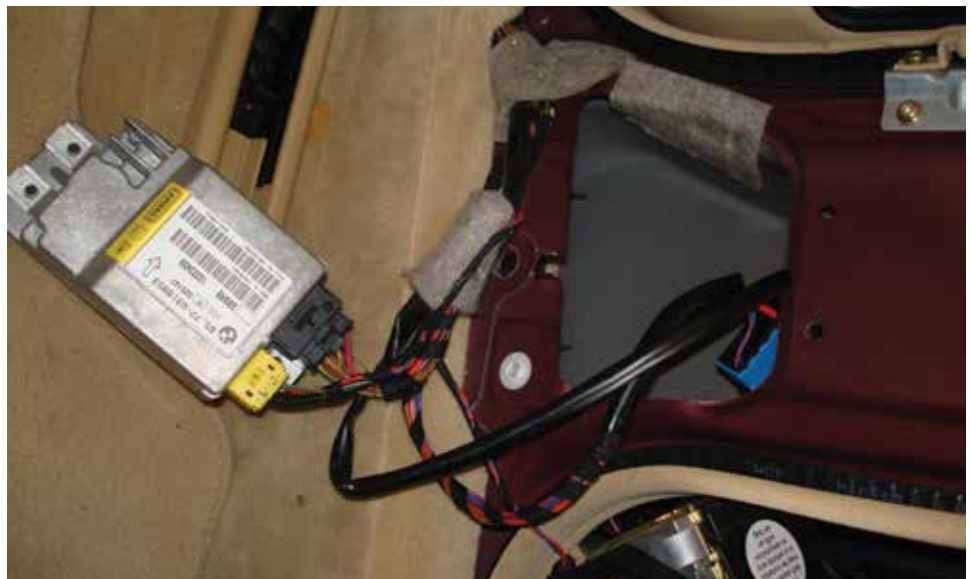
On the E65/E66 chassis, an airbag system control module, the SBSR, is used for EKP regulation. Because the SBSR incorporates accelerometers used for crash detection, do not manipulate it while the key is on. This is a common cause of fuel pump circuit failure.

The SBSR is on the Byteflight network. This means that the command path for fuel pump control goes from the DME over PT-CAN to the central gateway module, or ZGM. From there the activation signal is sent over Byteflight to the SIM and passed on to the SBSR. Suddenly the importance of a complete vehicle scan becomes clear. On all other BMWs with a dedicated EKP module, the module is on the PT-CAN. So the signal path is much less complicated. As a side note, the EKP module contains one of the two terminating resistors for PT-CAN.

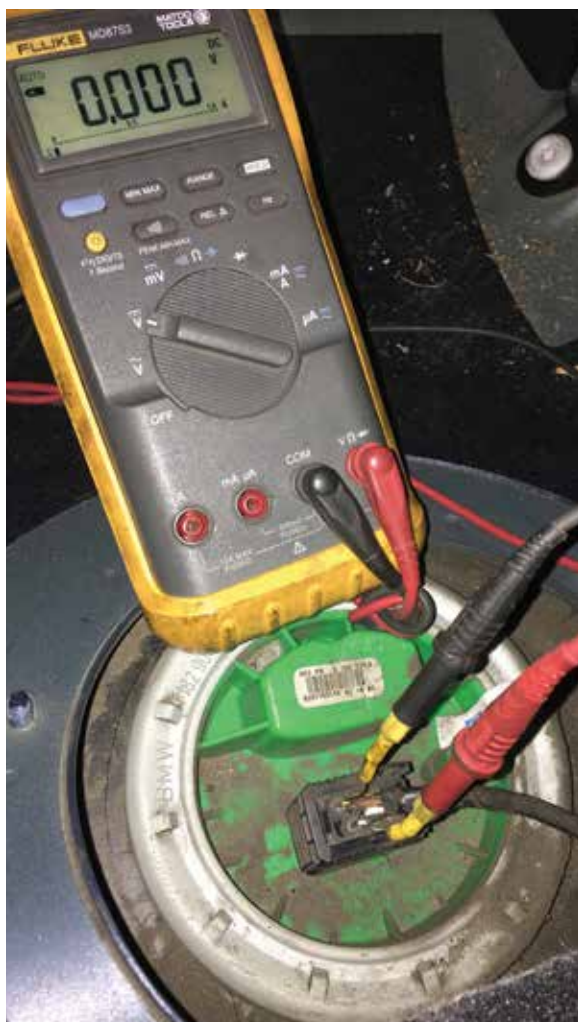
A DVOM and a solid understanding of voltage drop theory is all you need to fully analyze the fuel pump circuit.

Now that the circuit is complete, or commanded on via scan tool, perform a voltage drop test across the fuel pump connector under the rear seat. You should be measuring within half a volt of system voltage (some will be lost through various connections). If measurement is within spec, and you cannot hear the pump running, clearly the problem is in the tank. Remove the electrical connector and visually confirm that the contacts are not burnt before proceeding with a pump replacement.

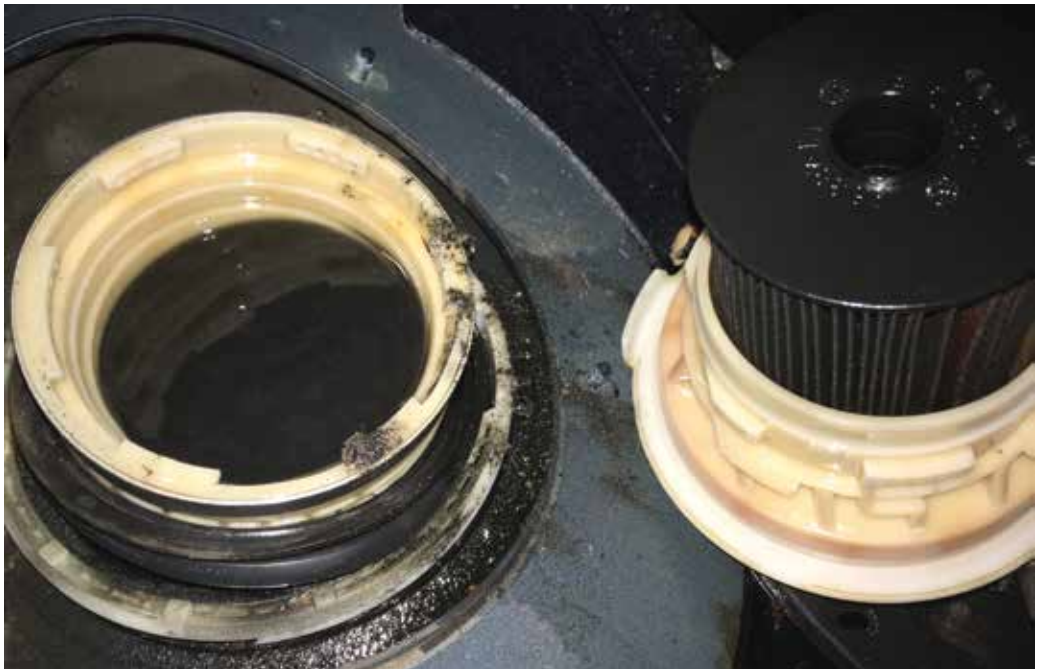
Always replace the fuel filter when replacing a faulty pump. This in-tank filter has become heavily contaminated after less than 120,000 miles of use.

When replacing a faulty fuel pump, you should always replace the fuel filter too. If the repair requires replacement of the EKP module, it will likely need coding or programming. If you are replacing the SBSR, after coding and programming don't forget to restart the system time for the passive safety system. ●

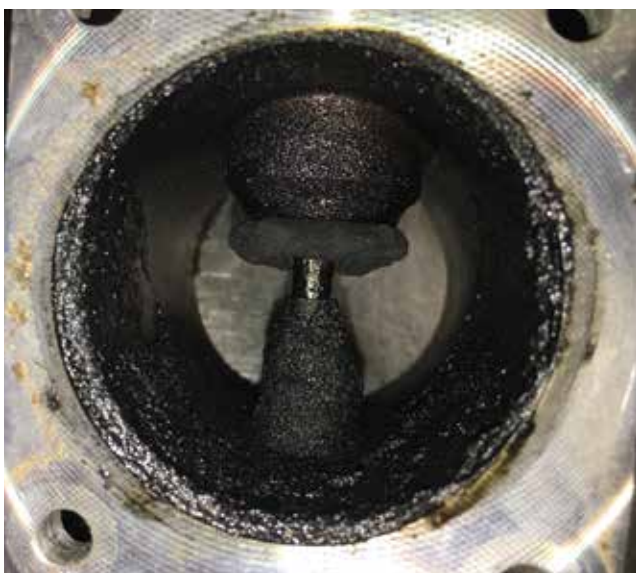
Here you can see how much carbon can develop on the EGR valve mechanism.

The EGR valve is located in the throttle housing. Exhaust gas is ducted from the exhaust manifold to the throttle housing. There is a connection at the forward end of the manifold for this purpose. Connected here is the EGR valve, which controls the volume of recirculated exhaust gas. The EGR systems differ between the E70 and the E90. Both vehicles use the “high-pressure EGR,” but the E70 uses an additional “low-pressure EGR” system. The low pressure EGR system is required in the E70 due to its additional weight and higher operational loads (i.e. towing etc.).

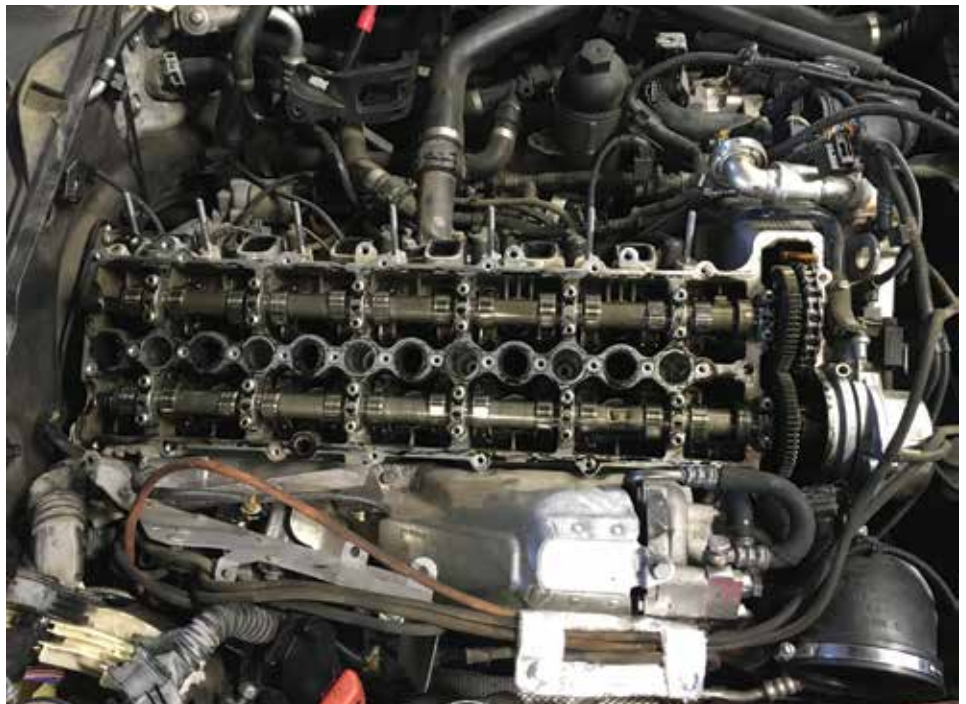
M 57 engine with intake manifold and valve cover removed

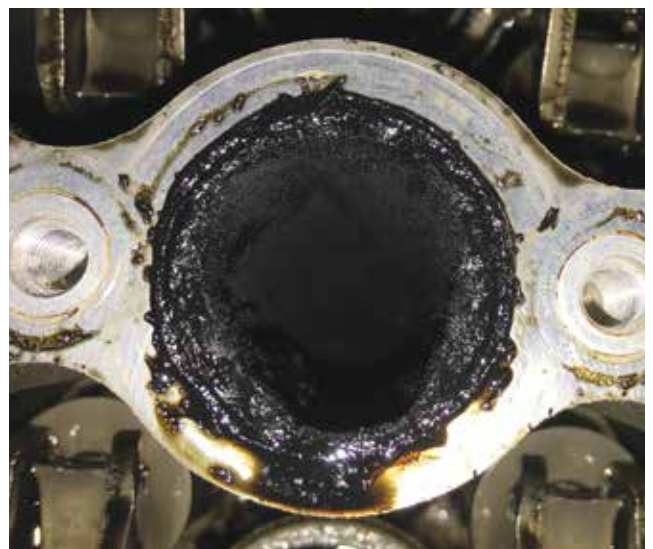
Carbon can build up in cylinder head swirl ports in addition to other places within the induction system.

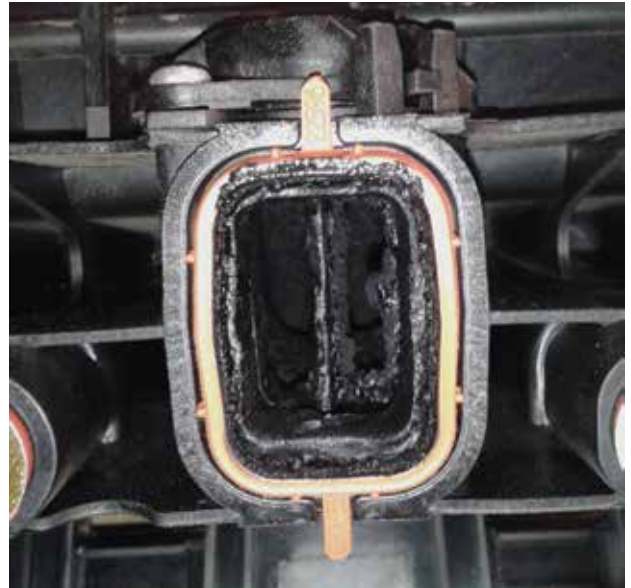
Other places where carbon can build up include the tangential ports on the intake manifold and the tangential ports on the cylinder head.

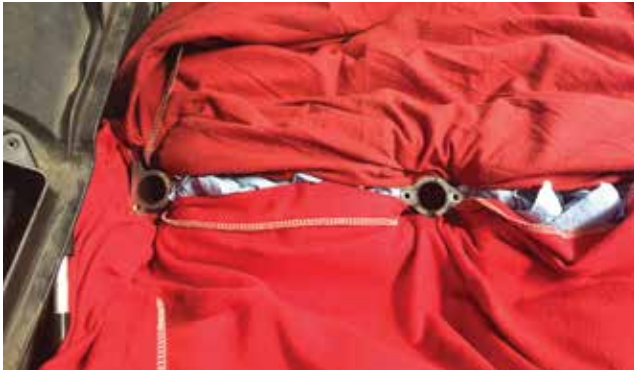
Here is an example of how thoroughly you should seal off ports and passages prior to carbon blasting.

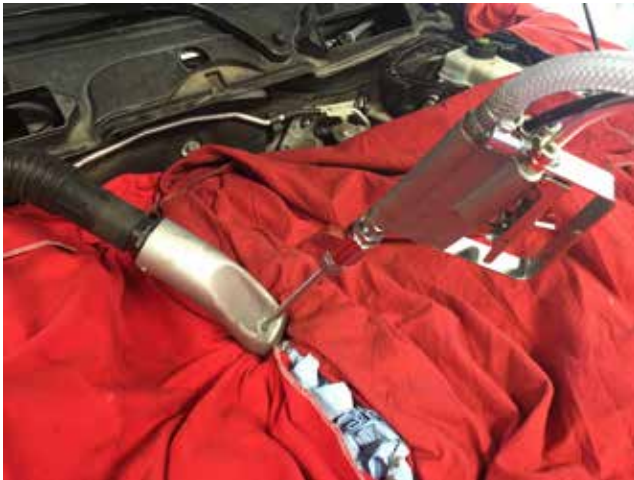
Using carbon blaster on swirl port.

In addition to the blaster, you will need specific adapters for the M57 engine (part numbers 2 356 966 and 2 356 967) and blasting wands (part numbers

2 356 968, 2 356 969, and 2 356 970). It is best to obtain an extra set of wands as you will find that making some modifications to them will give you more freedom to clean difficult-to-reach areas of the intake ports. For more information about the BMW carbon blaster and how to use it check out service information bulletin 11 03 14.

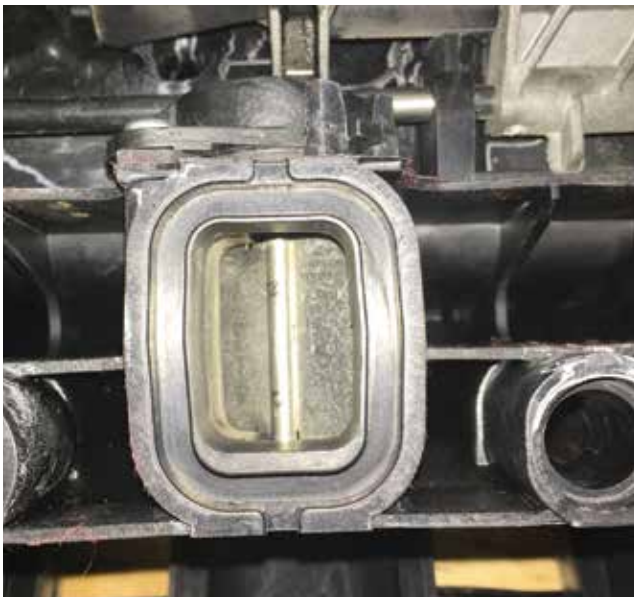
This is a tangential port on an intake manifold with swirl pot closed after soda blasting.

The intake manifold is also going to need to be cleaned. Many service centers are simply replacing the intake manifold with a new one. However, the intake manifold can be successfully cleaned using a soda blaster. This is a blasting cabinet that uses baking soda as the abrasive media. Soda is soft enough to not cause any damage to the plastic or even the impregnated rubber seals on the swirl ports.

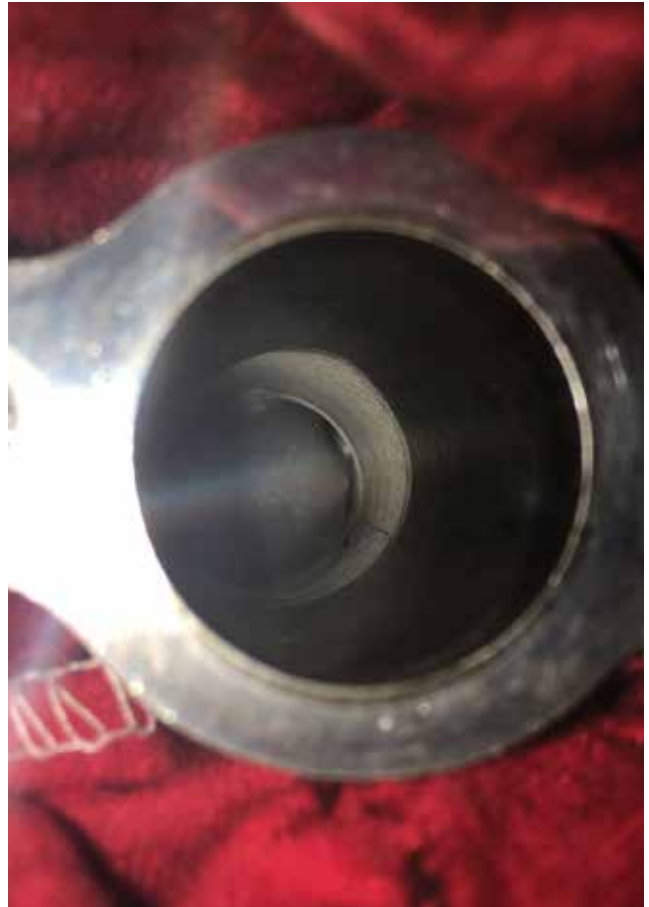
The swirl ports on the cylinder head can look like this after cleaning.

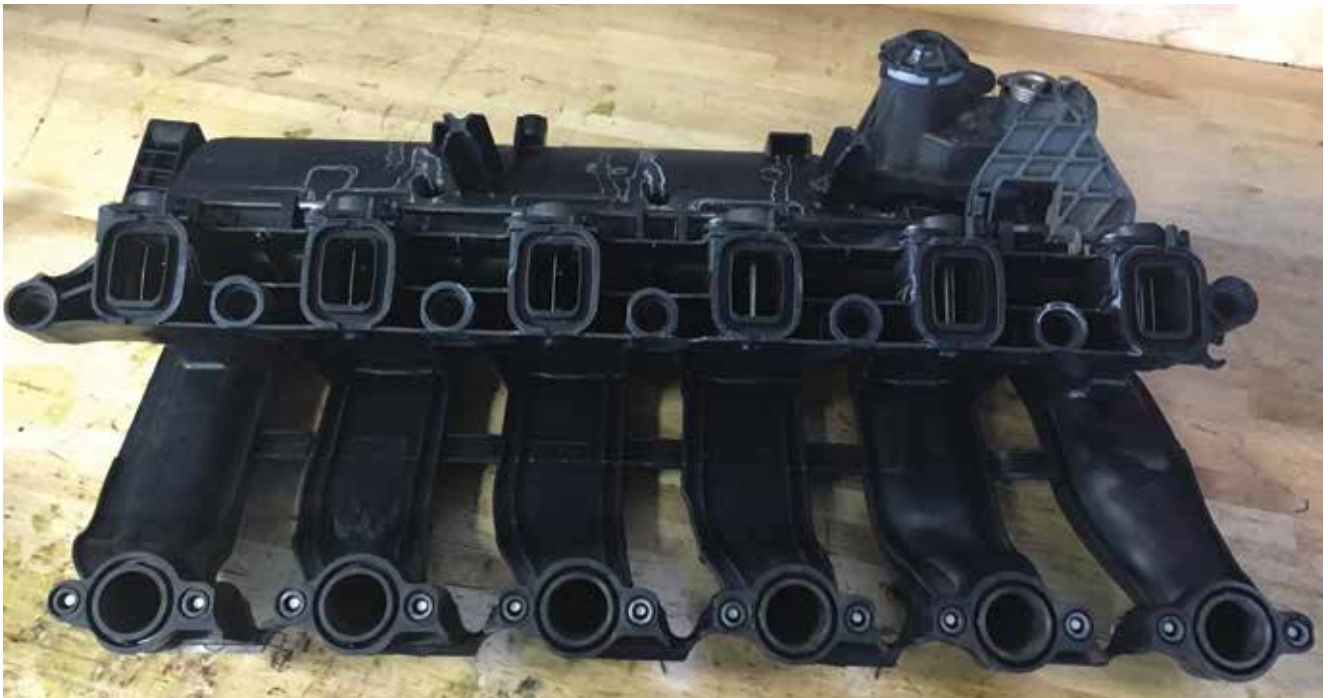
Here is a complete M57 intake manifold reassembled after soda blasting.

If you choose to use this method, completely disassemble the intake removing all the swirl pots, sensors, hardware, actuators, and replaceable gaskets before cleaning. You will need to clean the throttle body and EGR valve before reassembly. You can also use the soda blaster for this or use a good throttle body cleaning chemical. Be sure to keep any chemicals from flowing along the actuation shafts and entering the electronics.
