# TechNews

Fall/Winter 2016 | Volume 9 | Issue 3

- | **No-Start Diagnostics Part 2**
- | **Understanding Differential Gear Ratios**
- | **Pre- and Post-Repair Scanning**
- | **Nissan Power Window Control Repair**

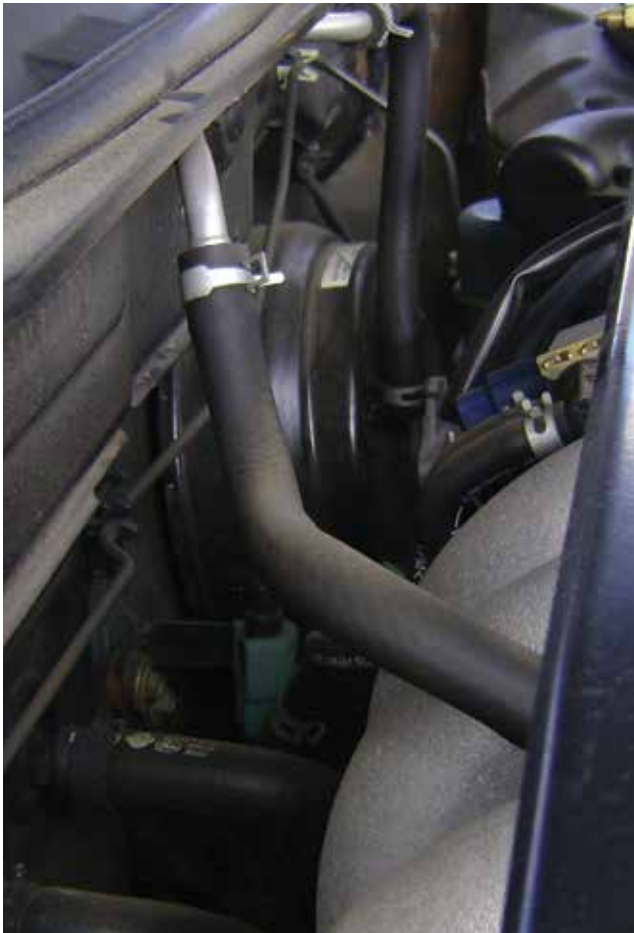
Even a loose or leaking vacuum hose this size will not typically cause a no-start, although this can easily cause the P0171 code to appear.

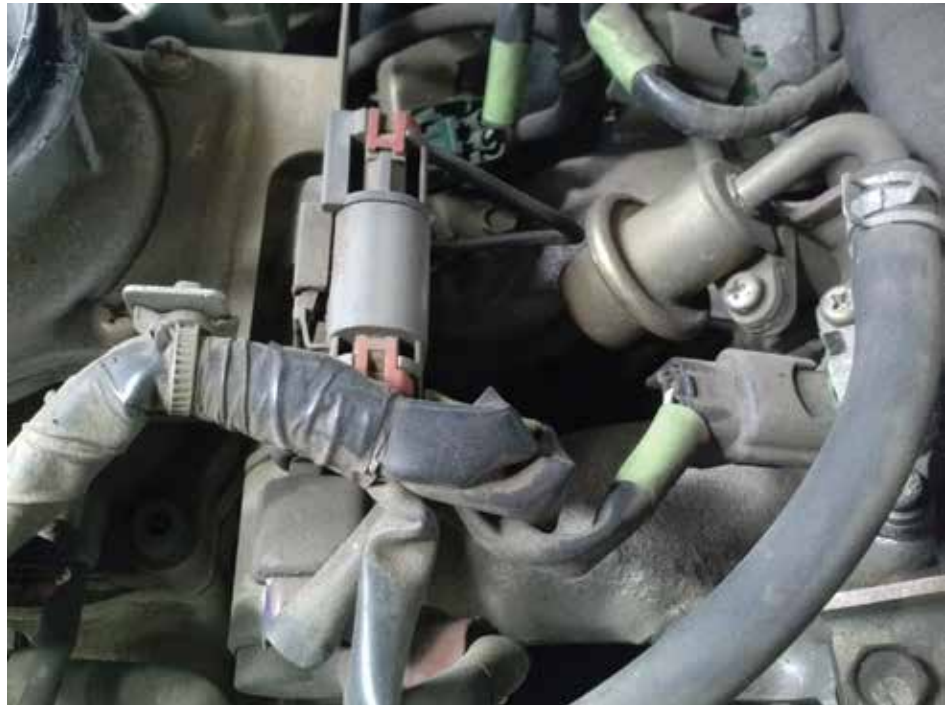
The presence of too much fuel may be the result of a fuel pressure issue. Check the fuel pressure regulator vacuum hose for fresh fuel.

cause a no-start. If you smell gas, pull the regulator's vacuum hose and see if there is fuel in it. The presence of any fuel means a new regulator is needed to start with.

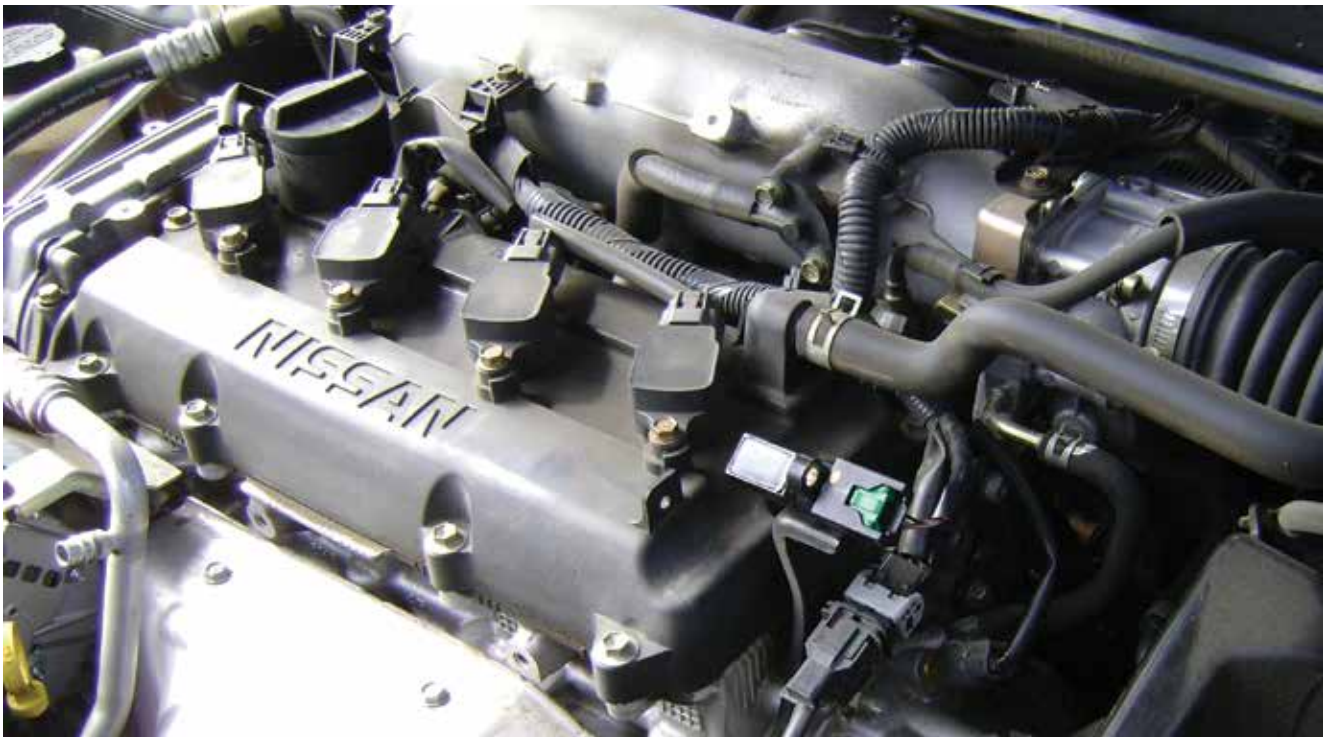
It's better to assume a common problem, like a CMP sensor, than to assume four bad coils.

The code P1320 will cause a no-start or, worse yet, an intermittent no-start condition. The code is indicating that the ECM does not see the ignition coil primary circuit. If you have any other codes with it, like P0335, P0340, or P1136 start with those codes first, especially since a bad CMP sensor can cause the P1320. If however this is your only code, patience and diligence will come in handy. And don't rule out a bad CMP sensor.

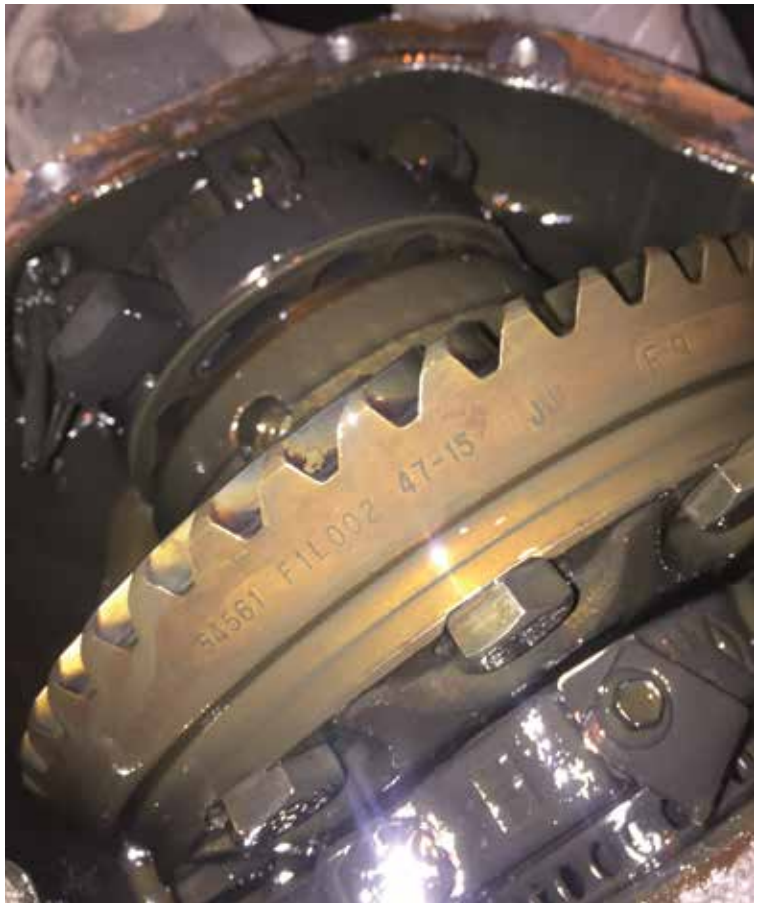
When all else fails, the differential cover can always be removed to reveal the ring gear stamp. This is an Xterra® with an M226 rear differential. 47-15 indicates 47 teeth on the ring gear and 15 teeth on the pinion gear, which is a gear ratio of 3.133.

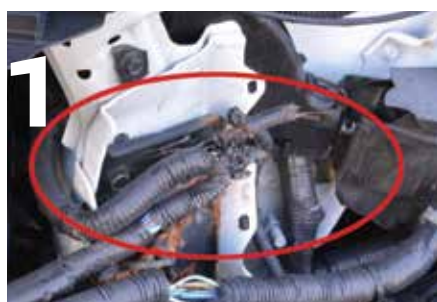
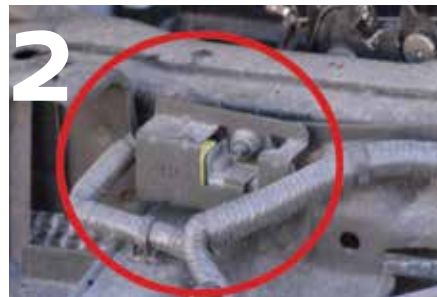
This front-hit 2015 Rogue® shows damaged wiring (red circle 1 – driver side) for the front crash sensor. Although the crash sensor itself shows no visible damage (red circle 2 – passenger side), it must be replaced because even minor impact-related internal damage can prevent proper sensor operation in a future collision. Pre-scanning would find a DTC (B0094, etc.) noting an issue in this sensor's circuit, and post-repair scanning would alert the technician to the need to calibrate the replacement crash sensor, or confirm that calibration had been successfully completed.

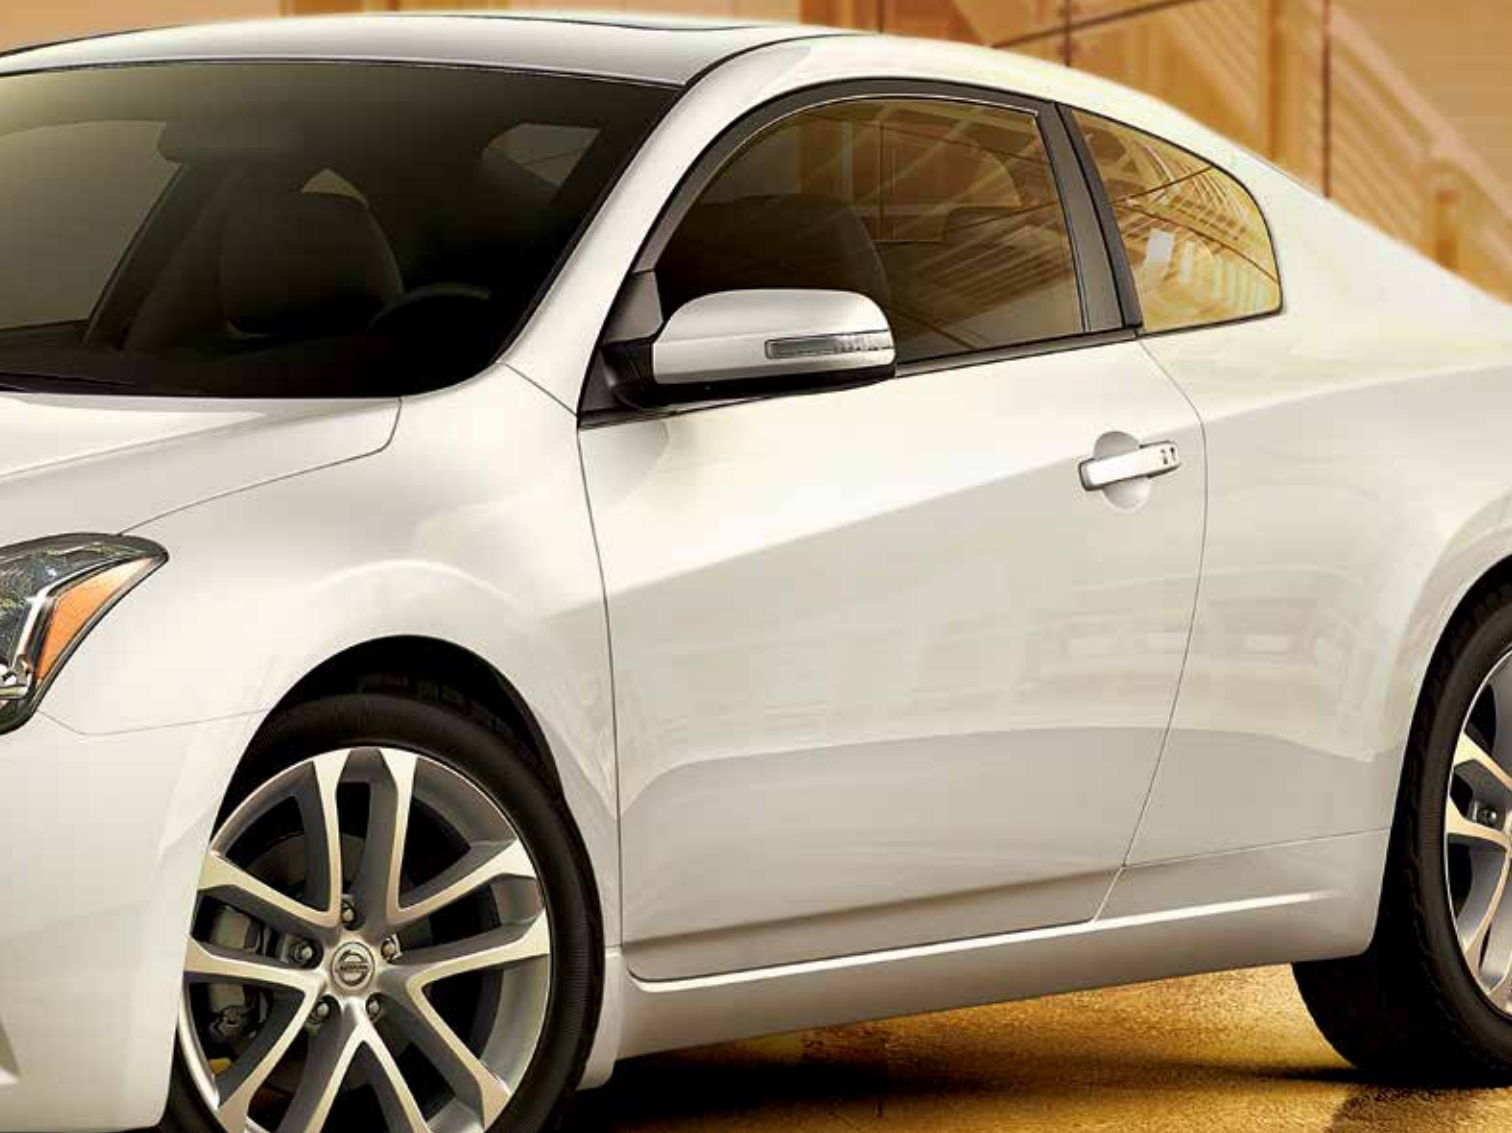
Nissan power windows now include Auto-Up and Anti-Pinch features that must be initialized after any event or repair procedure that interrupts power supply to the power window system. Initialization is easy, and information about the procedure and when to use it is available in your Nissan service manual.

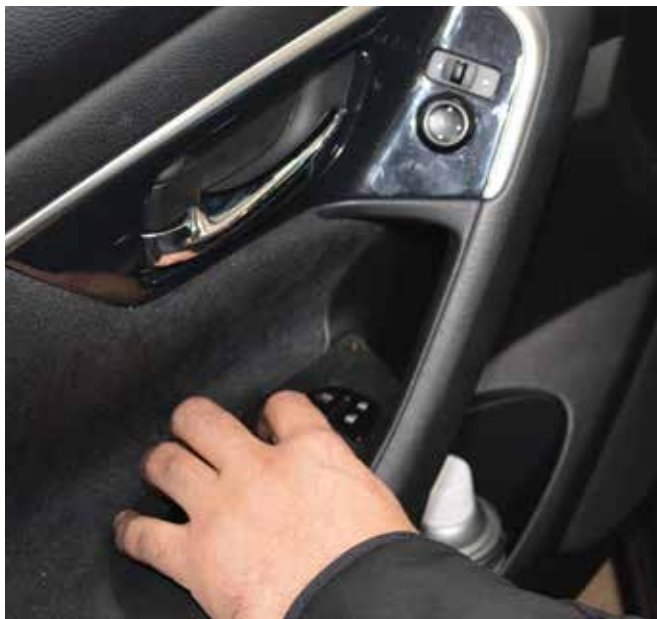
The Altima® sedan power windows now have Auto-Up and Anti-Pinch features. They are simple to diagnose if a problem occurs, and easy to re-initialize.

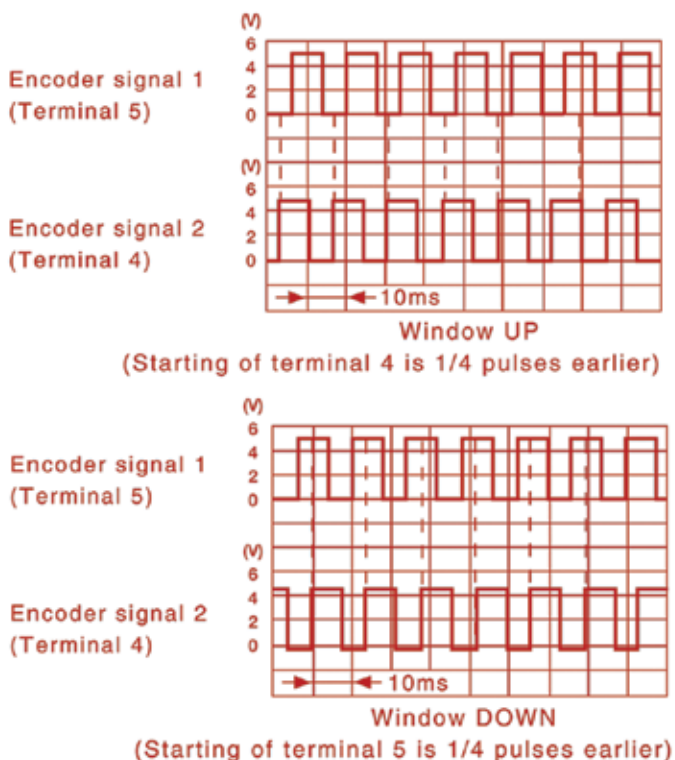
The encoder signal from the main power window switch should show an on-off square wave pattern that alternates between zero and five volts. Differences between the patterns relate to whether the window is going up or down, and which pin (signal) is being monitored

The main power window and door lock/unlock switch circuit also includes an encoder feature that converts the rotation of the power window motor shaft into a pulse signal. The encoder continuously monitors the rotation of the front LH (left hand) and RH (right hand) window motor shafts and transmits the pulse signal to the power window and door lock/unlock switch. The pulse varies based on the direction of window travel (up or down), and the rate of travel.
