# Transmission Maintenance

Let's take a look at three modern Mercedes-Benz automatic transmissions and the details of their needs.

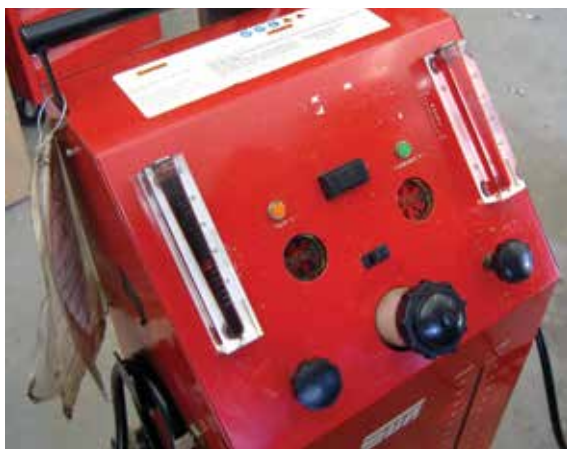
Regular transmission fluid maintenance is much more expensive with synthetic ATF than it was with conventional Dexron, but transmission work is much more expensive, too. The visual comparison of clean to dirty ATF as seen on this flush machine is a powerful customer pleaser.

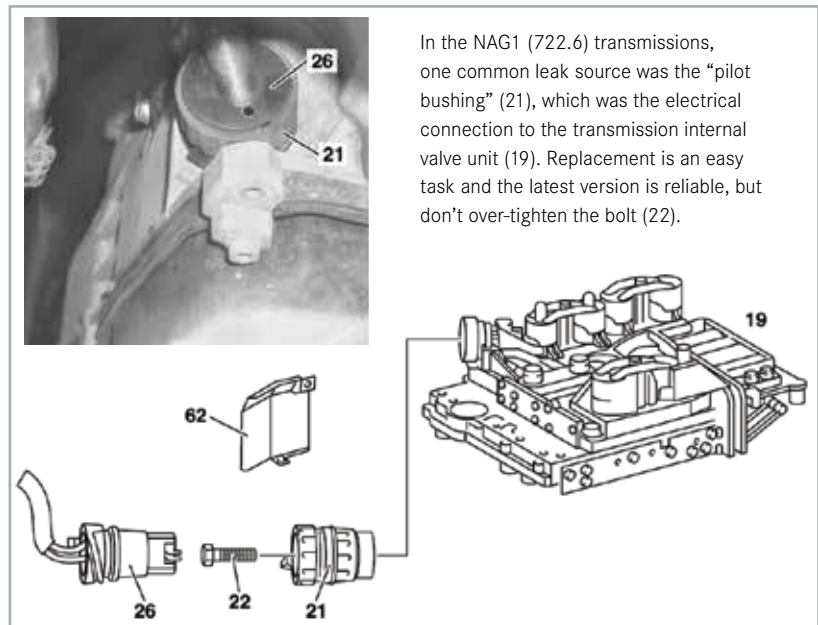
In the NAG1 (722.6) transmissions, one common leak source was the “pilot bushing” (21), which was the electrical connection to the transmission internal valve unit (19). Replacement is an easy task and the latest version is reliable, but don't over-tighten the bolt (22).

One service issue seen often on the 722.6 is the so-called "pilot bushing", which is the electrical connector located in the front right of the transmission just above the pan. Early versions of this component had O-rings, which tended to leak — slowly, over time.

This slow drip would often not be addressed by the customer until it was almost too late, with slipping shifts and eventual loss of power transmission entirely. The solution is to replace the entire part, and to be sure to tighten the single central bolt holding it in place carefully to specification, a downright miniscule 2.5 Nm, which really is just finger-tight. But don't trust your fingers: Use a good micro-torque wrench, or risk a repeat failure. The modern version of this part is quite reliable.

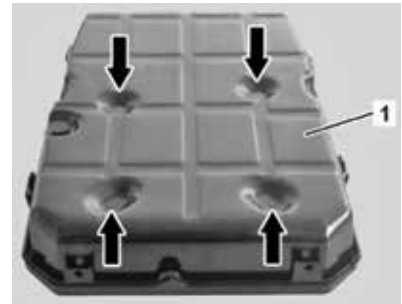
In 2010, the design of the oil pan of the NAG2 (722.9) was changed, indicating the need for a different fluid and overflow tube. Here we see the “newer” version pan, which has deeper oval indentations (arrows) and a green overflow pipe (visible with the drain plug removed). The side of the pan is flat, unlike the older version pan, which has a noticeable angled chamfer. Be sure to follow the WIS instructions for the version you're working on.
