Technical Knowledge for Volkswagen®, Audi® and Porsche® Service Professionals

**Audi's Electro-Mechanical
Parking Brake System**

Porsche Engine Rebuild

VW Coding Mysteries

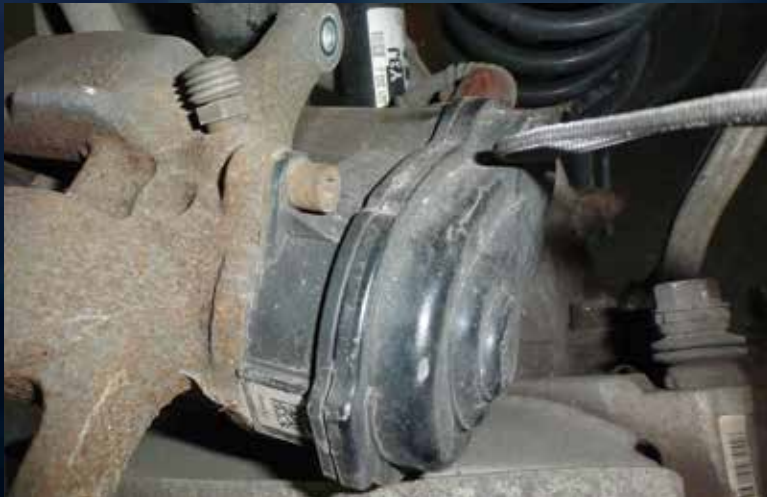
The actuator is a simple bolt on design attached to a modified brake caliper.

The rear brake actuators are the workhorses of the electro-mechanical parking brake system. Audi has integrated electric motors attached to a multi-stage gear assembly to securely lock the rear wheels. As robust as they are, these electronic actuators do fail from time to time. Most often, the electric drive motors wear out, position sensors fail, or they become damaged by water.

If an actuator fails, it may prevent you from removing the brake caliper during replacement. In these cases, the actuator must be removed from the brake caliper. Once removed, manually turning the exposed drive gear on the caliper will allow the caliper piston to be fully compressed. This is only used in cases where the caliper, or actuator, is damaged, since damage also may occur during manual removal.

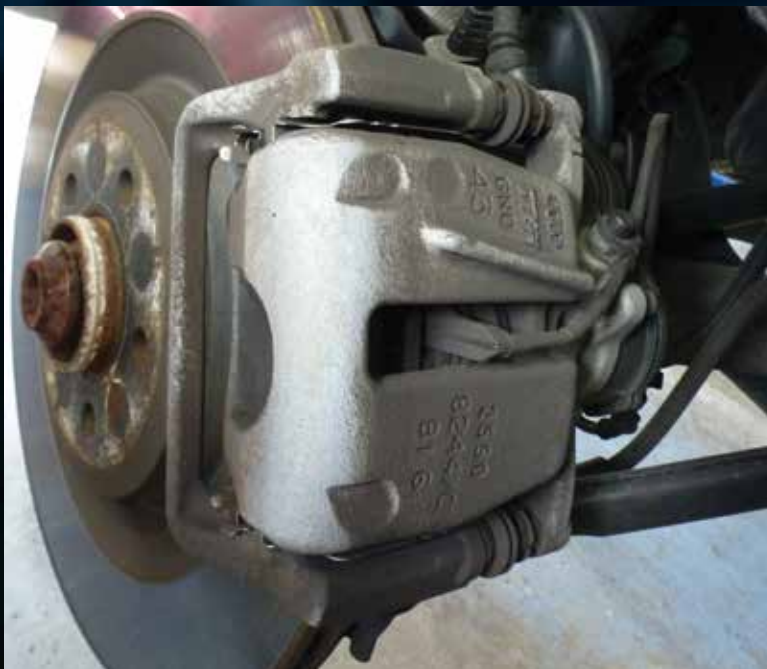
Often even looking from the inside it can be difficult to gauge brake pad thickness.

Brakes should be inspected at every service without fail. During brake inspection, it is critical to observe both the outboard and inboard pads on both sides of the vehicle, front and back. Often, the inner pad wears more quickly, and an outer brake pad that looks OK at 5mm thickness may have a 2–3mm inboard pad thickness. Often, rear brakes do not have wear sensors, so inspection is necessary here to avoid metal on metal brakes.

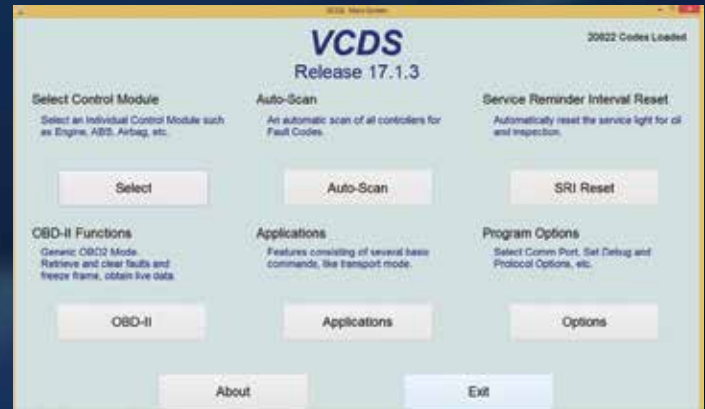
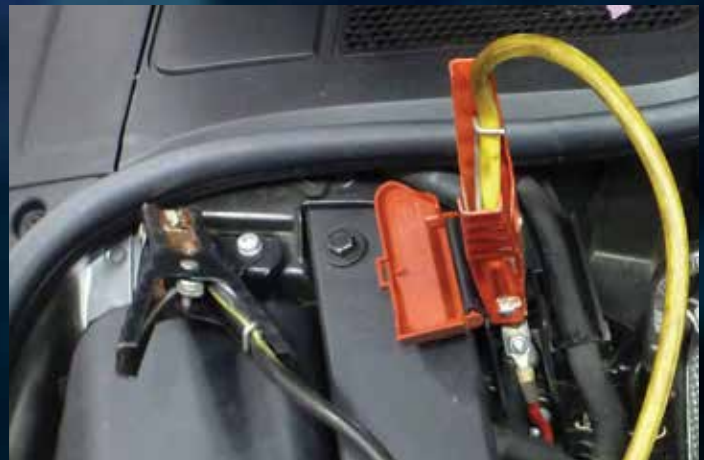
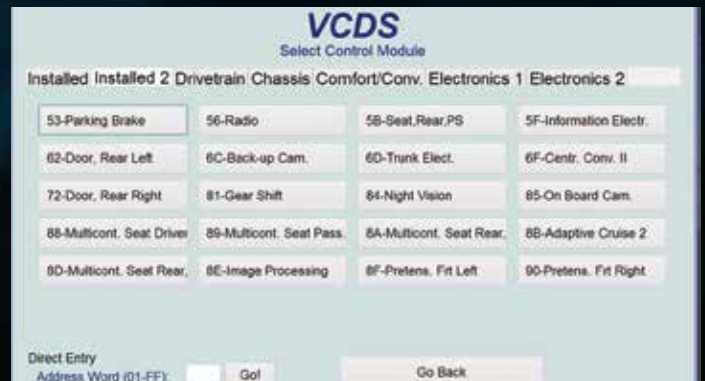
Any time you are scanning a vehicle, you must use a charger properly.

A battery charger is also required for the brake renewal process. Because you must remain connected to the vehicle while doing the repair process, battery voltage must be regulated. The EPB system measures the clamping force required to lock the wheels and requires a constant voltage supply to maintain proper operation. The electro-mechanical parking brake module, or EPB, is sensitive to voltage fluctuations and causes problems if battery voltage drops during the process.

Module failure is known to occur if low voltage is present during the process. Conversely, overcharging the battery during EPB service can damage many systems. If your charger has a programming setting, this is ideal. A constant 12.8–14.2 battery voltage is perfect for scanning, programming, etc.

It is not recommended to place charger leads directly onto the battery terminals on many newer Audi models. A battery management module is used to control power to many vehicle systems. Without proper charger lead placement, modules may not be functional. When placing the charging leads on the vehicle, always use the proper charging lugs. These may be located under the hood, or on some models in the trunk of the vehicle.

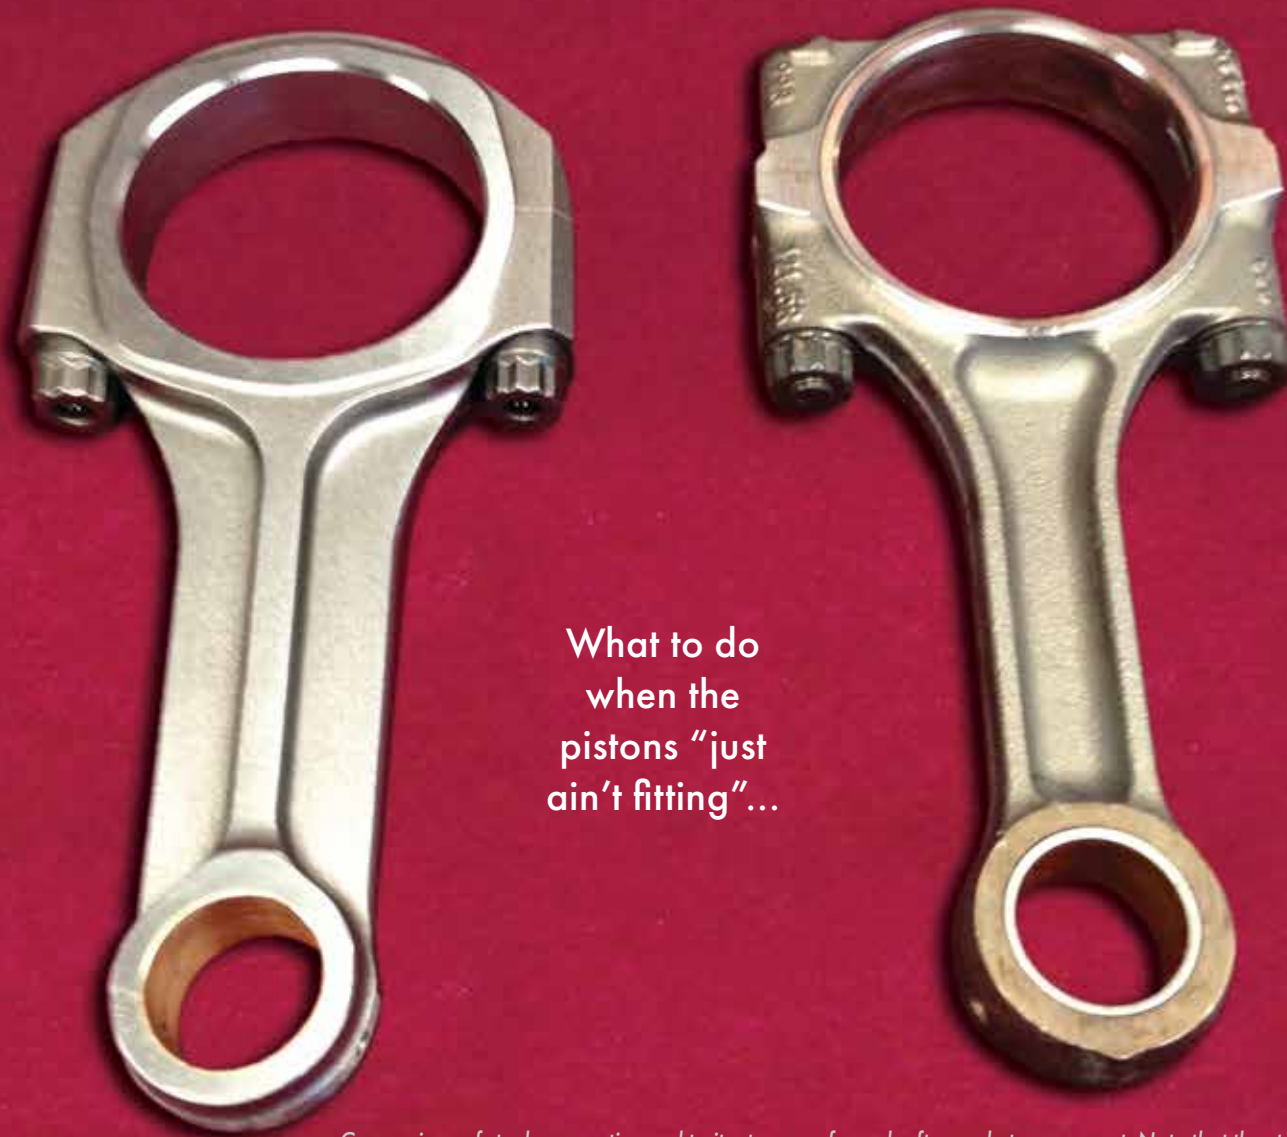
Comparison of stock connecting rod to its stronger, forged, aftermarket component. Note that the stock rod is narrower towards the base of the I-beam. Internal clearances must be carefully inspected and material relieved as necessary if interference exists.

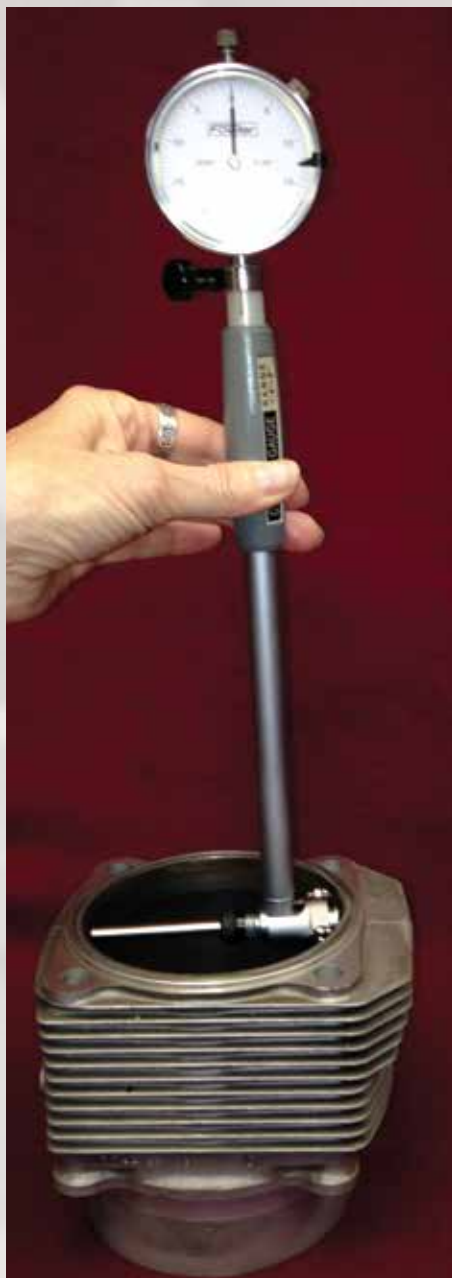
Always follow the manufacturer's procedures for measuring any engine component. This cylinder is being assessed for reuse, and should be measured at several different points for roundness and taper.

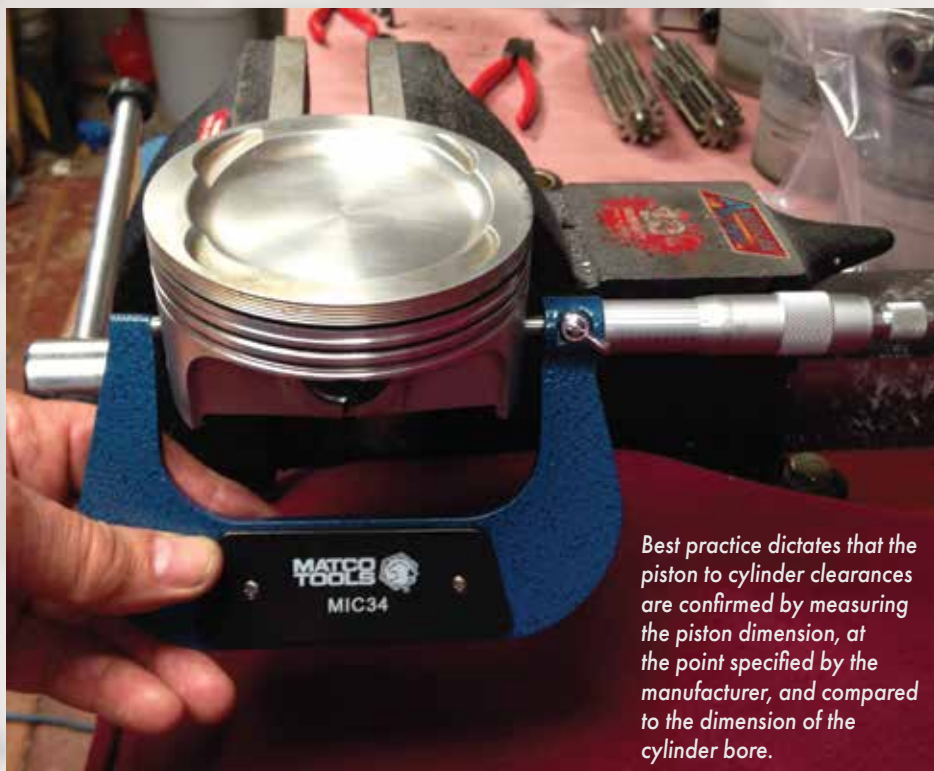
Best practice dictates that the piston to cylinder clearances are confirmed by measuring the piston dimension, at the point specified by the manufacturer, and compared to the dimension of the cylinder bore.

Being familiar with an engine family is surely a plus, but it can also lead to complacency. Consider this scenario. You know from experience that the factory spec for piston-to-bore clearance for factory pistons in the Porsche engine family is 0.004. Yet when double-checking pistons and liners in hand, you find clearance of just 0.0015. And the mystery deepens when you find exactly the same clearance on all six pistons and their cylinders.

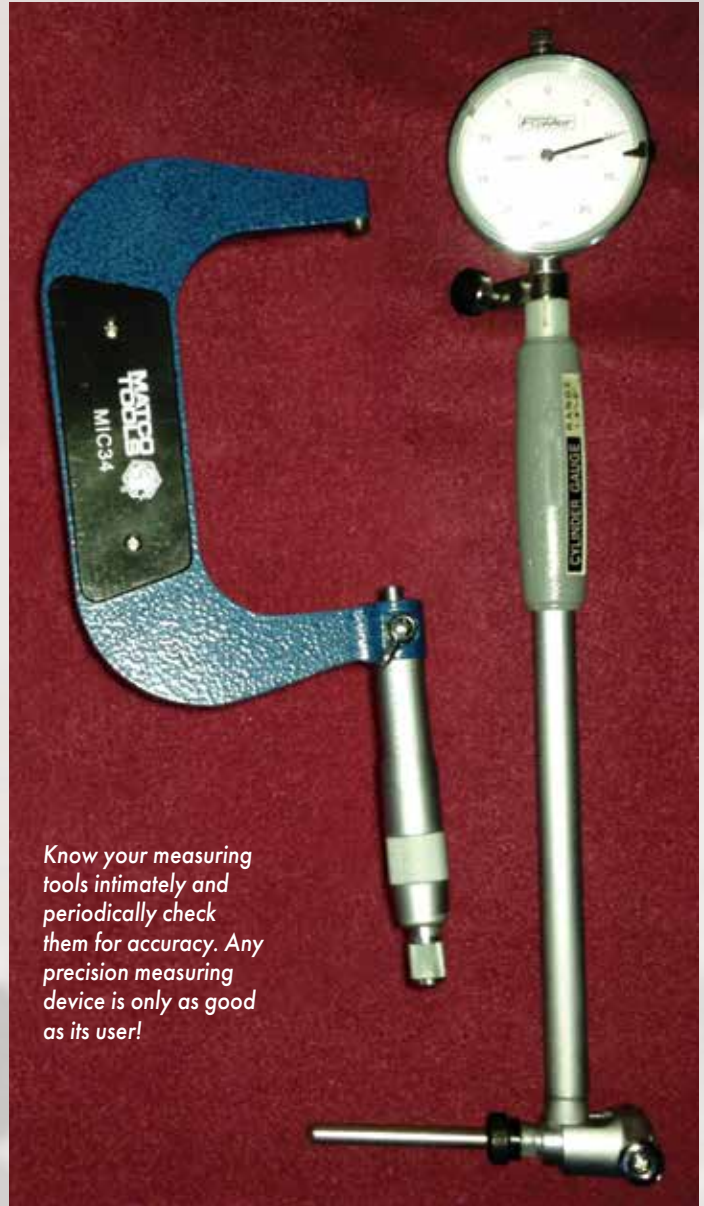
Know your measuring tools intimately and periodically check them for accuracy. Any precision measuring device is only as good as its user!

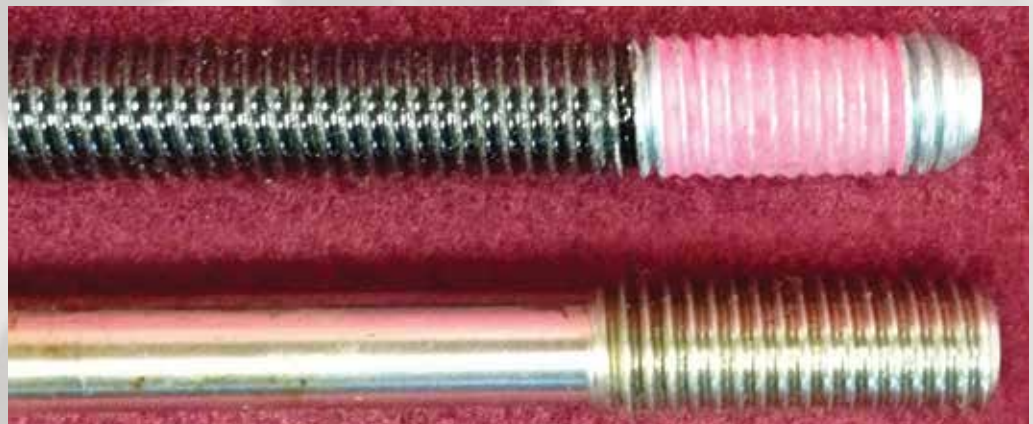
Cylinder head studs have been designed and redesigned to the point where there are now many good options. Compare material, strength and ease of use when considering something that is going to hold up better than original components. The latest factory "fully threaded" stud comes with a thread locking compound already applied. Be certain to use a high strength thread locking compound when installing aftermarket studs.

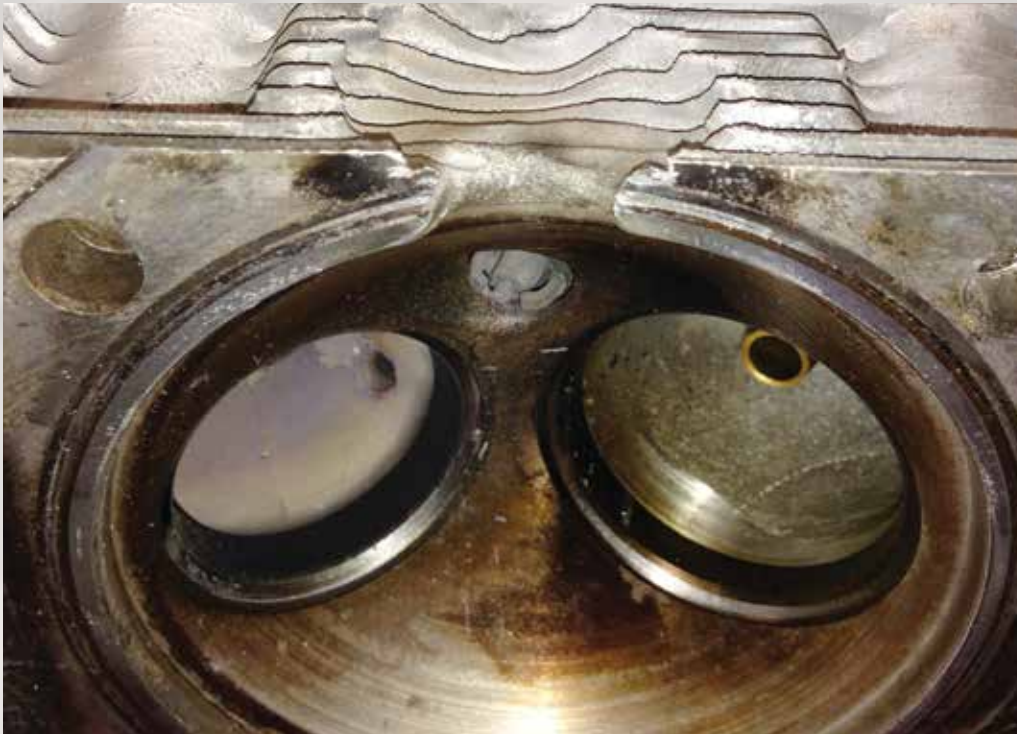
This turbocharged engine got too hot! Lean fuel to air ratios can turn an engine into a very expensive plasma cutter! Note the melted cooling fins on the side of the cylinder.

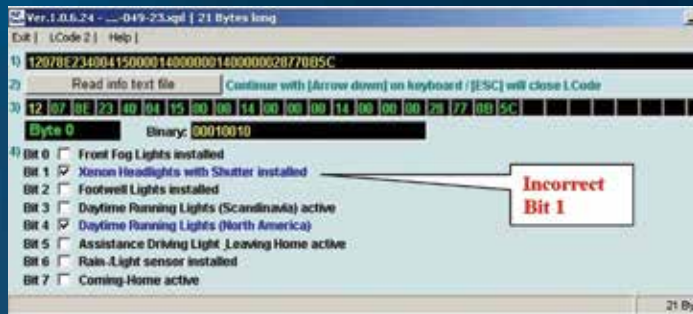
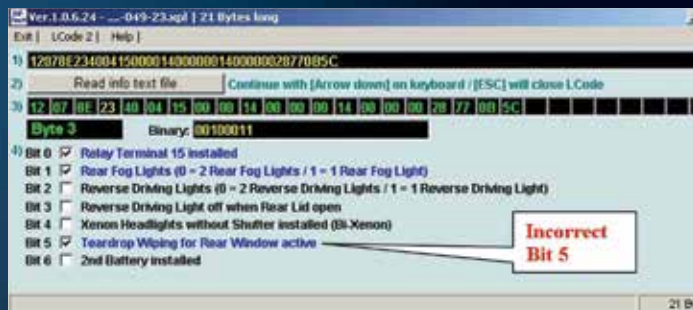
The next two images indicate the incorrect coding with explanations to follow.

Bit 5 is also incorrect for this model

12078E234004150000140000001400000028770B5C

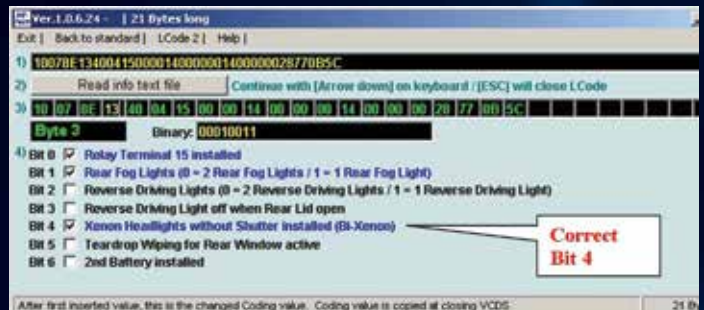
Notice the difference with the coding now when the model is identified with the correct equipment at Byte 0. Take the time to notice the differences between the two set of images {Correct and incorrect}.

At Byte 3, the last change was made and saved.

- The next two images are correct.
- The coding is saved and now the high beam function works correctly.

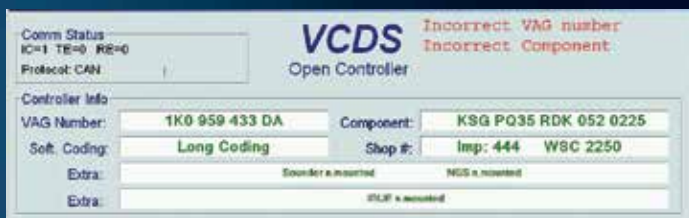
The last digit of five of the WSCs (Work Shop Codes) is removed from each image.

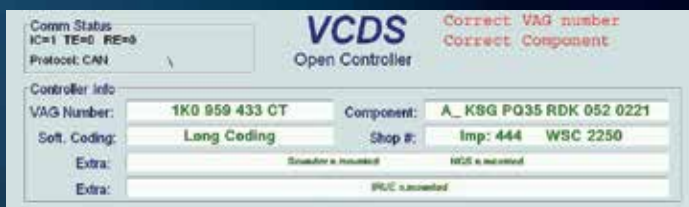
Imp: 444 is a US importer code.

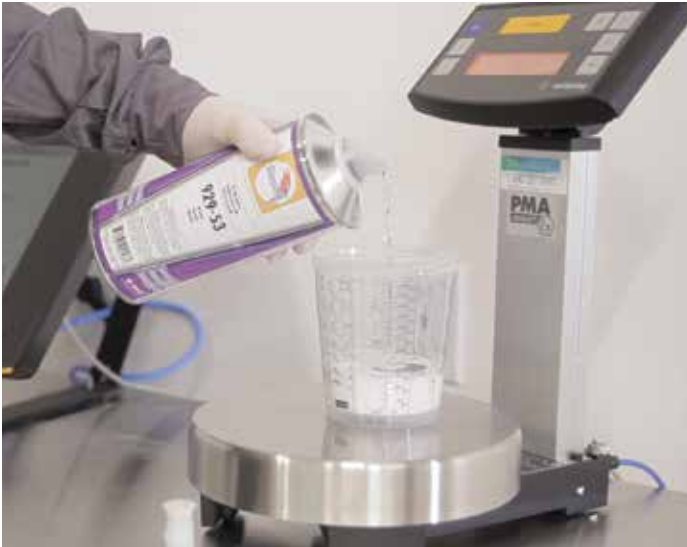
This painter is adding Glasurit 929-53 hardener to a mix of a 2 component Glasurit Urethane Sealer to create a ground coat color formula. The resulting gray ground coat enables poor hiding colors such as reds and yellows to achieve coverage and excellent color match with fewer coats.

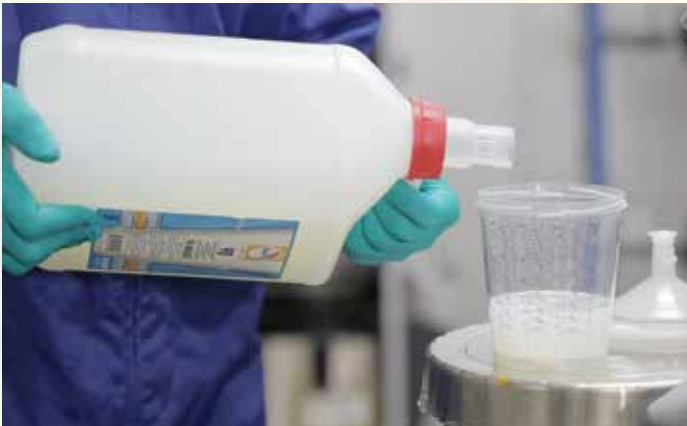
Adding 90-M4EDT (Extended Dry Time) Mixing Clear to Glasurit 90-Line or R-M Onyx basecoats in high heat, low humidity climates prevents paint film from drying too fast for proper pigment flop.

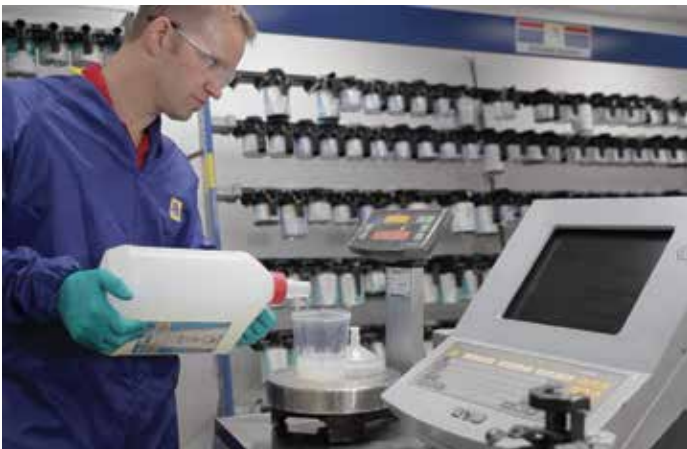
BASF color formula software interfaces with an electronic smart scale to allow pinpoint control of color mixing.

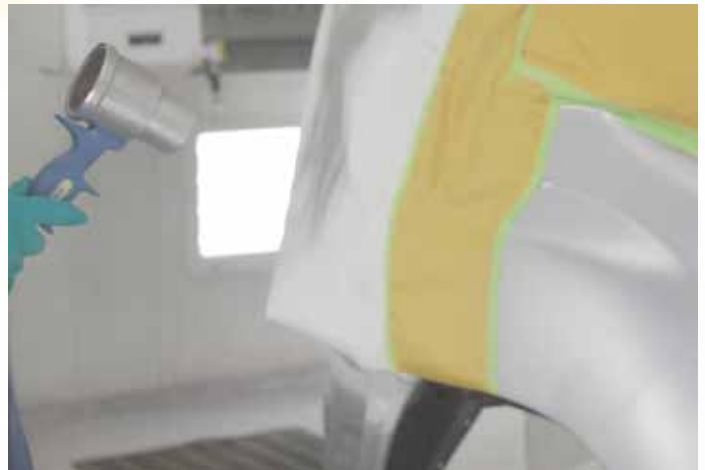
Portable air blowers are significantly less costly to operate than increasing the heat in your booth bake cycle.

FACT: Without turbulent air movement, waterborne basecoats take longer to dry. The standard laminar (downflow) air in a paint booth follows the contour of the vehicle or parts being painted. As laminar air flows around the vehicle or part, it creates a boundary layer of slow moving air close to the painted surface, even though air that is further away is moving faster. As water evaporates from a waterborne basecoat, this slower moving boundary air layer quickly becomes

saturated with water. The saturated layer blocks and reduces the rate of evaporation of additional water from the paint film.

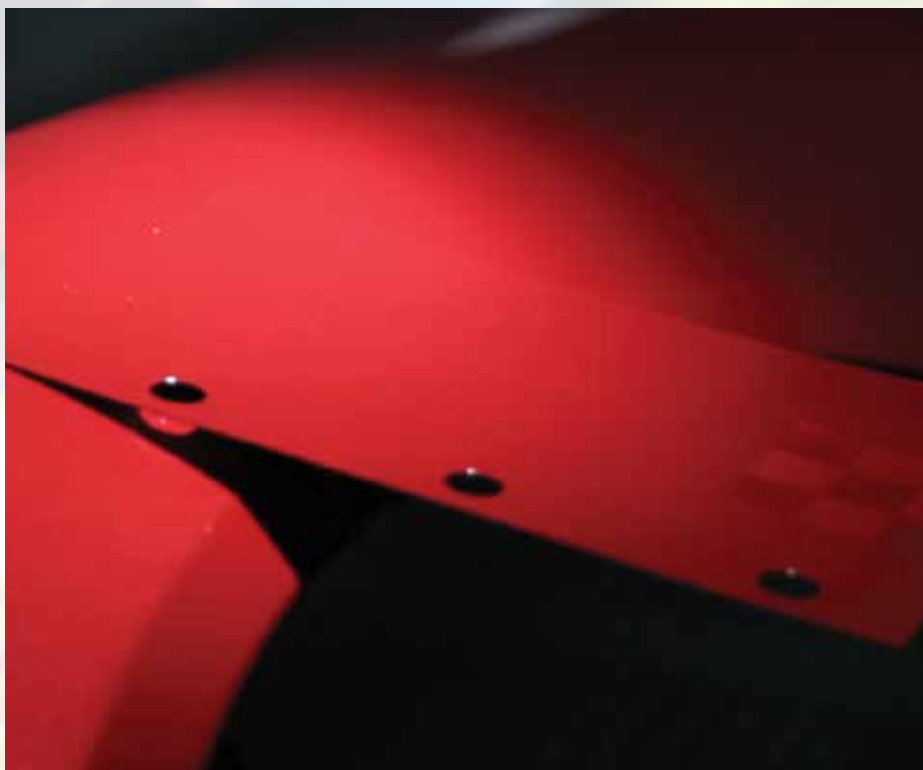
The color and gloss of waterborne paint is not finalized until it is dry and clear-coated. You won't know whether or not you've achieved a good color match until the clear has dried. This makes use of sprayout test panels absolutely critical to success.

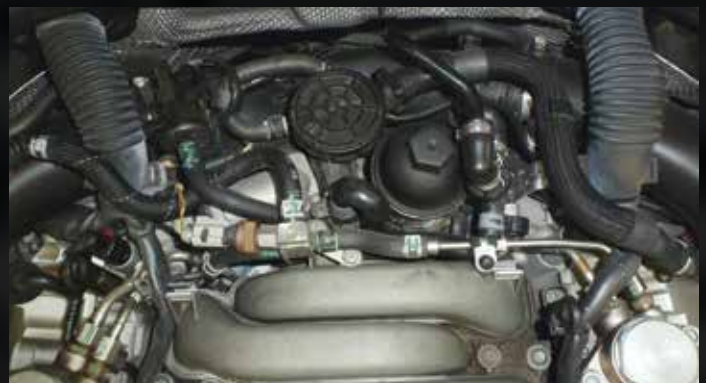
On many Audi engines, the oil filter resides on top of the engine. This makes for a much quicker and cleaner replacement.

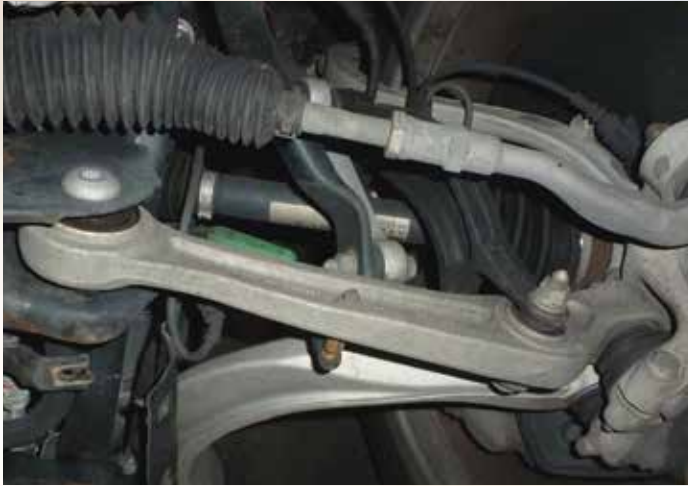
Small tears in the bushing are normal and do not call for replacement. Longer tears that completely separate the bushing mean the it has failed and needs replacement. The upper control arms are readily visible once the vehicle is on a lift.

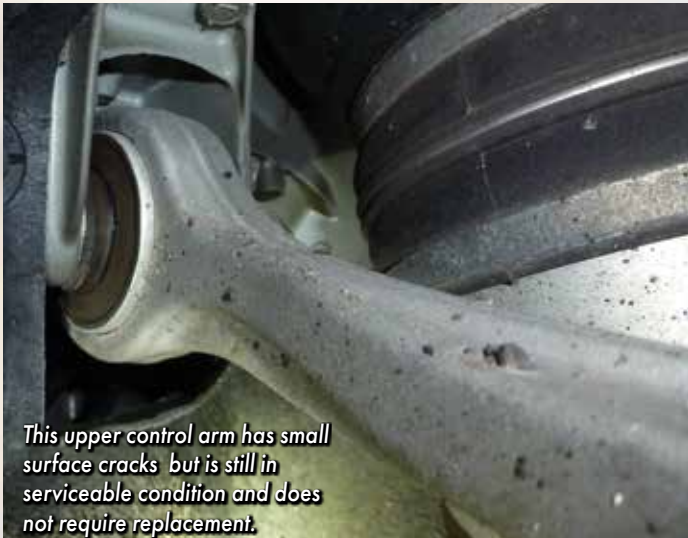
This upper control arm has small surface cracks but is still in serviceable condition and does not require replacement.

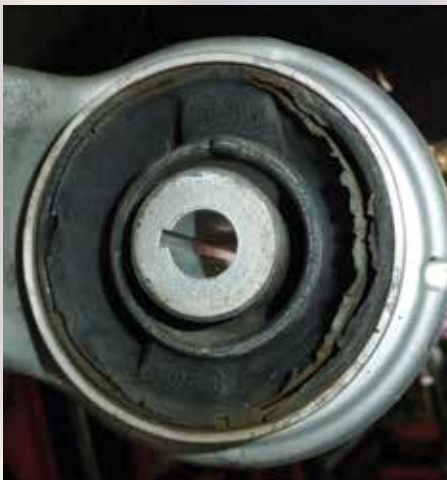
This lower control arm bushing has failed, allowing excessive wheel movement and noise.

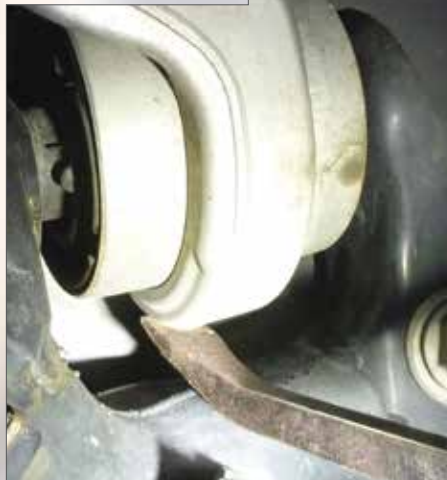
Using light pressure on the bushing with a pry bar can help determine if the bushing has failed.

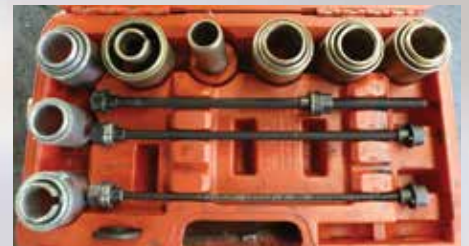
A good bushing press kit can service almost any vehicle that comes into the shop.

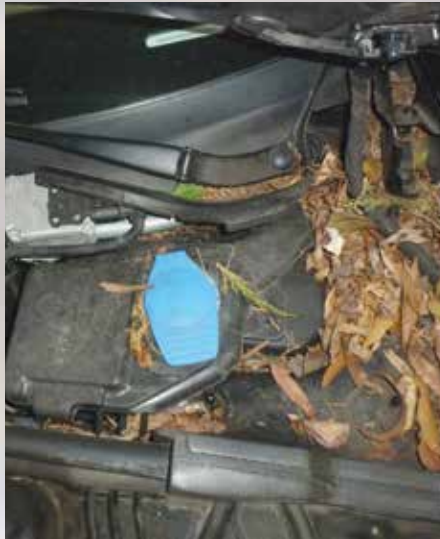
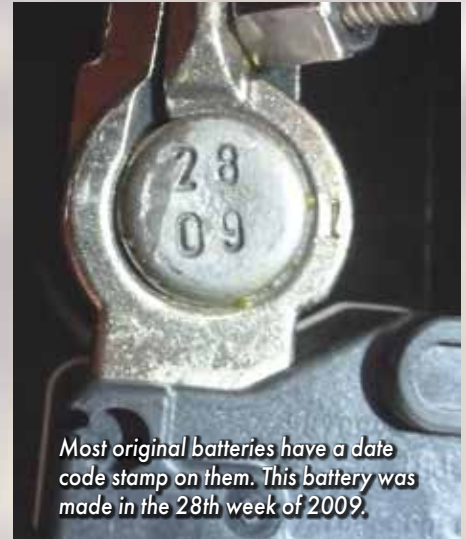
Most original batteries have a date code stamp on them. This battery was made in the 28th week of 2009.

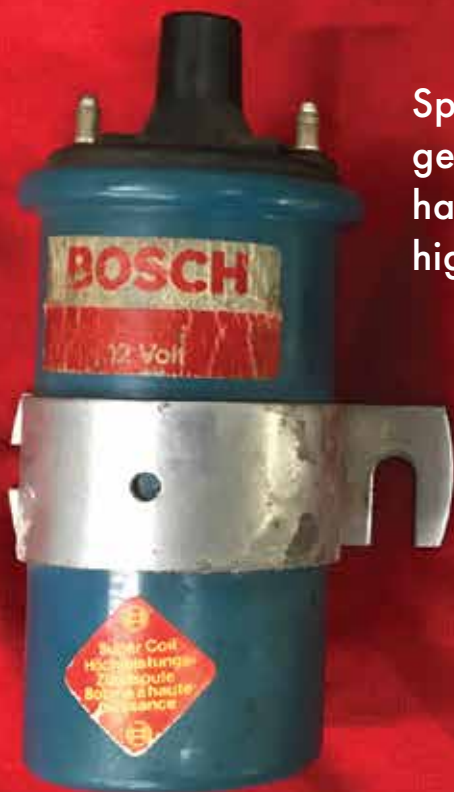
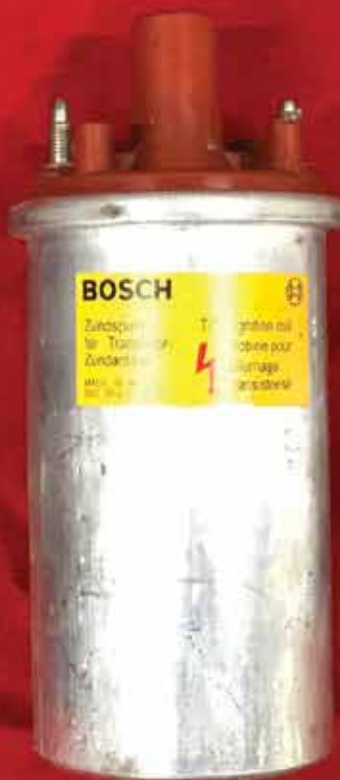
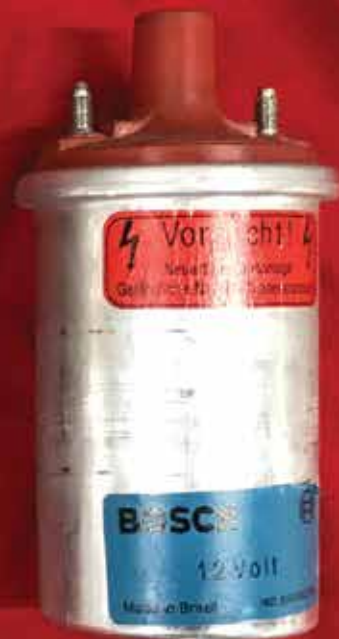
Example of three early ignition coils. Sometimes bigger is better! The bigger the coil, the more room for secondary windings. This allows for a more powerful, high voltage spark.

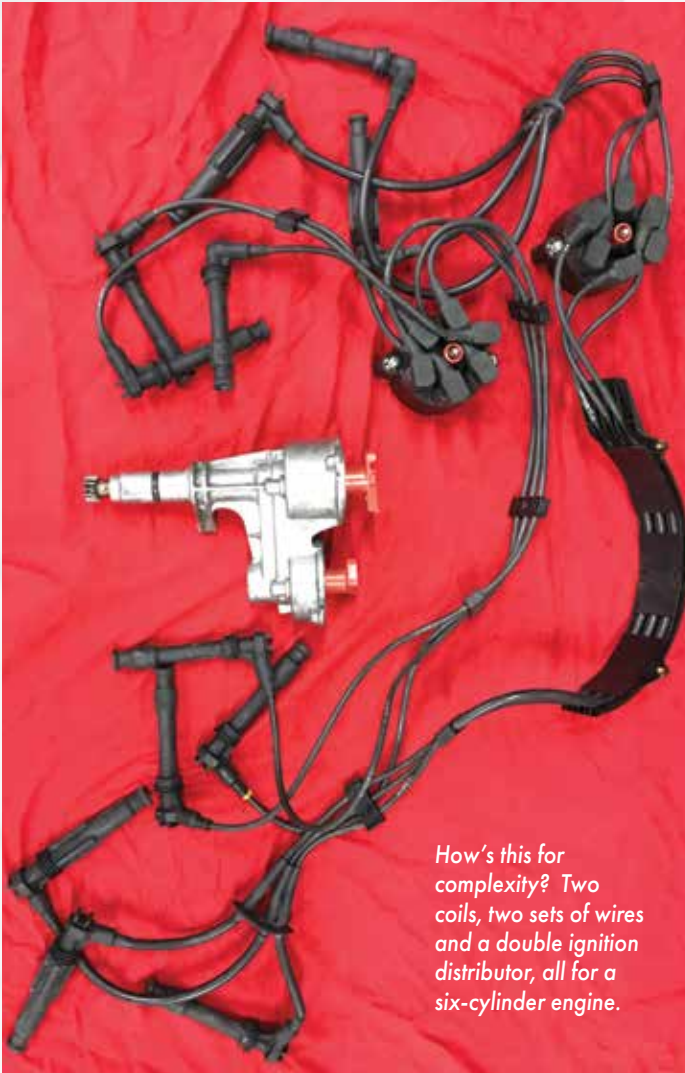
How's this for complexity? Two coils, two sets of wires and a double ignition distributor, all for a six-cylinder engine.

The other drawback is that the single coil ignition system requires an elaborate spark delivery system. Ignition distributors, distributor caps, ignition rotors, and high-tension spark plug wires are all required paraphernalia when using only a single coil. With a system this elaborate, there are lots of potential areas for failure.

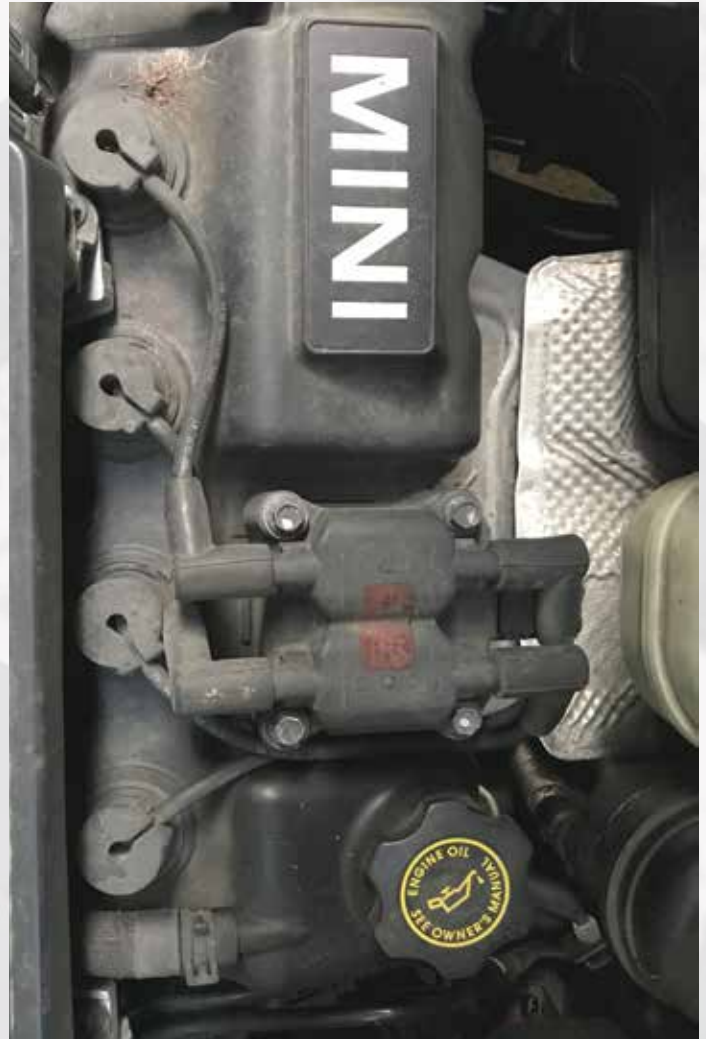
This is a typical waste spark system with one coil firing two cylinders.

The idea is that a single coil can serve two cylinders. This coil fires two spark plugs serving companion cylinders simultaneously. One spark plug is igniting the fuel air mixture for the cylinder that is on its compression stroke while the other plug is just firing needlessly on the companion cylinder's overlap stroke.

The reason for firing two plugs at the same time was two-fold: It simplified the triggering of the coil and, by firing two spark plugs at once, it allowed the coil to fire in one direction. That is, the secondary current would flow only in one direction, so the spark would jump from positive to negative on one cylinder while its companion would jump from negative to positive. This can be evidenced by examining spark plug wear.

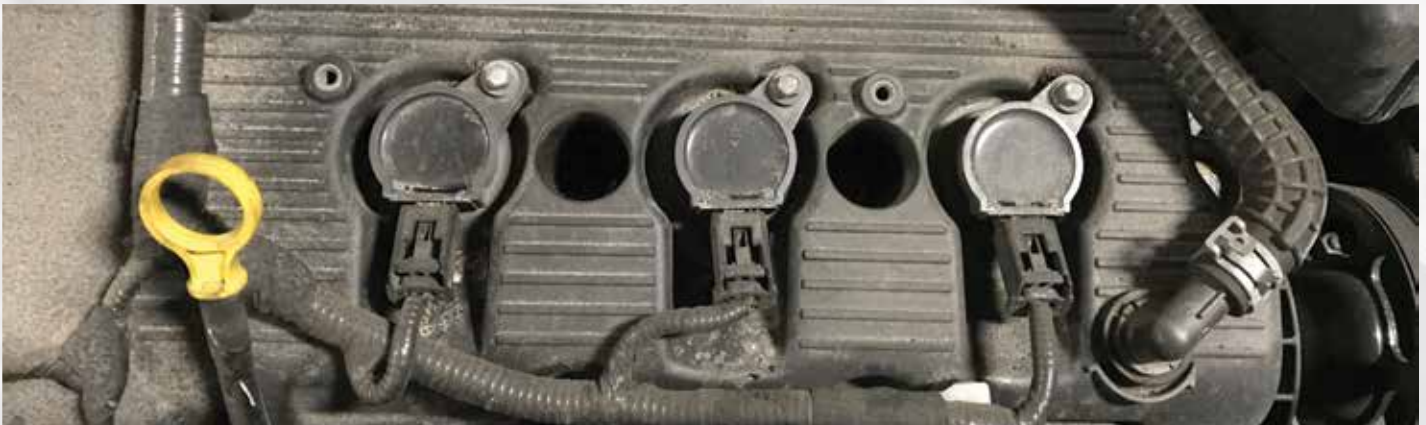
Half of a V-6 engine shows one coil for each of the three cylinders. This allows enough time for thorough coil saturation.

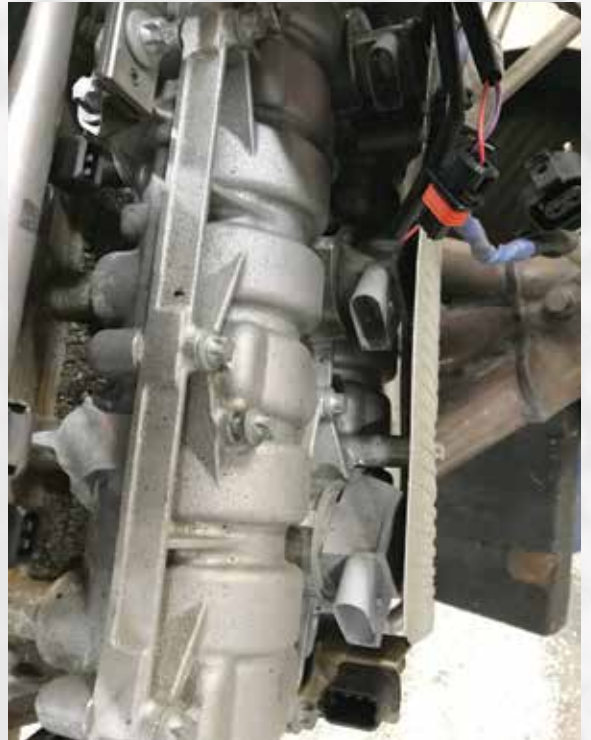
Were it not for the fact that this engine is out of the car, one would not be able to even see these coils. Servicing coils and plugs on this engine requires removal of exhaust components, heat shields and whatever else happens to be in the way.

Porsche engines, at least the engines in their sports models, utilize a horizontally opposed layout. Among many other advantages, this layout provides a low profile and low center of gravity. It also provides a challenge for coil on plug ignition systems in that the location of the coil exposes it to not only heat from the exhaust, but all the elements; rain, snow and road grime.

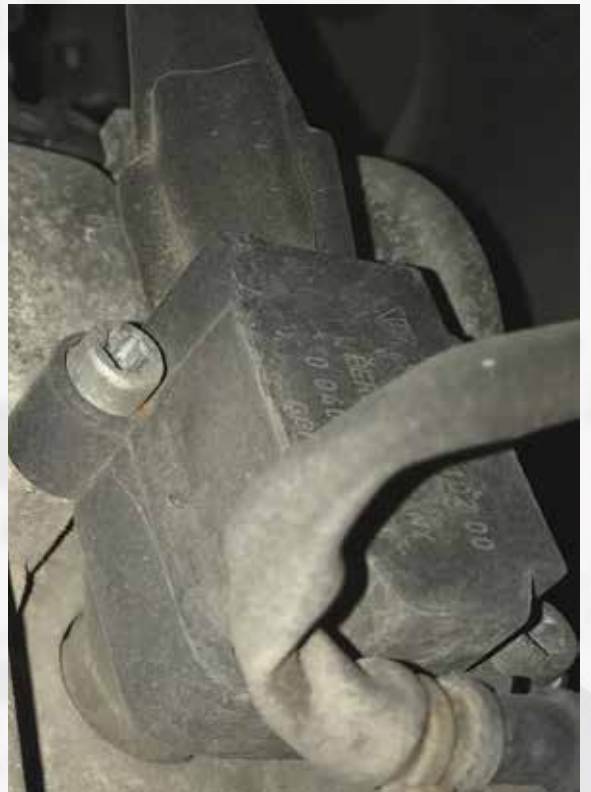
How's this for a bad environment? This coil has to live under the engine where all the water, ice and road salt can attack.

It is especially important to inspect these coils on Porsche engines for damage as a result of rust and corrosion from living in this highly hostile environment.

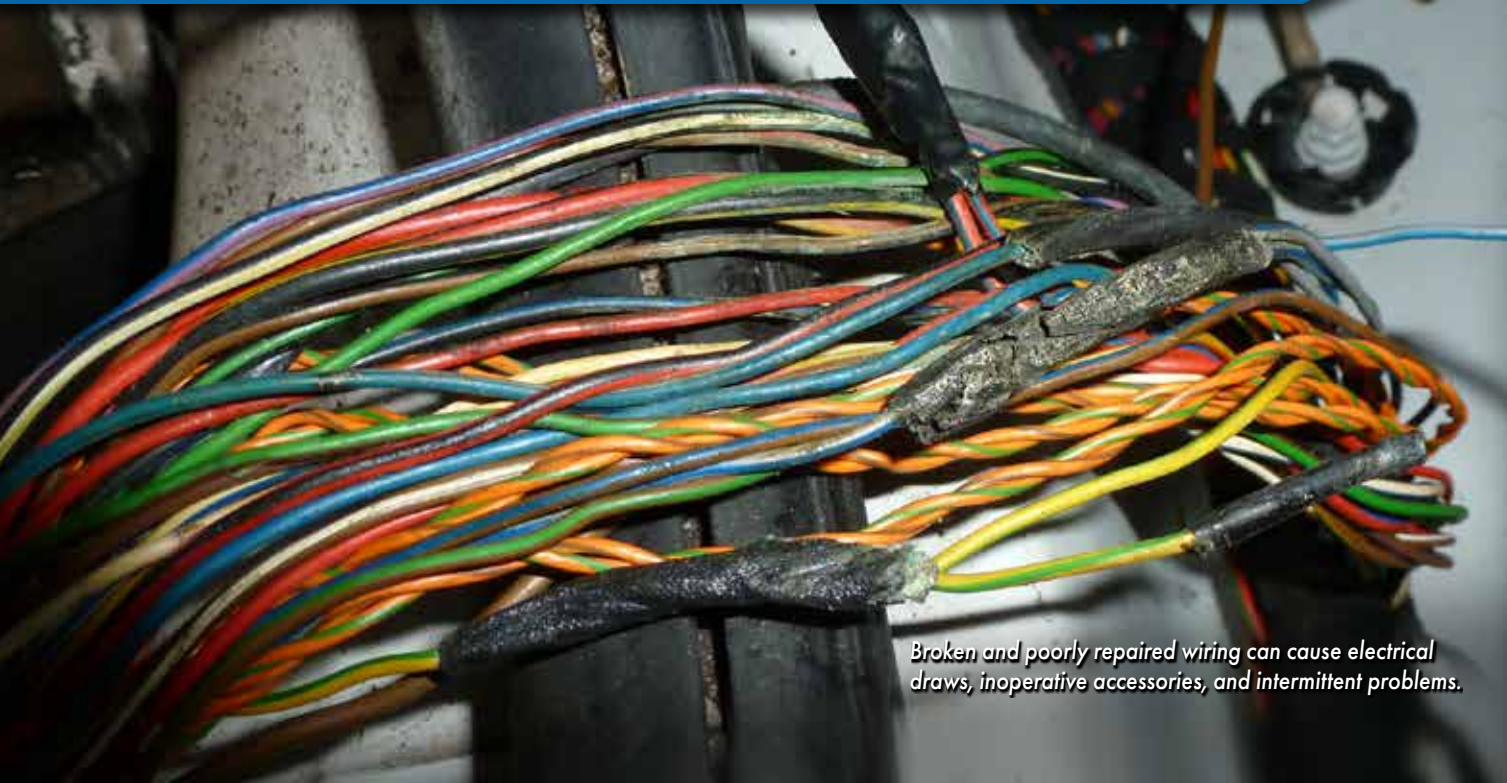
Broken and poorly repaired wiring can cause electrical draws, inoperative accessories, and intermittent problems.

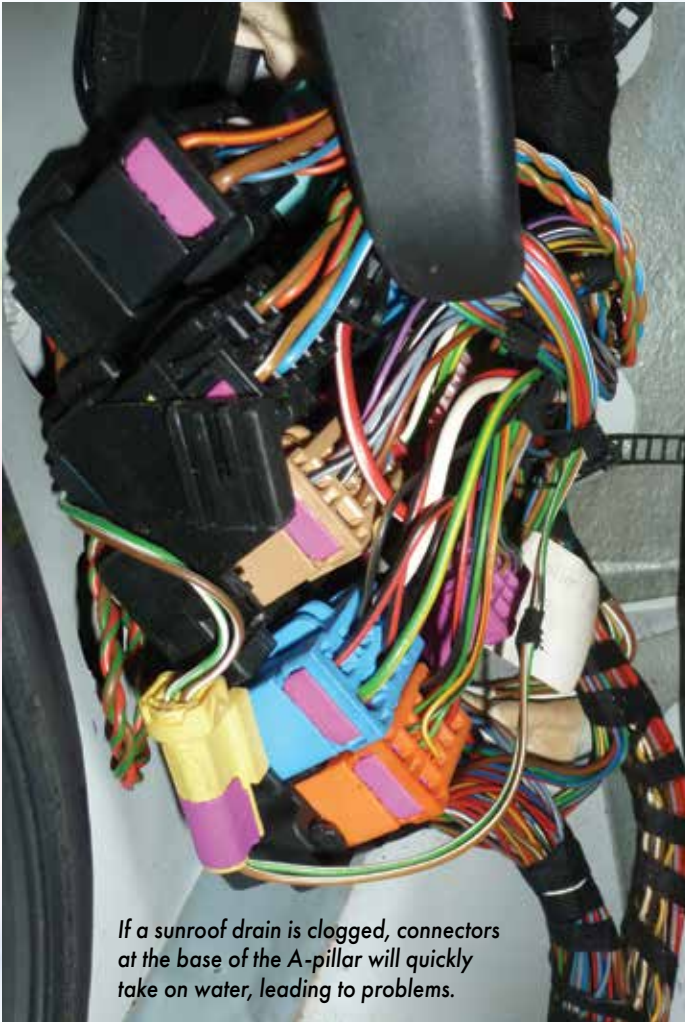
If a sunroof drain is clogged, connectors at the base of the A-pillar will quickly take on water, leading to problems.

VW service states that sunroof drains should be cleaned at least every 30K miles, and sooner in cases where the vehicle may be parked outside under trees or in certain climates. Most often, a blocked drain is due to dirt and plant matter accumulation. If such blockages are left without repair, the drain water can quickly become an issue. Front sunroof drains are the most common to experience clogging. When these drains become obstructed, rainwater travels down the A-pillar and drains inside the vehicle. The components that lie below this part of the vehicle are susceptible to damage, as they may be electrical components. These can be fuse/relay boxes, door harness connectors, and electronic throttle units.

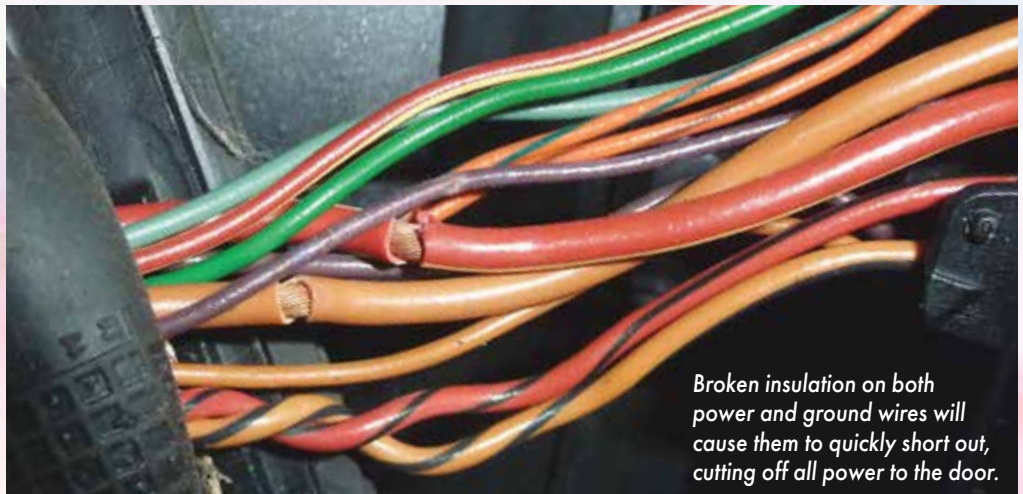
Broken insulation on both power and ground wires will cause them to quickly short out, cutting off all power to the door.

Another area of the vehicle that sees tremendous use is doors. With numerous convenience features available in modern VWs, a lot of wiring has to travel to the doors, more so in the driver's side. This wiring, being constantly flexed, sometimes degrades. Often, a customer's complaints will lead you to a faulty door harness wiring. Nonfunctioning windows and inoperative power locks are the most common complaints. It is smart to do a full vehicle scan as a first step in diagnosis. This will help take you in the right direction if there are multiple system faults such as short to ground or open circuit faults in any of the vehicle systems that share the door wiring.

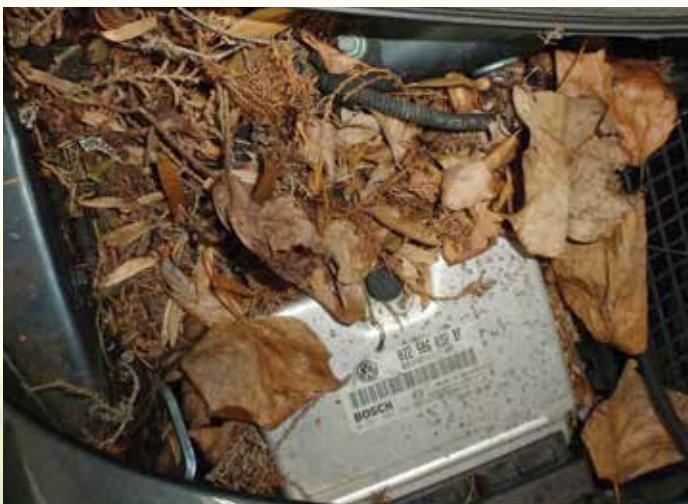
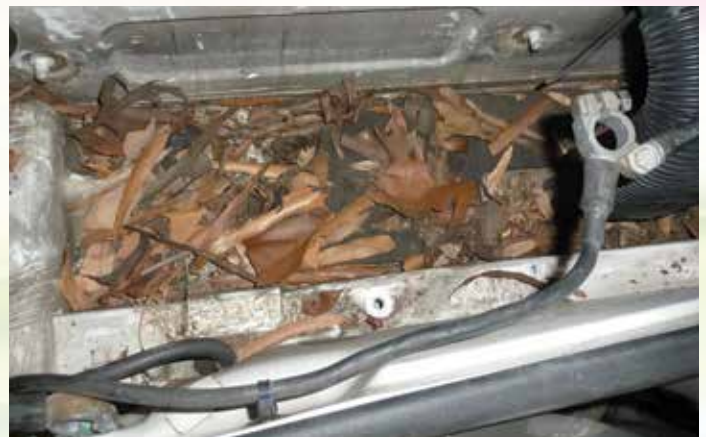
If not periodically cleaned, the cowl area will eventually clog, leading to water ingress.

The cowl drains elsewhere in a vehicle also contribute to water ingress if left unchecked. When the underhood cowl drains become clogged, the water often overflows directly into the vehicle's fresh air inlet. This will force water into the interior of the vehicle and collect on the floorboards. Many early 2000 Passat models suffered from water ingress issues. The main body harness typically runs through the floors, and water can make its way into connectors and splices there, resulting in a myriad of issues. Close visual inspection is best here, checking for split insulation, corrosion, and broken wires. Often, electronic modules are also located in the floorboards and can quickly be submerged and damaged from water.

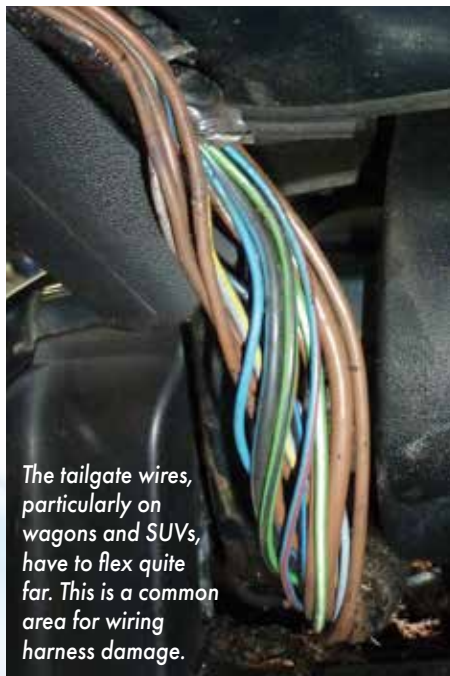
The tailgate wires, particularly on wagons and SUVs, have to flex quite far. This is a common area for wiring harness damage.
