Technical Knowledge for Volkswagen®, Audi® and Porsche® Service Professionals

**Audi's Electro-Mechanical
Parking Brake System**

Porsche Engine Rebuild

VW Coding Mysteries

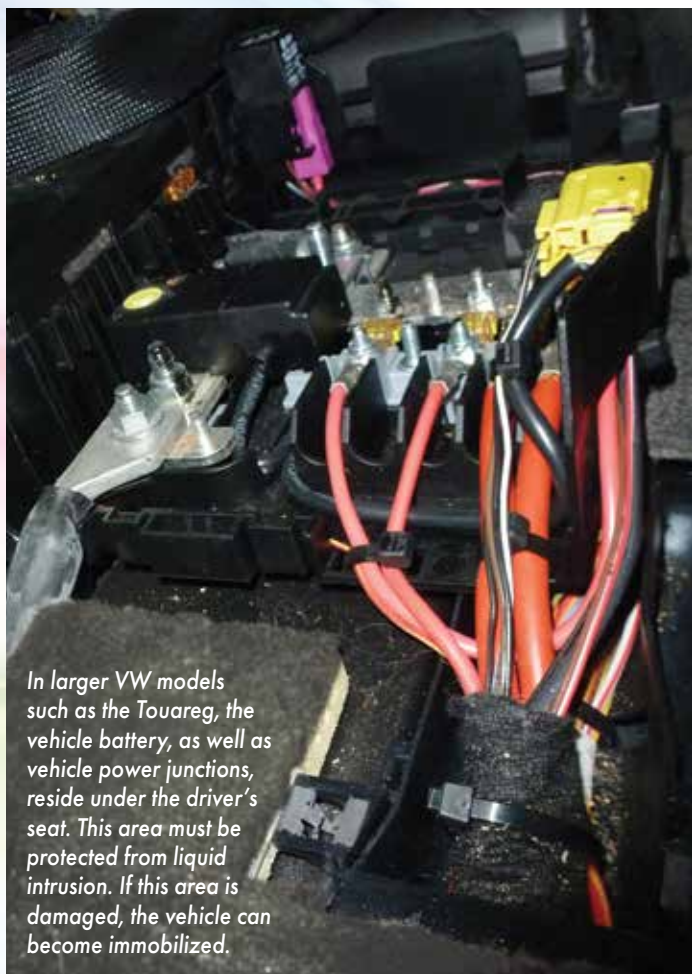
In larger VW models such as the Touareg, the vehicle battery, as well as vehicle power junctions, reside under the driver's seat. This area must be protected from liquid intrusion. If this area is damaged, the vehicle can become immobilized.

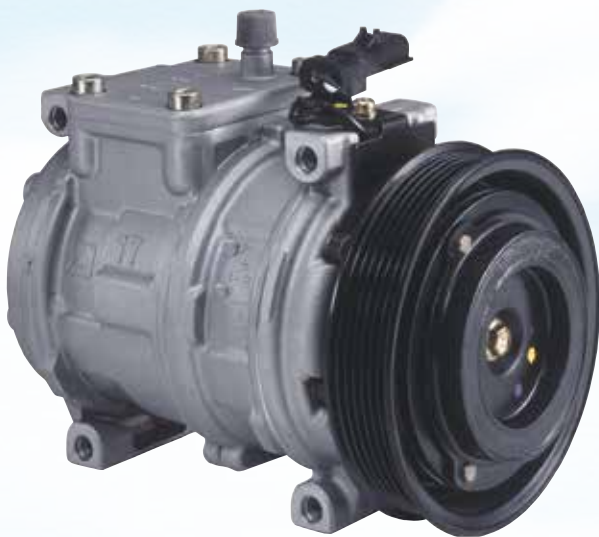
If you replace a Sanden with a Denso (shown here) compressor in a 2011-2015 Volkswagen, you'll need also to flush the system to remove the existing oil. The Denso compressor requires a different PAG formulation than the Sanden. The two PAG oils cannot be mixed in the same system.

A real-world scenario is the need to switch lubricant if you are replacing a Sanden with a Denso compressor (or vice-versa) in a 2011-2015 Volkswagen (all models except the Routan). Both are R134a systems and use PAG oil, but each compressor brand requires a different PAG formulation. You must flush the entire system to remove all of the existing PAG oil before installing the replacement compressor.

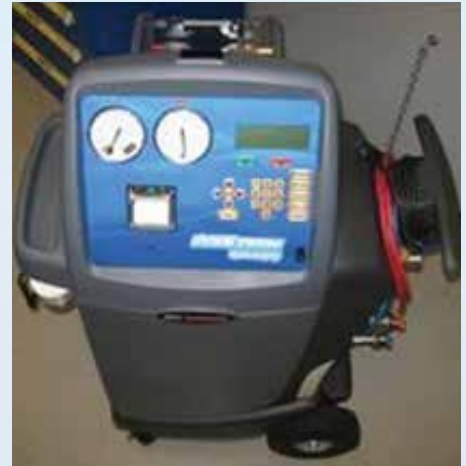
The ROB134APF Air Conditioning Service System with VAS 6337/1A Air Conditioning System Flushing Device offers complete refrigerant recovery, evacuation, recharge and system flushing in a single service machine.

Use the A/C Service Station with Flushing Device – VAS6381 – or Air Conditioning Flush Tool – VAS6337 – for refrigerant flushing. The flush function and flushing tool are built-in on these A/C service machines,

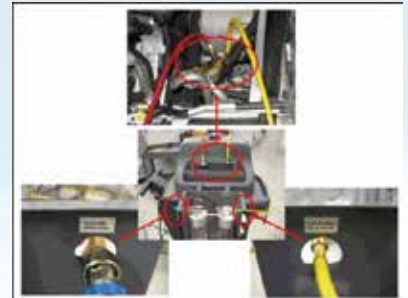
Connecting from the vehicle to the service equipment and then to the flush machine allows you to perform a system flush in the opposite direction of the normal refrigerant flow.

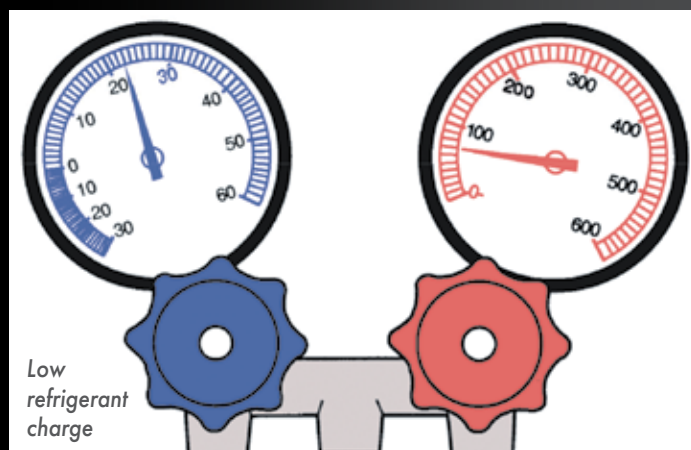
Low refrigerant charge

Condition 1: High pressure remains at static pressure and increases only slightly, low pressure drops quickly to suction pressure.

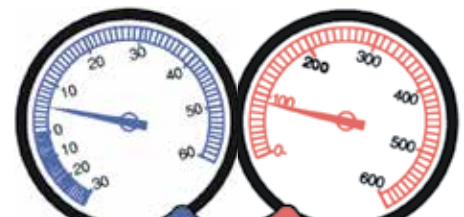
Low pressure switch faulty

Condition 4: Low pressure too low, low pressure switch shuts off compressor, proper cooling performance is obtained when system operates.

The low pressure switch may be faulty, or there may be a compressor problem.

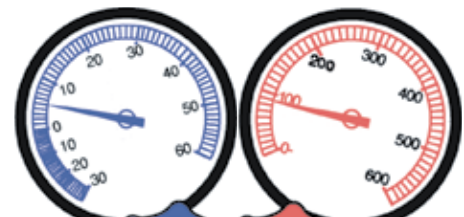
Low refrigerant charge

Condition 5: Low pressure too low, low pressure switch shuts off compressor, proper cooling performance is not obtained when system operates.

This may indicate a low refrigerant charge.

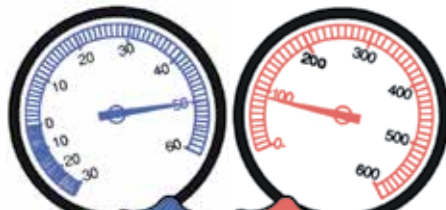
A/C compressor faulty

Condition 2: High pressure increases only slightly above static pressure, low pressure drops only slightly below static pressure.

This may indicate a faulty compressor.

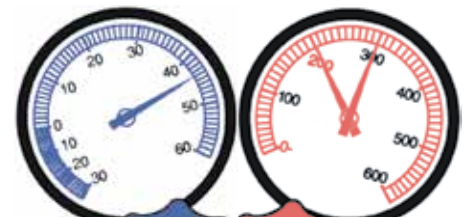
System is overcharged

Condition 6: Low pressure too high, high pressure normal or increases above specified value.

This may indicate a system overcharge.

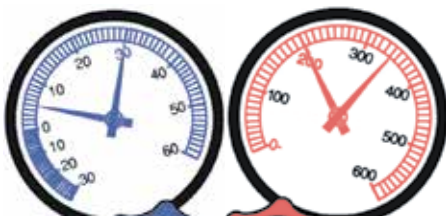
Moisture in system, restrictor ices up

Condition 3: High and low pressures normal. After a period of time, high pressures rise above the specified value, low pressure drops below the specified value.

This may indicate the presence of moisture in the system, and restrictor or expansion valve icing.

The dryer, dryer bag or dryer cartridge in the system can absorb approximately 7 grams (1.42 teaspoons) of water before becoming saturated. If any more water is in the system, it flows up to the expansion valve (TXV) nozzle or restrictor. There it freezes, causing the TXV to become stuck open or closed, and reducing cooling performance. Pull a deep vacuum after refrigerant recovery – the A/C system will thank you.

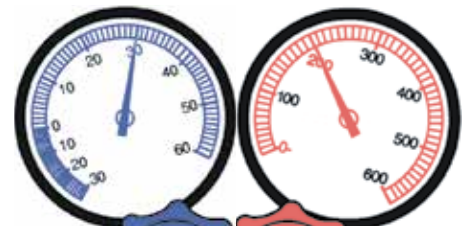
Too much oil in system

Condition 7: Low pressure normal, high pressure normal, proper cooling performance is not obtained.

This may indicate there is too much refrigerant oil in the system.
